Good information on HD 6 speeds

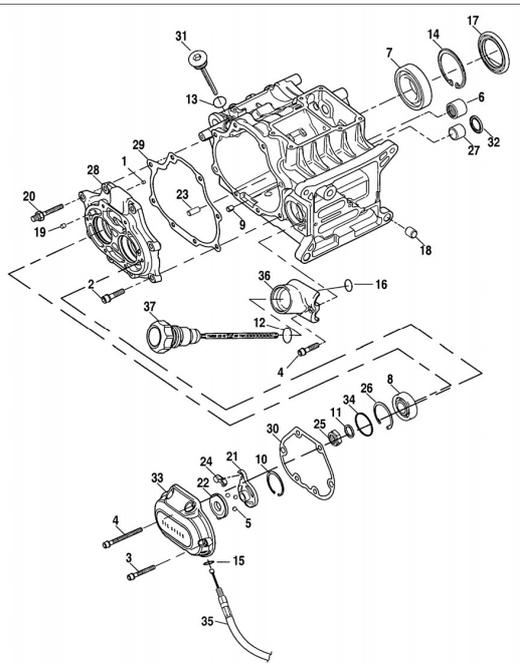
1.

Die Lager des Direkten-Gang Rades 7 zeigen erhöhten Verschleiss..

Zu erkennen ist dies durch metallischen Abrieb, der sich im rechten Getriebedeckel 33 abgelagert.

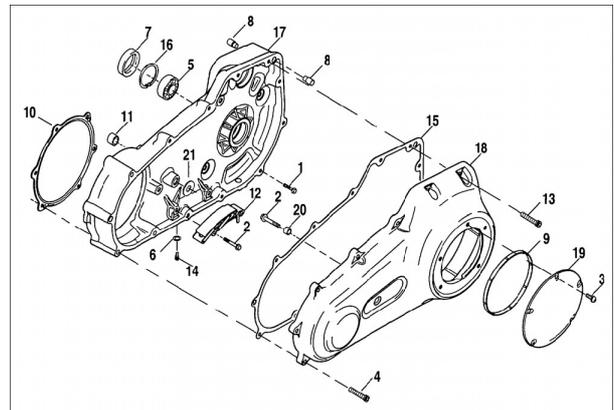
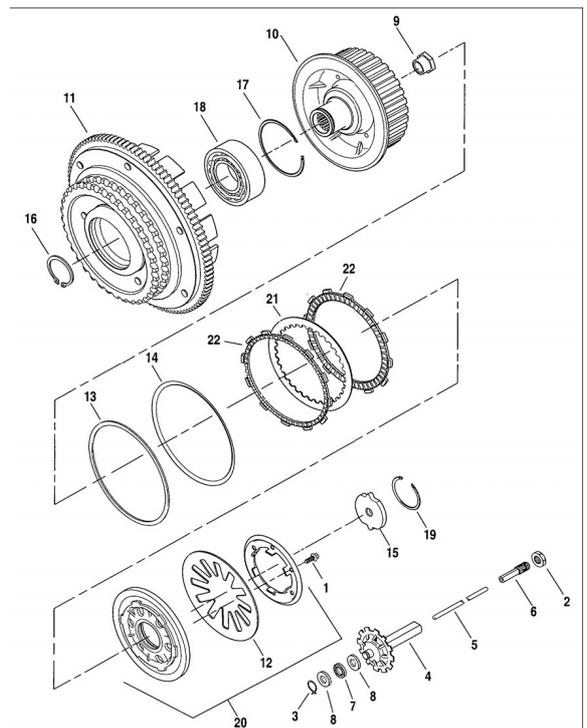
2.

Durch Schrapnells die von der Kupplungs-nabenverzahnung abplatzen, werden das Hauptwellenstütz-lager 5 im Primär sowie das Kupplungs-naben-lager, 18 beschädigt.
