SIB 64 07 17

## RECALL 17V-676: BLOWER MOTOR WIRING

E90 (3 Series Sedan including M3)	E91 (3 Series Sports Wagon)	E92 (3 Series Coupe including M3)	E93 (3 Series Convertible including M3)
-----------------------------------	-----------------------------	-----------------------------------	---

Vehicles produced from February 1, 2005 to December 16, 2011

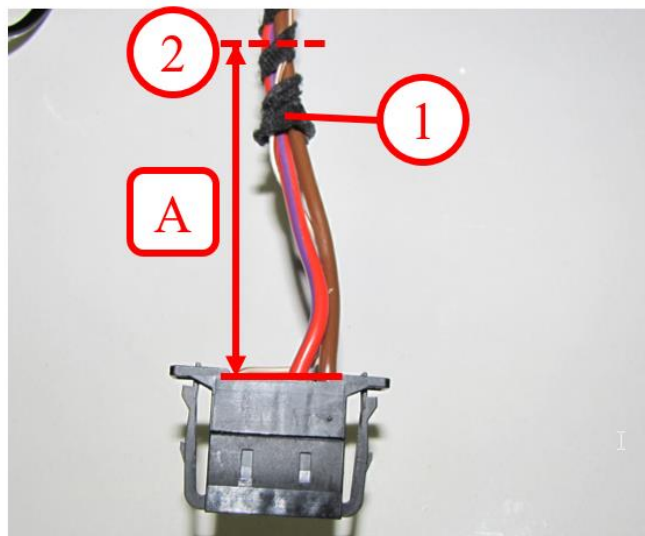
- Measure distance (A) 6 cm from the connector housing and mark the harness (1) at (2).
- This area of the harness is used for your inspection

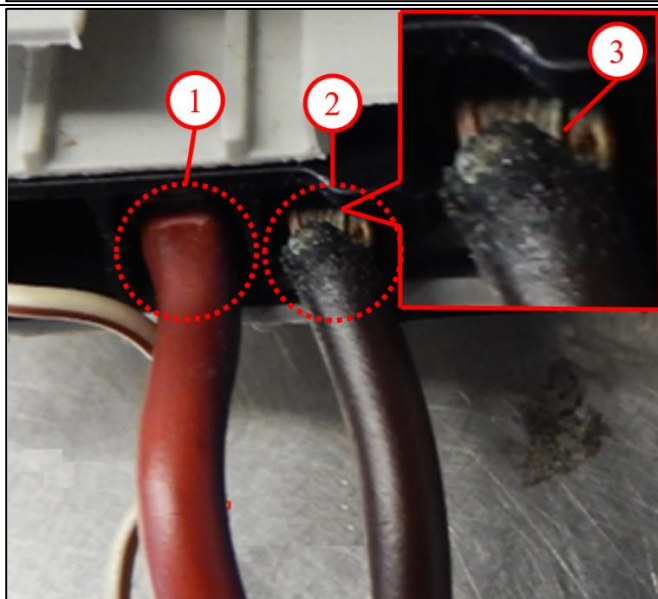
- Inspect the harness wires (1) and (2) at the connector for discoloration and copper wires (3) exposed.
- Are there both discoloration in the harness insulation and copper wire exposed as in the picture to the left?

**Yes** – This is a **Type 1** case.  
Install the long repair harness and replace the blower regulator in order to finish the repair.

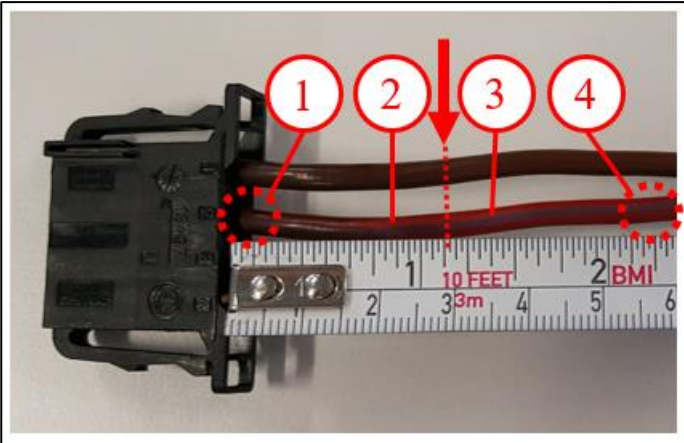
- Inspect the wires (3) end (4) next to connector end (1). Do this for both Red/Blue (Red/Violet) (2) and Brown (5) wires
- Is there a difference in the discoloration of the wire insulation at (1) and (4) as shown in the close-up picture?

**Yes** – This is a **Type 2** case.  
Install the short repair harness and replace the blower regulator and finish the repair.

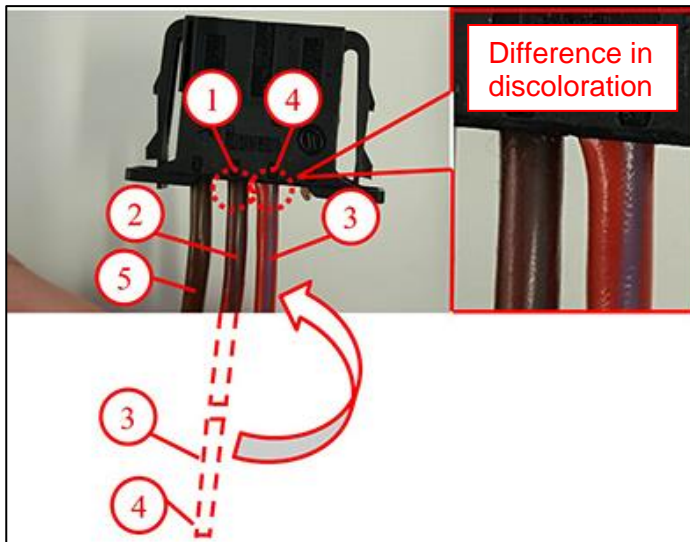
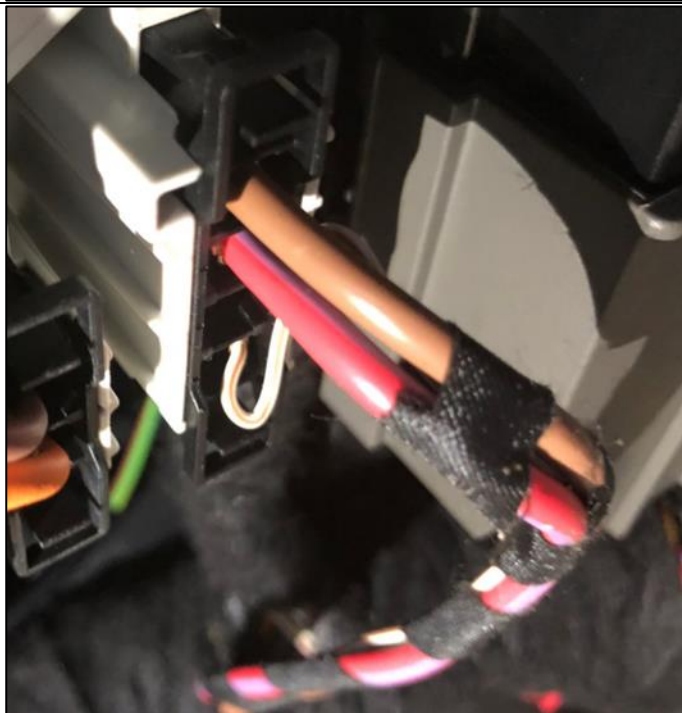
- If there is no discoloration in the wire insulation at all then this is a **Type 3** case.
- Install the short repair harness and finish the repair.
