SIB 09 03 21

NO RSU OFFER TO RSU CAPABLE VEHICLES

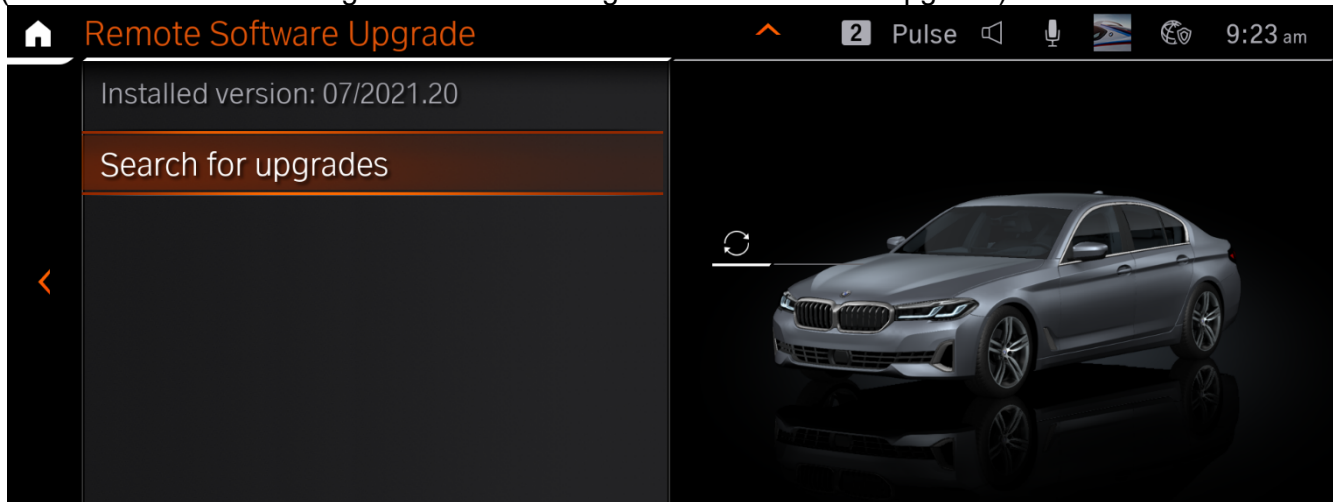
2. Check within the vehicle for an available Remote Software Upgrade
(Menu → Vehicle → Settings → General settings Remote Software Upgrade)

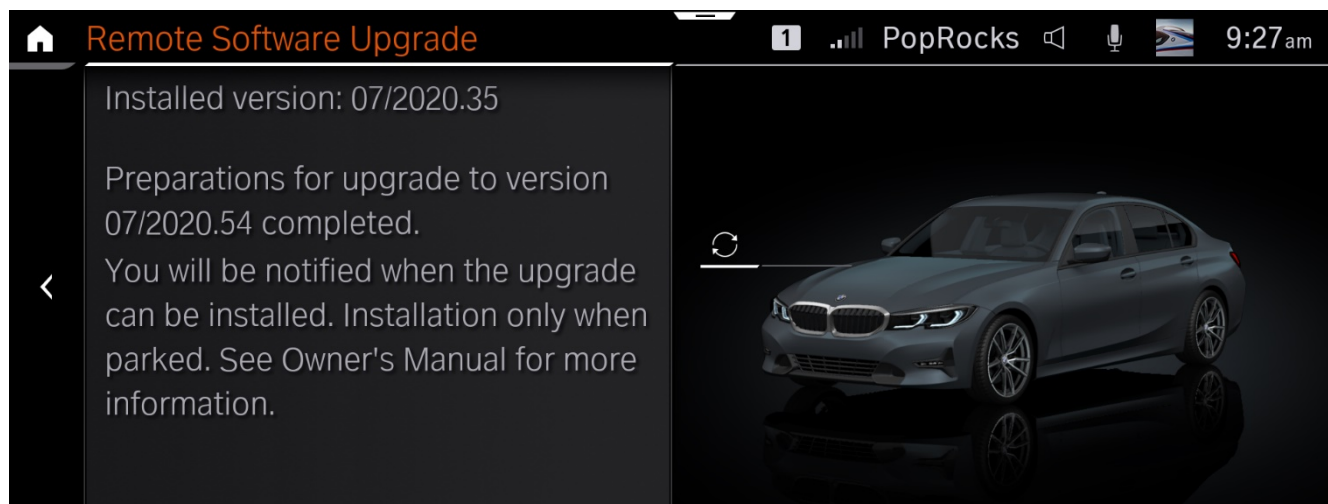
Please note that the RSU installation is only offered in the “goodbye” screen after completed preparation and when a driving cycle is ended (when the engine is turned off). The preparation is only performed during a driving cycle (or while in diagnostic mode).

- c. A vehicle is only potentially excluded from an RSU rollout when-
- The search for a rollout shows that there is no upgrade available, and-
 - The shown installed version is older than the current Software version rolled out via RSU and the RSU rollout is active since at least 5 weeks

d. In this case the vehicle can be programmed with ISTA and the programming costs will be covered by warranty.
