Technical Service Bulletin

93: DTC(s) P0A4000, P0A2E00 or P0A2B00 stored in the Electric Drive Control Module

93 22 69 2066596/1 March 25, 2022.

Model(s)	Year	VIN Range	Vehicle-Specific Equipment
A7 e quattro	2021 – 2022	All	Not Applicable

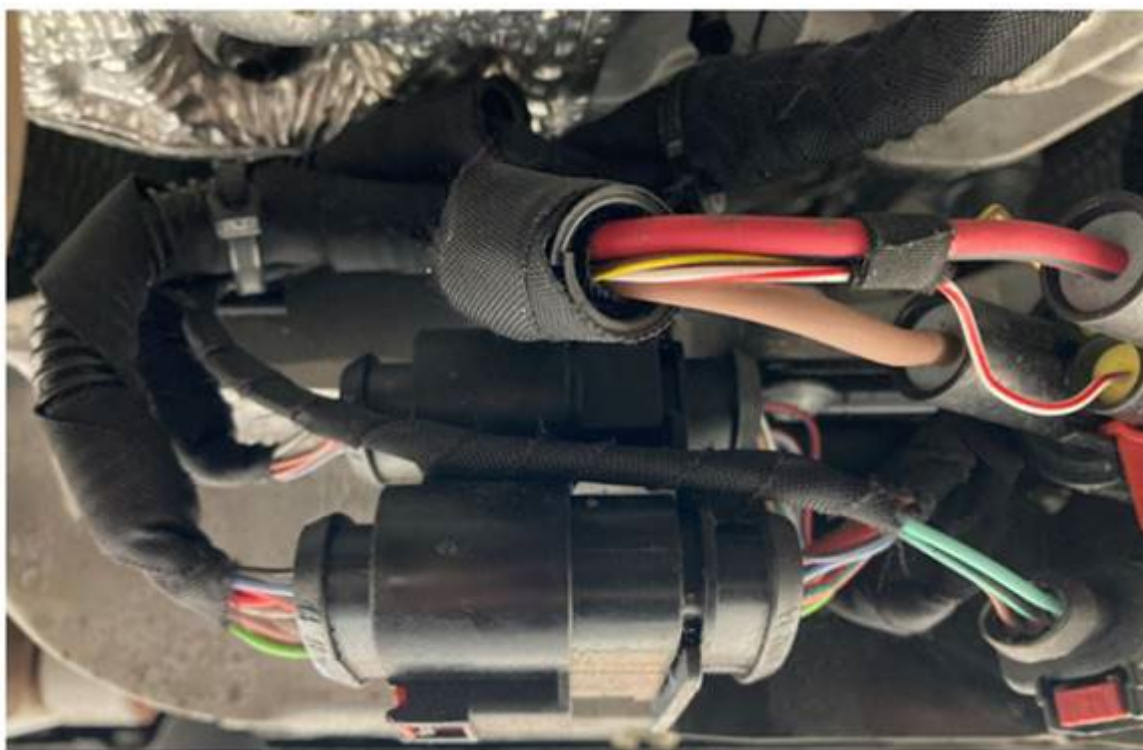
Contact abrasion in connector T6bm / T6bmX.

Figure 1. Connectors in the wrong position.

1. Check on the transmission bracket whether connector T6bm is installed at the top or the bottom of the bracket. The six-pin connector must be installed in the bottom position and the fourteen-pin connector T14k must be installed at the top.
2. If the connectors are in the wrong position (Figure 1), install them in the correct position (Figure 2).

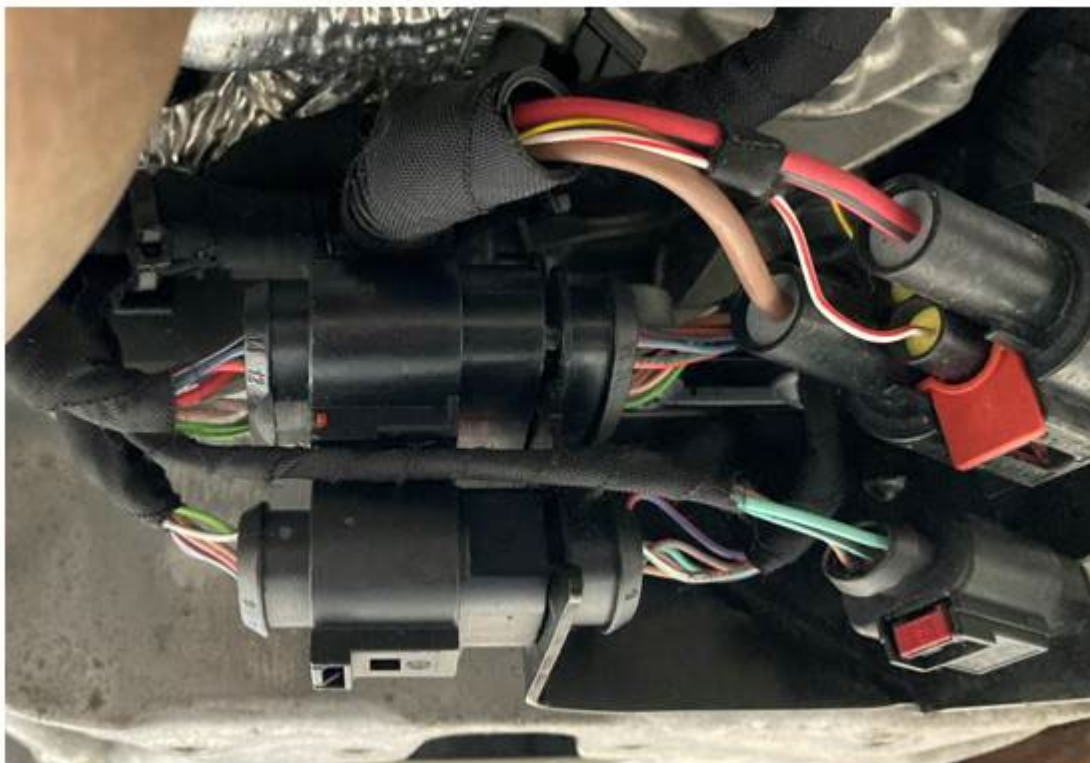
Figure 2. Connectors in the correct position.

3. To fix the complaint, unplug the six-pin connector and check the pins. If you do not identify any irregularities on the pins, plug the connector back in. Then erase all DTC memory entries and perform an extensive road test. If the complaint does not reoccur, the vehicle can be returned to the customer and the repair is done. Unplugging the connector and plugging it back in again renews the contact between the pins. This improves the contact resistance and should resolve the complaint. However, if the complaint reoccurs during the road test proceed to step 4.
4. If the complaint reoccurs or this TSB has been performed in the past, replace all the pins in the six-pin connectors T6bm / T6bmx with gold-plated pins from VAS 1978B wiring repair kit. Delete all DTC and confirm the repair with a test drive.
