## C180 Kompressor Timing chain replacement

### Which way does M271 27mm crank bolt turn to loosen?

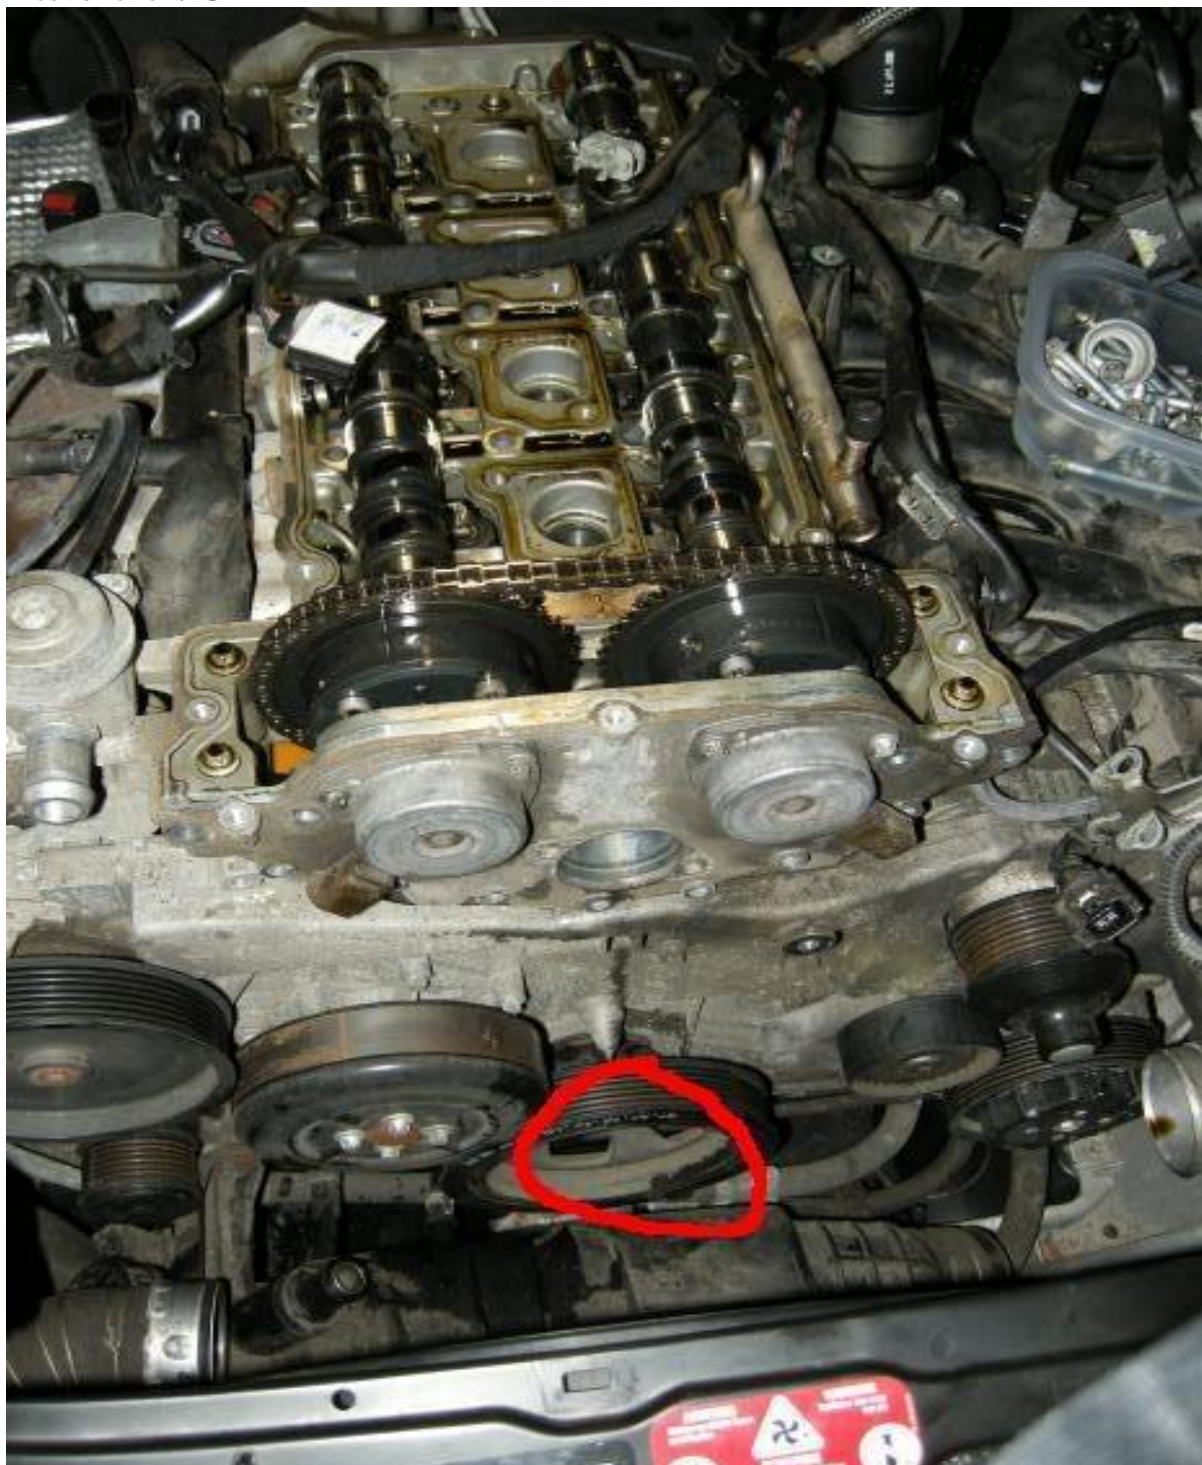
I'm in the midst of tearing down the engine in my 2003 C230 Coupe. Which way does the 27mm bolt on the front of the crank turn to take it off?

incase anyone ever finds this thread, it is 'normal' or counter clockwise to loosen it. And it requires like 170ft/lbs of torque.

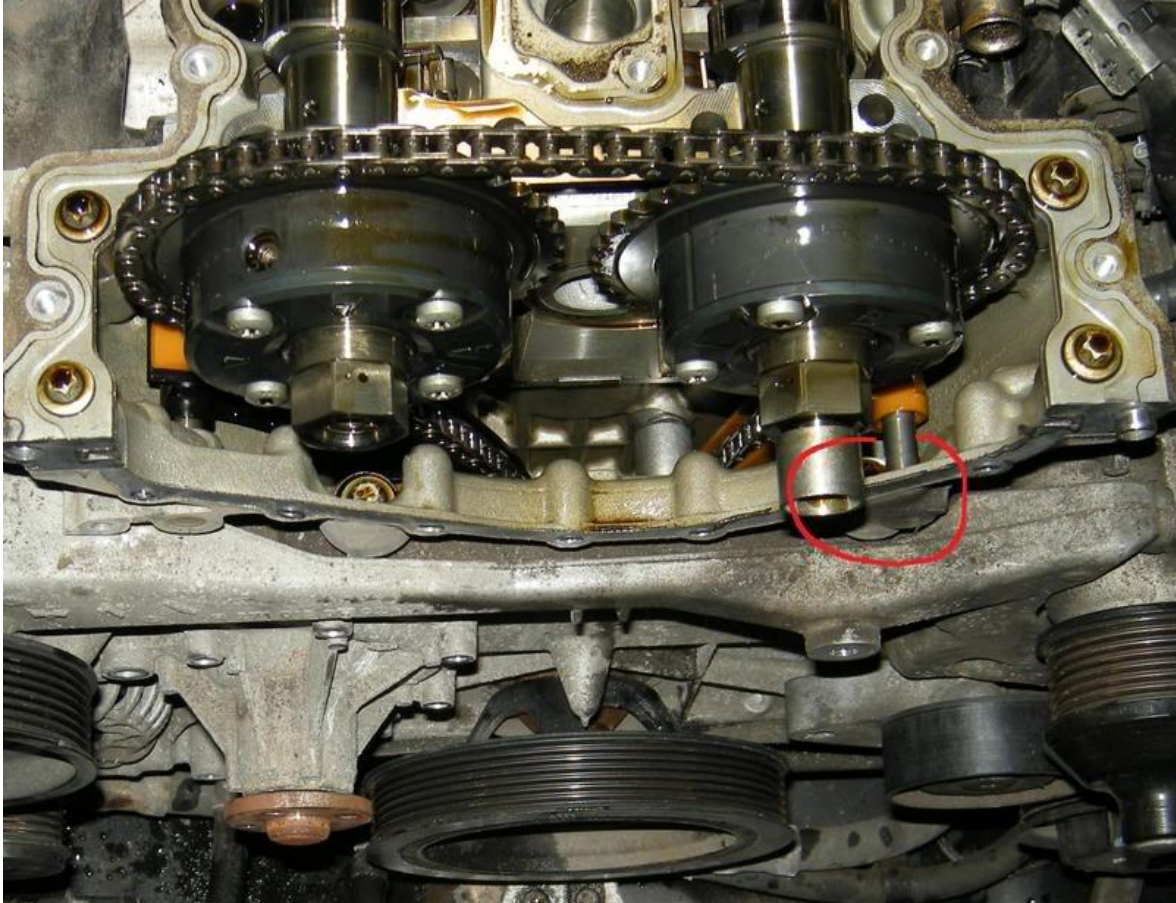
I am removing the cylinder head and there is one bolt remaining. Circled here:

The 'slide rail pin' that holds the driver-side chain tensioner is in the way of getting a socket on it. Looks like i need some kind of \$150 116 589 20 33 00 Impact Puller for slide rail bearing bolt, basic unit. <http://www.samstagsales.com/SirTool/...ompleteset.jpg>

Which I'm guessing I can just use something to thread into the slide rail and pull it out the front?

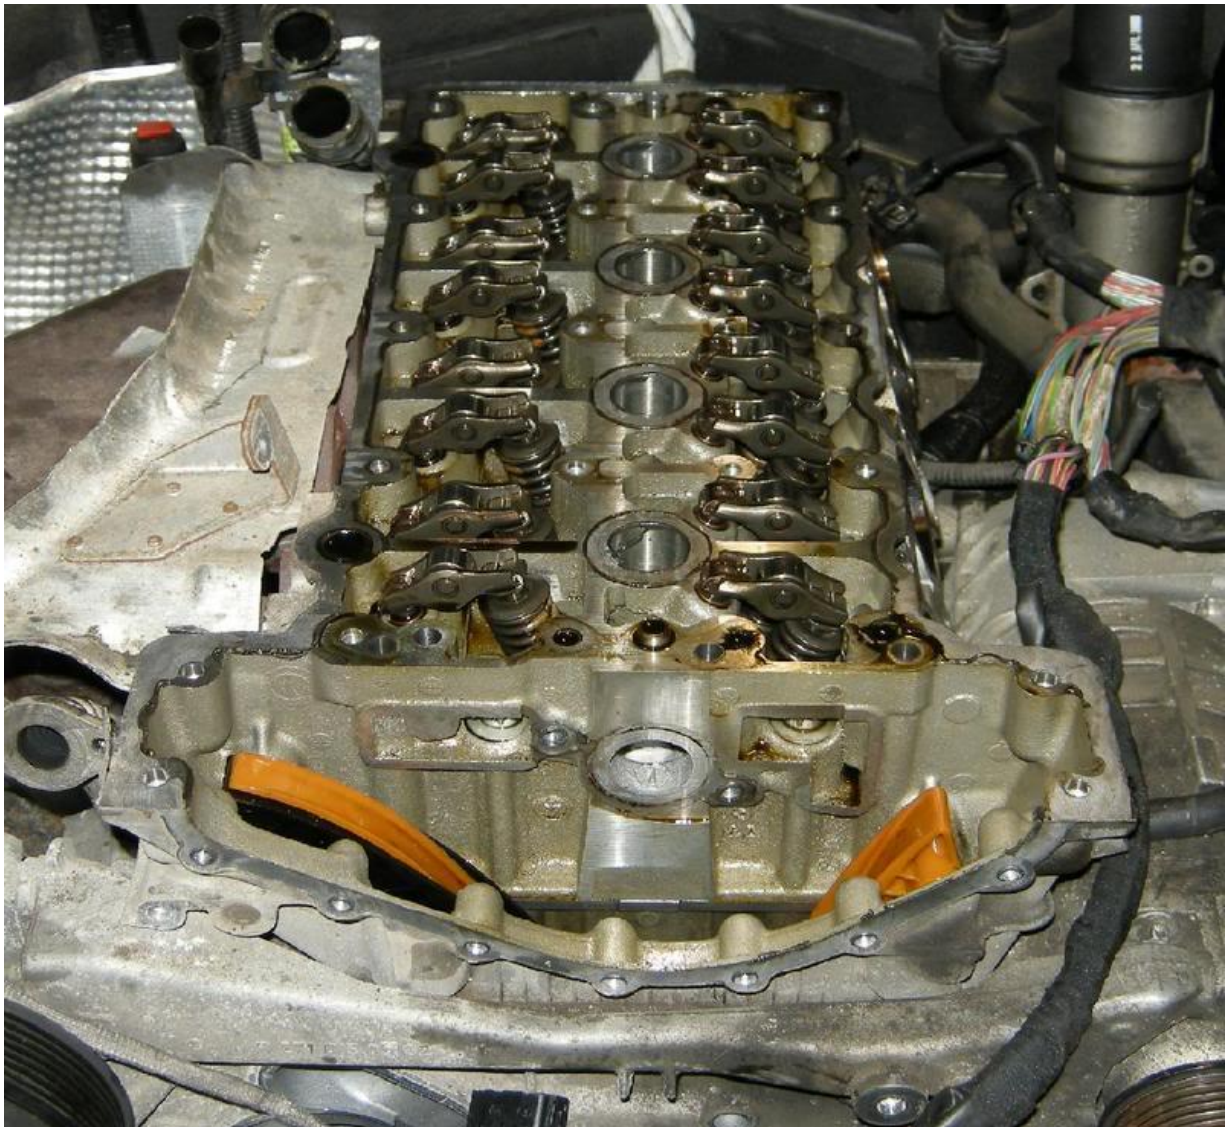
We got that "slide rail pin" out with \$2.63 worth of washers and a zinc bolt. F that \$150 tool 😊  
Here's what it looked like when we started tonight:

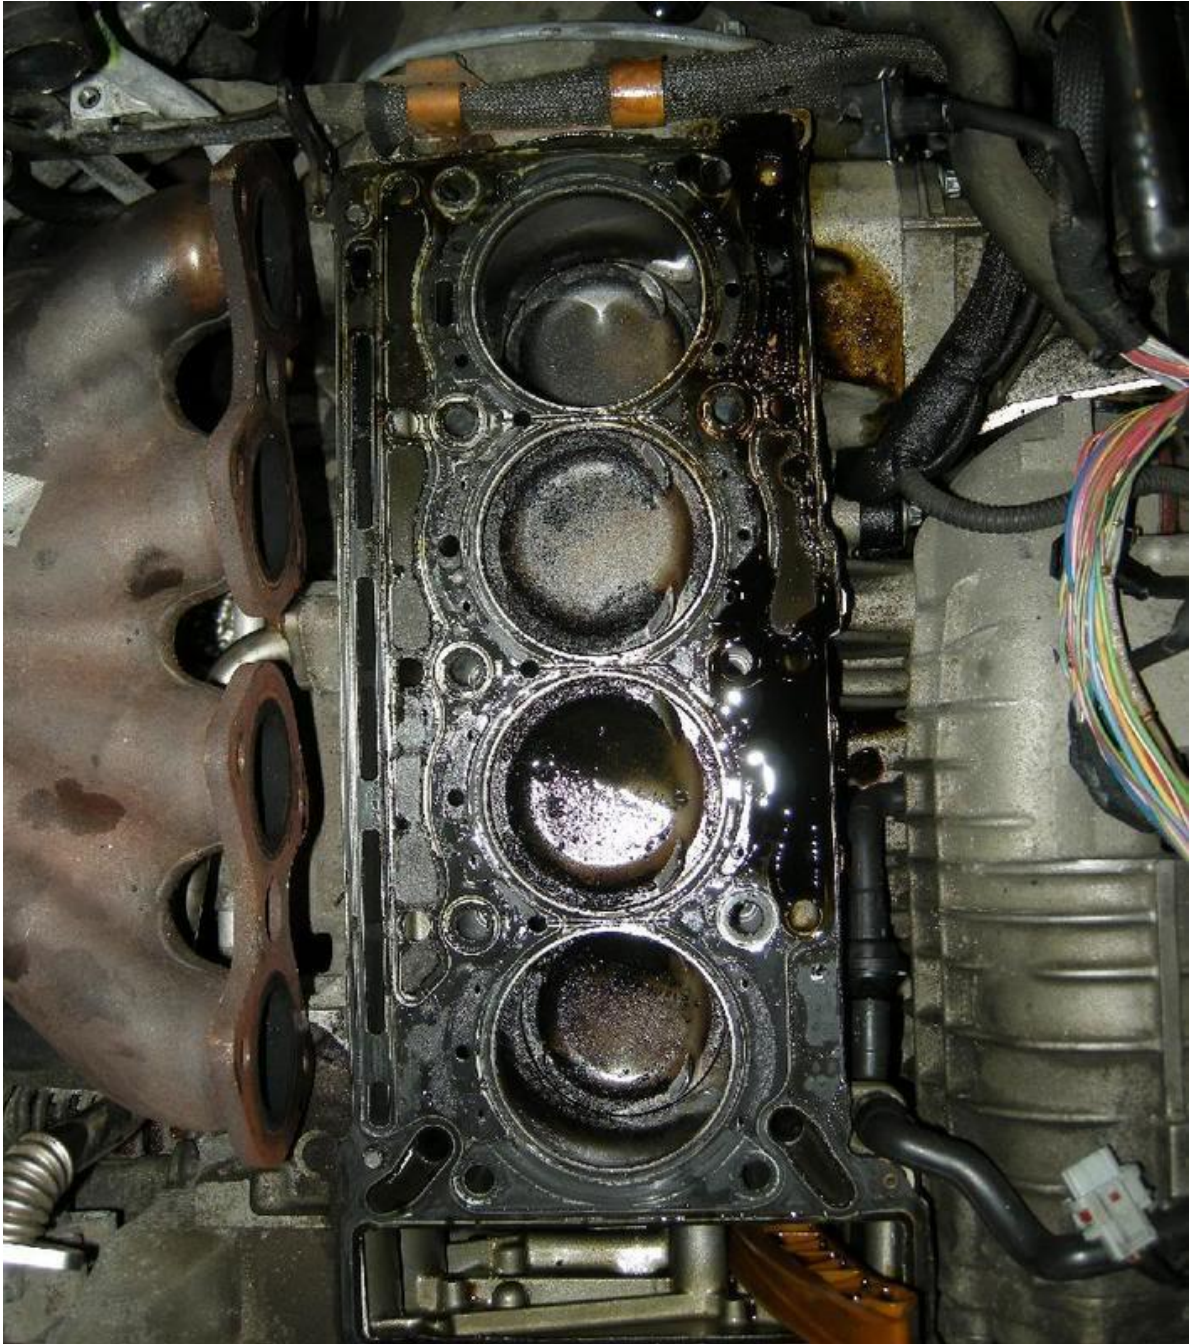
Had an issue one morning where the car wouldn't start. When it finally did it sounded like hell. Had it towed to MB and they said the timing chain jumped a tooth and there was bent valves and other damage.

Car is out of warranty and I wasn't paying MB to replace the whole engine so I tore it down myself. And to my surprise last night I didn't see any damage to the valves after getting the head off. So I'm heading to MB this afternoon with the cylinder head to see what they say.

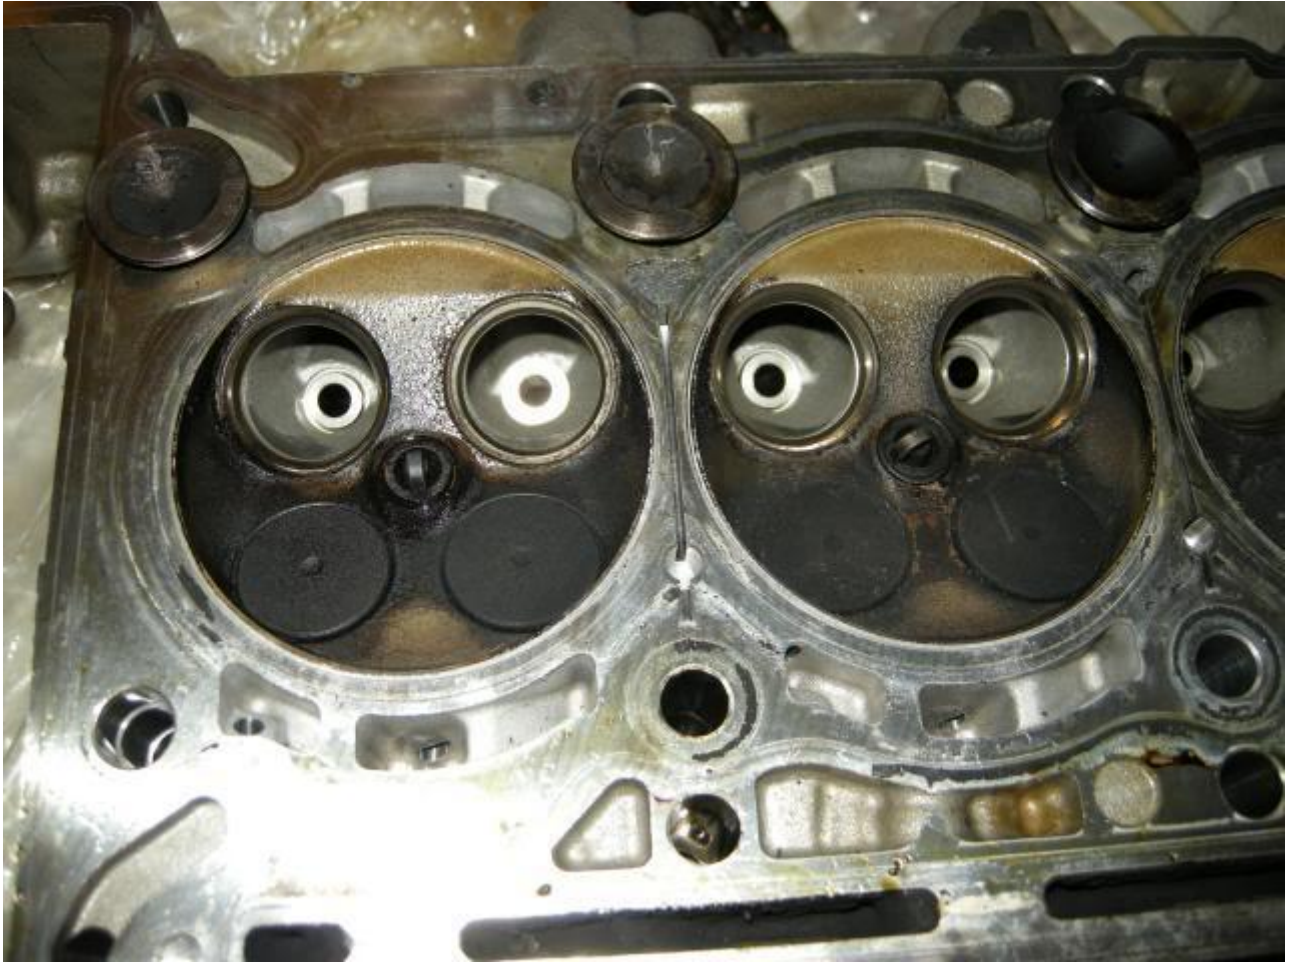
intake valves are out:

I think we'll just be regrinding the valve seats once they come in.

The weather here hasn't been co-operating but I took the cylinder head to a shop and they reseated the intake valves and said the new ones look good. But some of the exhaust valves weren't holding a vacuum seal so they were going to check them. Shoud have that back by the end of the week 😊

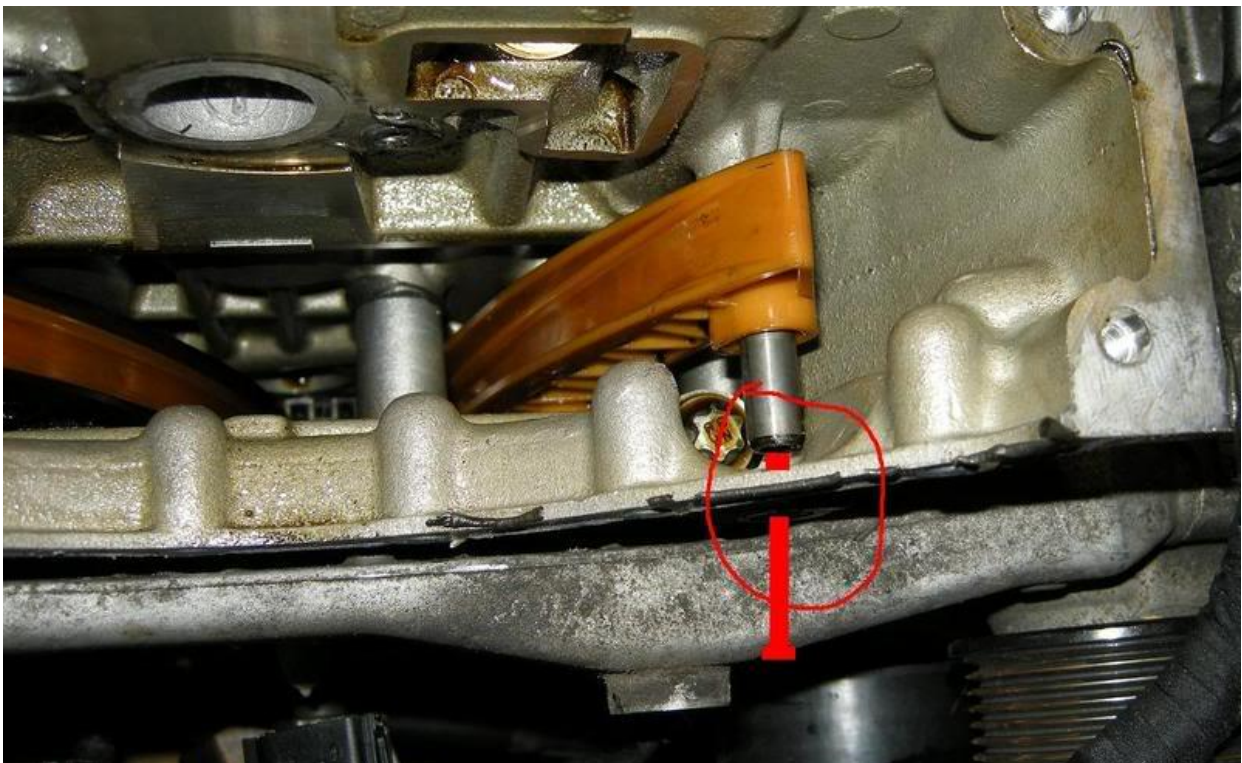
GEDaggett - I'm not sure what you mean, chain guide sleeve? The \$2.63 'tool' we created was a 2" bolt threaded just like all the other ones we've pulled from the engine so far with about 1 1/2" of washers on it. There was a little black plastic 'cap/plug' on the front of the timing chain cover that popped out. Pushed the bolt through and threaded it into the post that secured that orange timing guide. As you tighted the bolt it pulled the post from the engine block. I can take a pic the next time I'm over at the garage (if we're talking about the same thing)  
[edit] Like this:

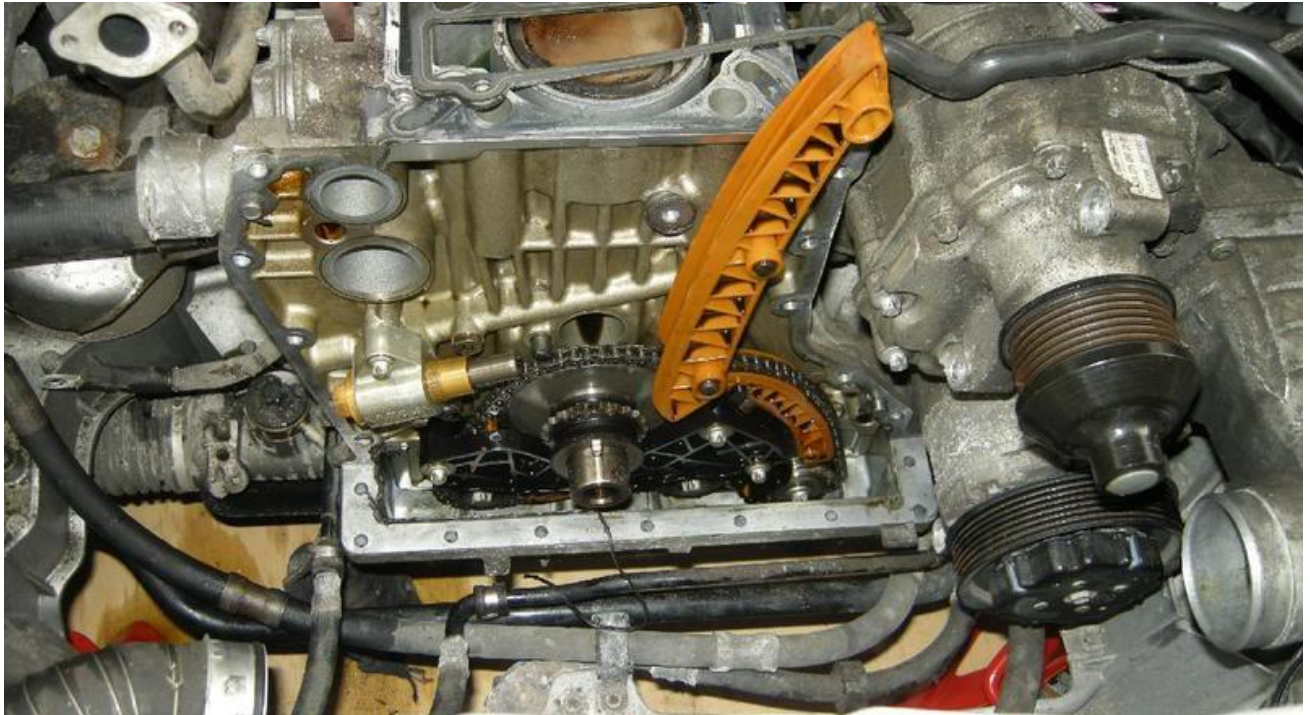
Sooooo it has really mostly been:  
These bolts hold that piece in.  
We need it out of the way.  
Take pics, remove them

Timing chain cover is off:

Going to clean it up and start the rebuild this week I hope.  
Once the cylinder head is back and the cams are ready it'll just be a matter of setting everything to  
Top Dead Center and securing the master link on the chain.
