## BMW Engine Breather Assembly Issue

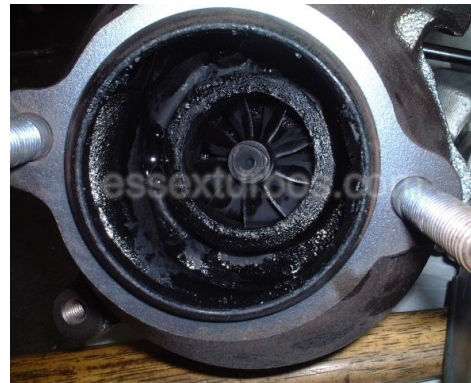
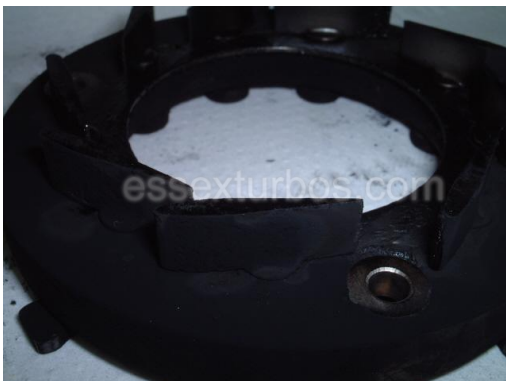
The leaking of oil into the exhaust housing can cause a smoking issue. Also over a period of time the leaking oil can also build up around the variable vanes assembly interfering with their operation.

As the build up of oil carbonises around the vanes they can become what people refer to as 'sticky' vanes which can cause them to operate erratically. The driver may experience issues with the turbo boosting and the vehicle smoking. In some cases the outcome is a destroyed turbo.
