Toyota AYGO Peugeot 107 Citroen C1 Door Boot Tailgate Seal Leak Fix Seal Kit Seals Install Instruction Guide

by x8rltd

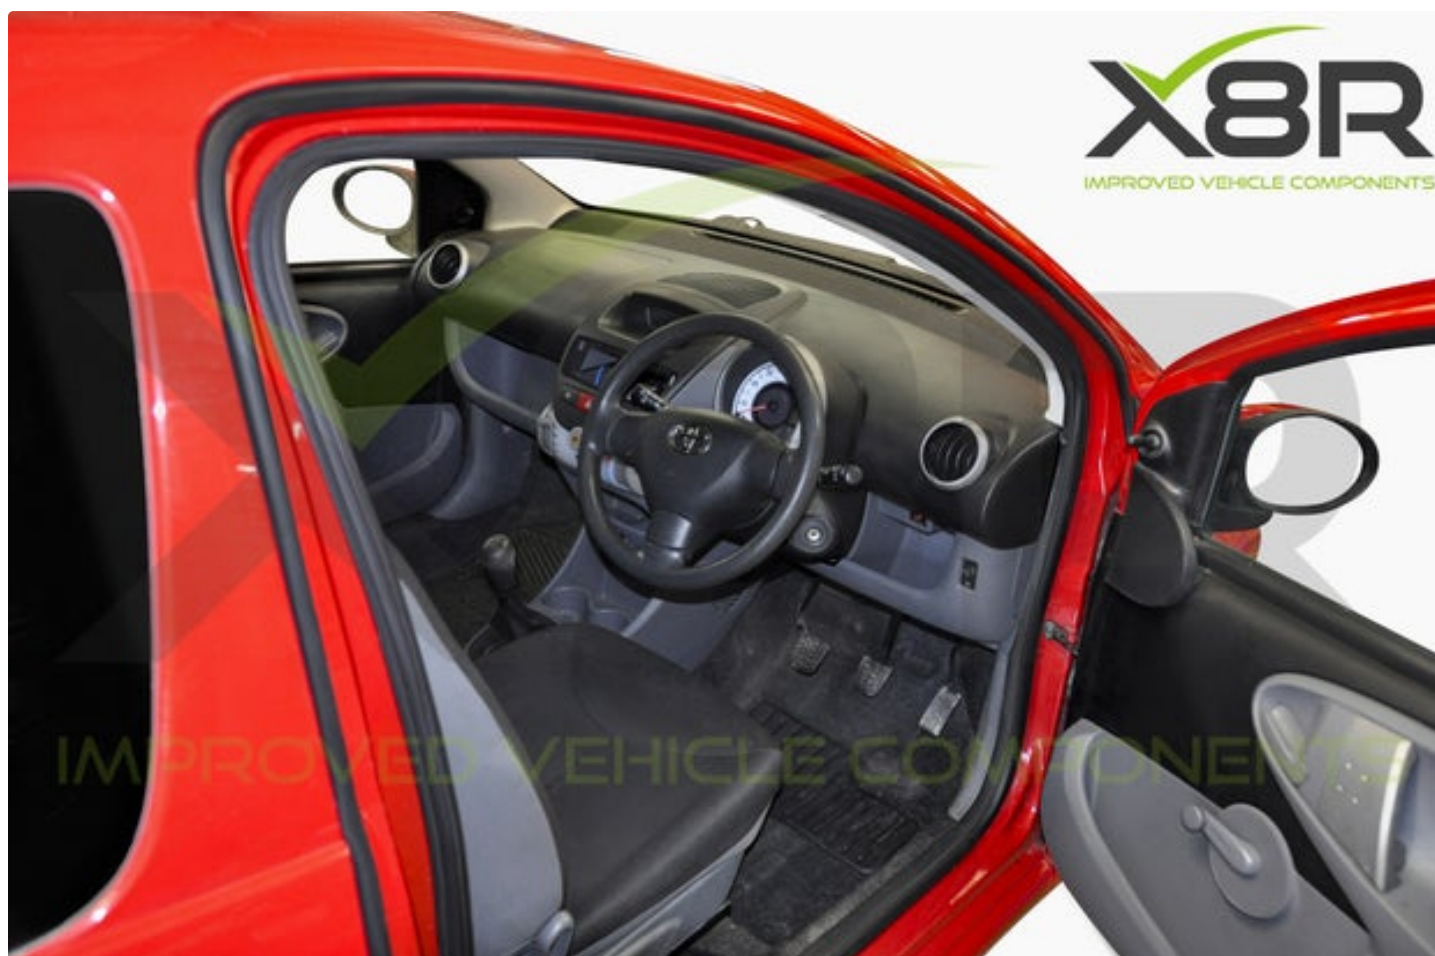
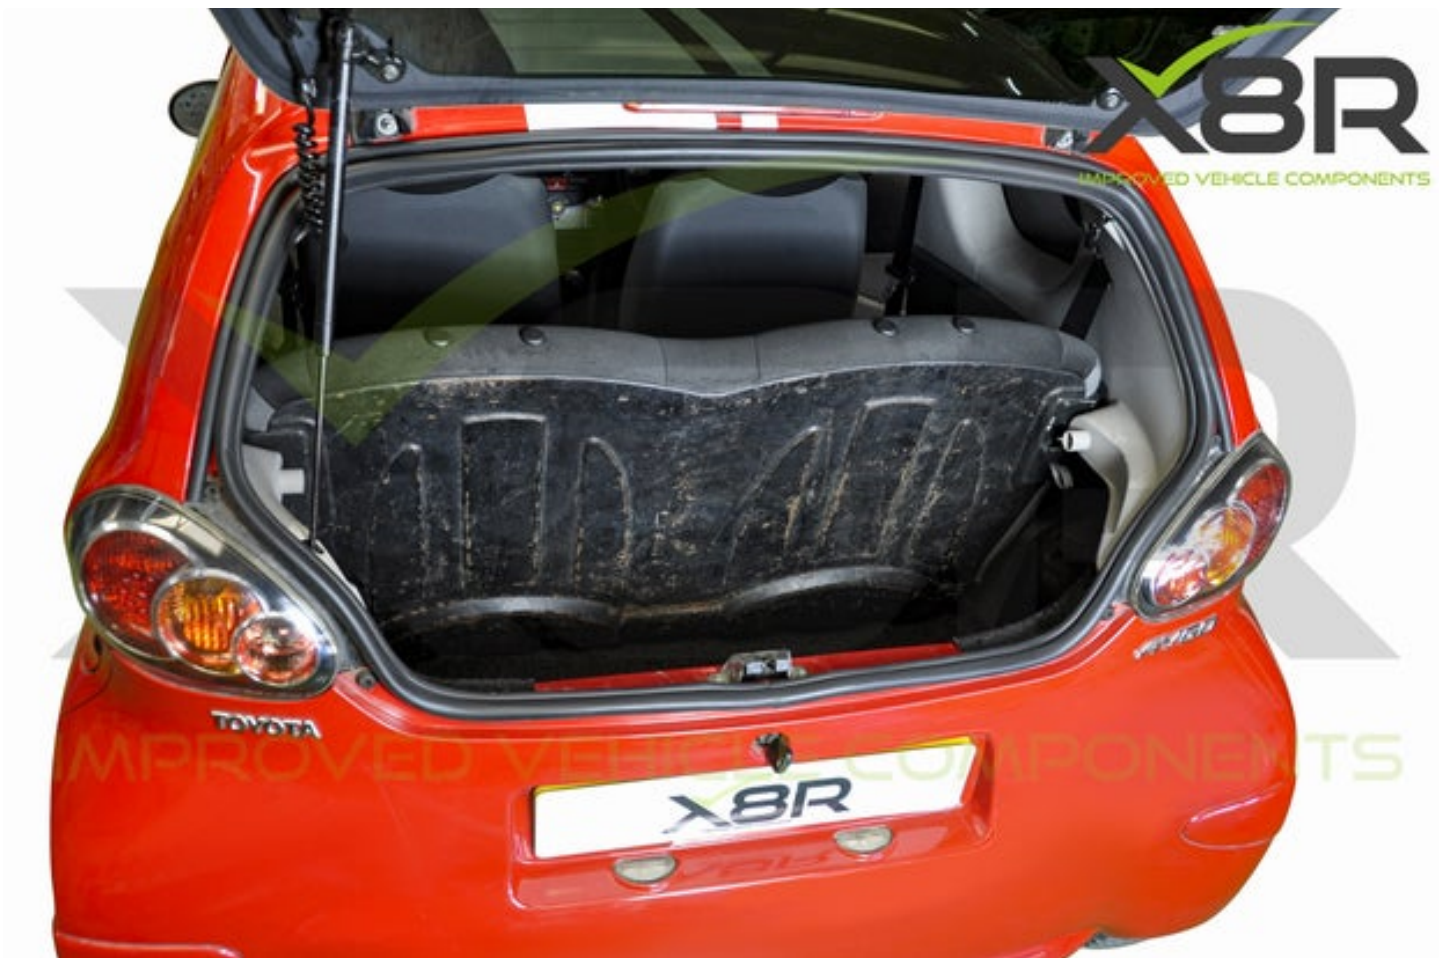
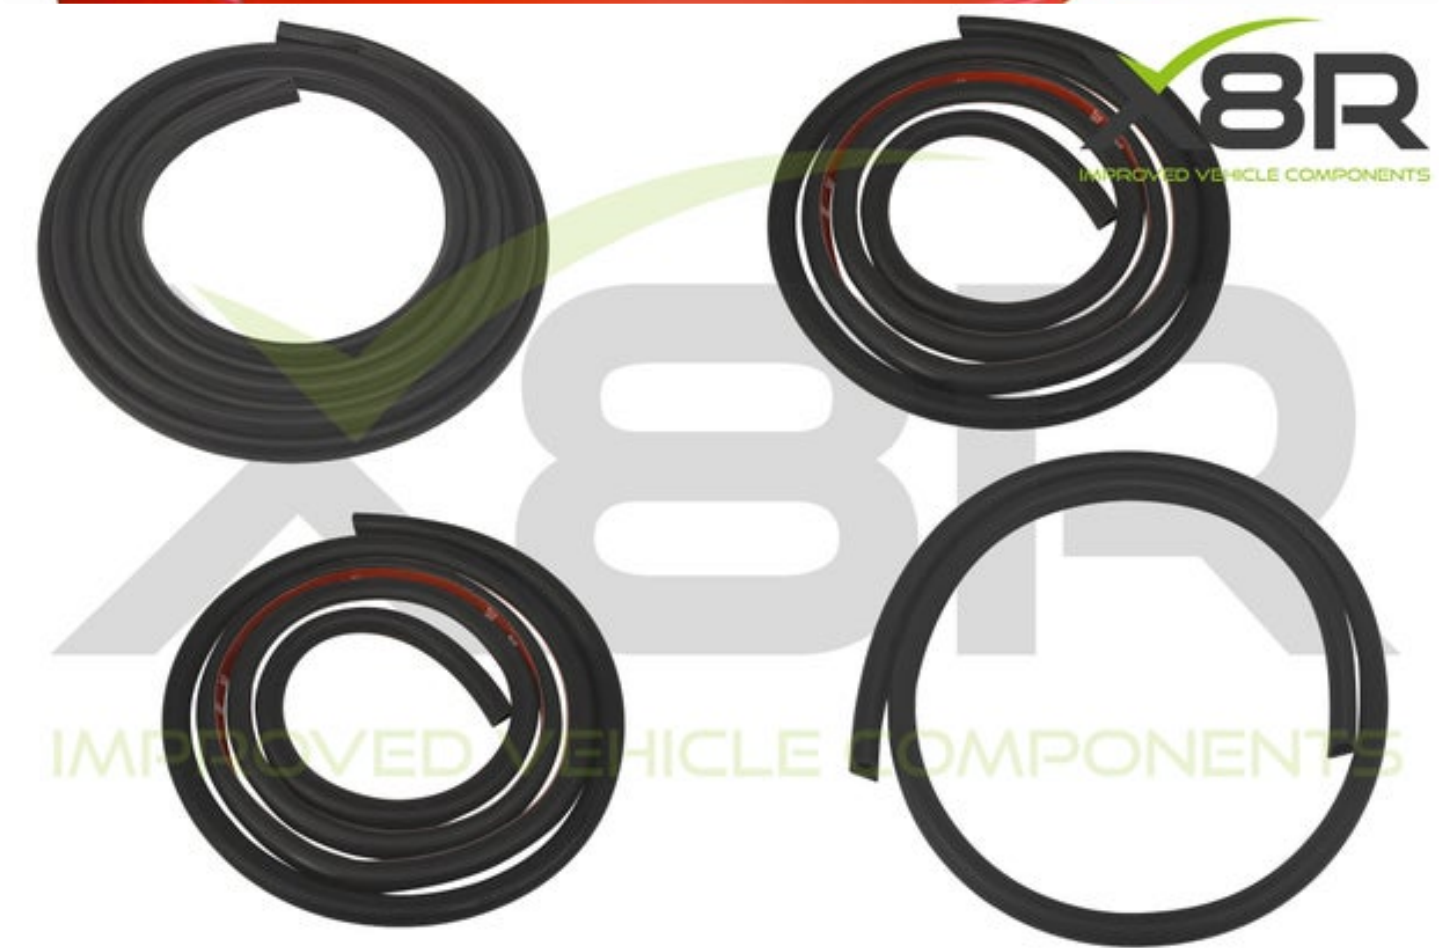
You will receive

X2 External door seals

X1 Improved design tailgate seal

X1 External tailgate seal

X3 Alcohol wipes

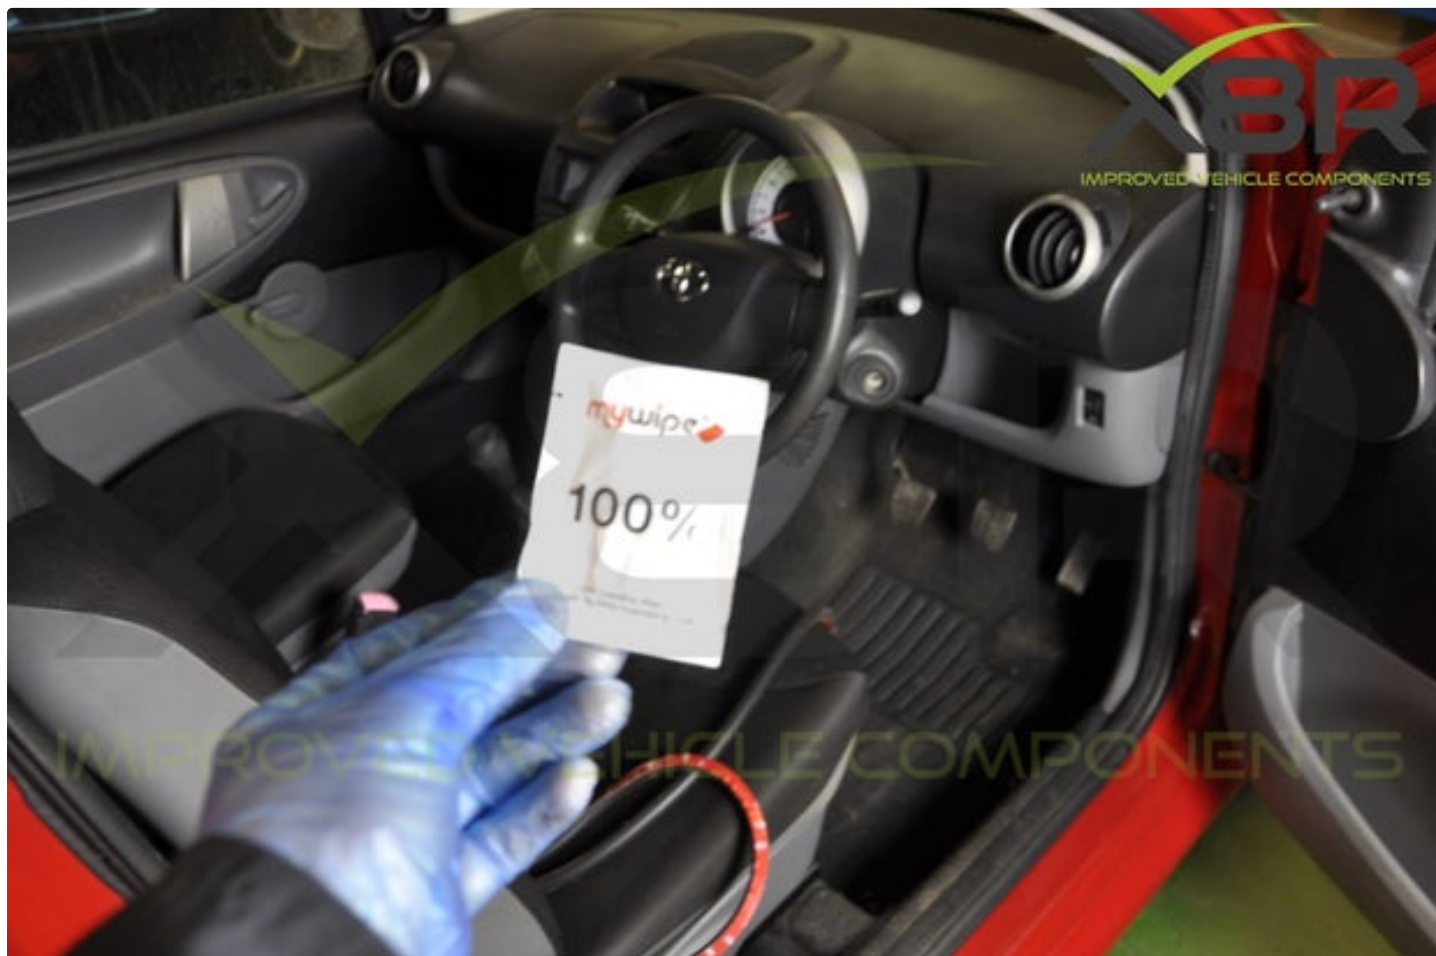
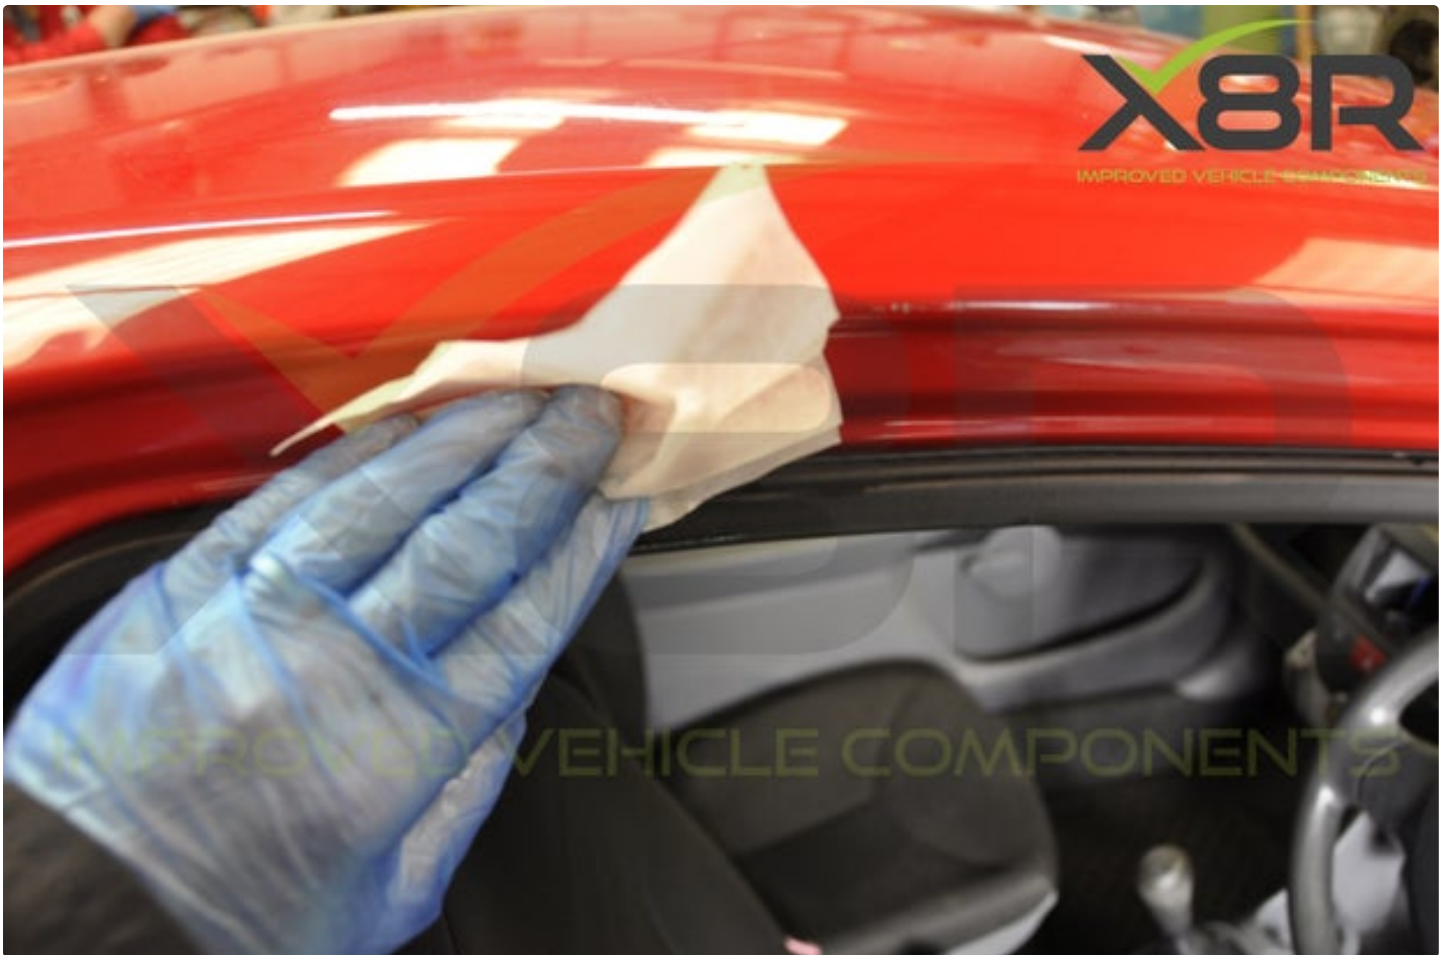
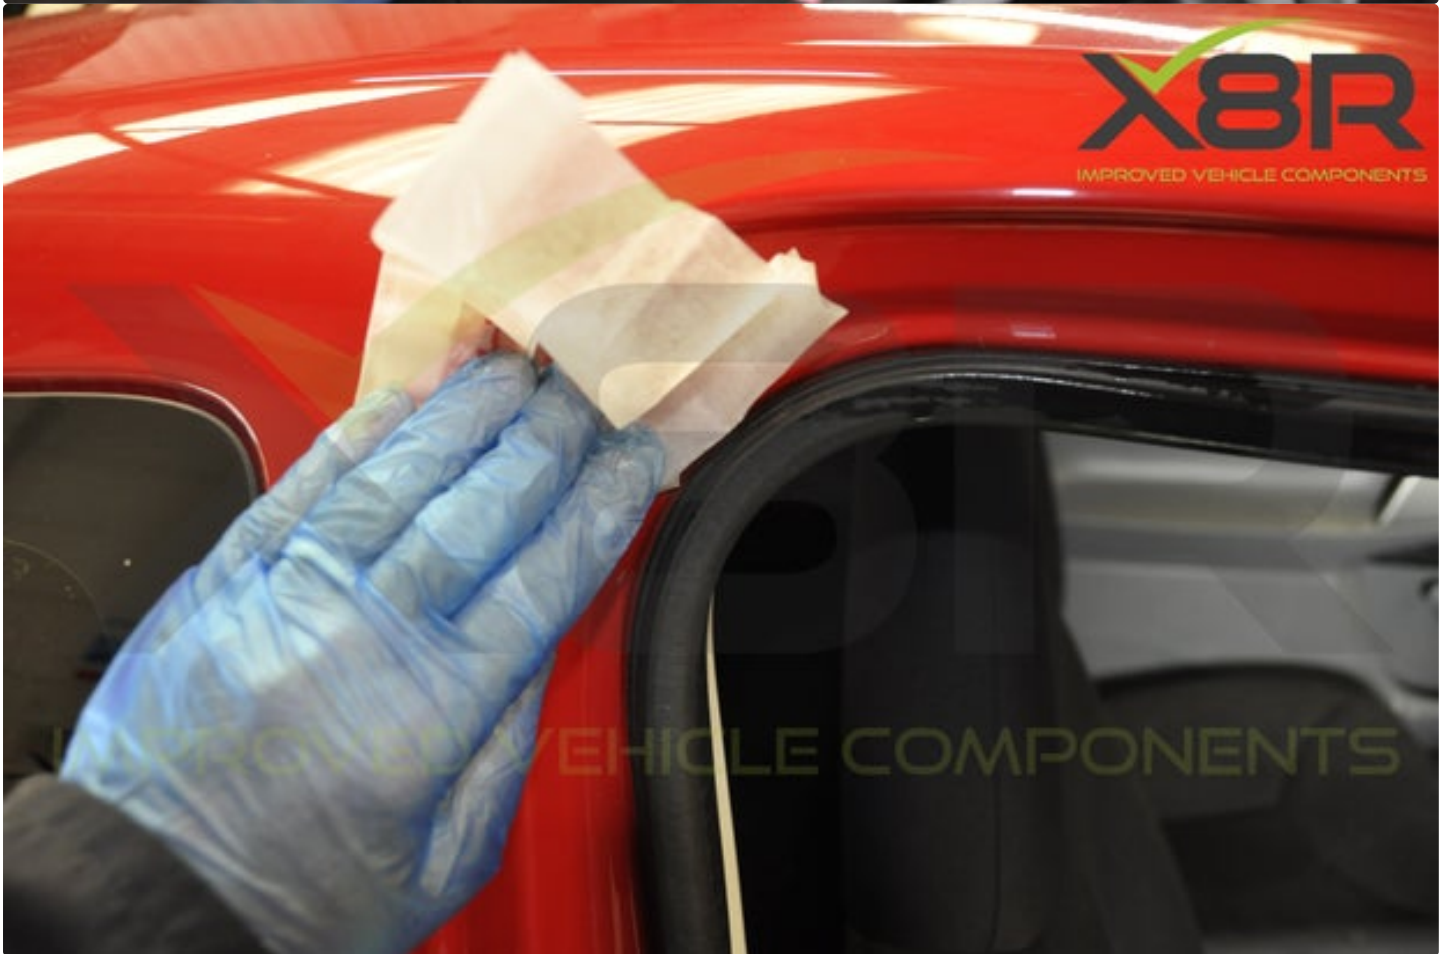
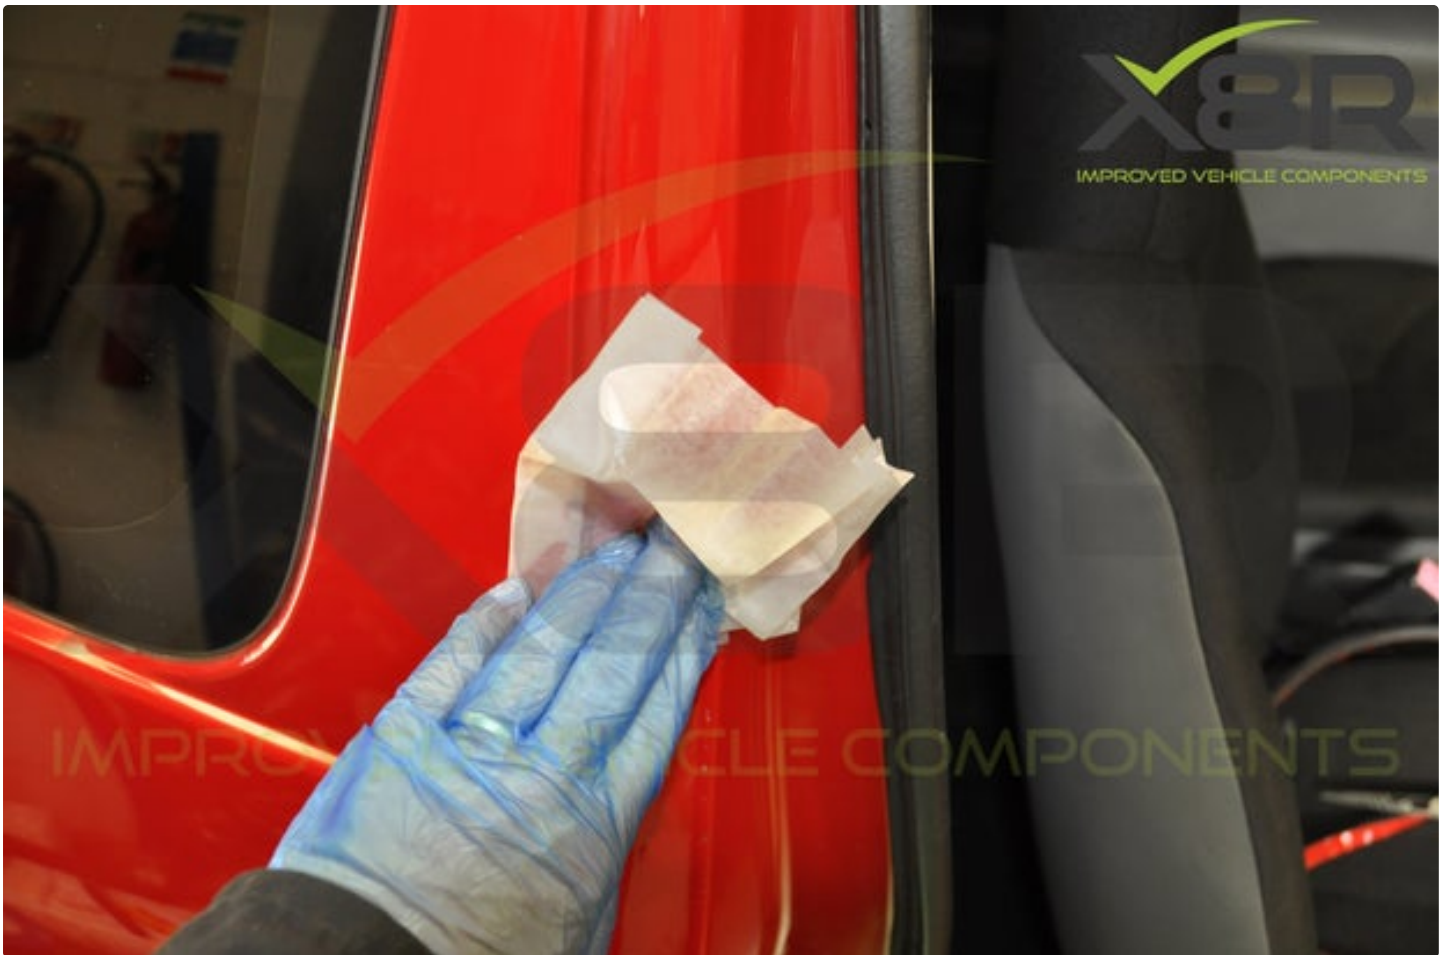
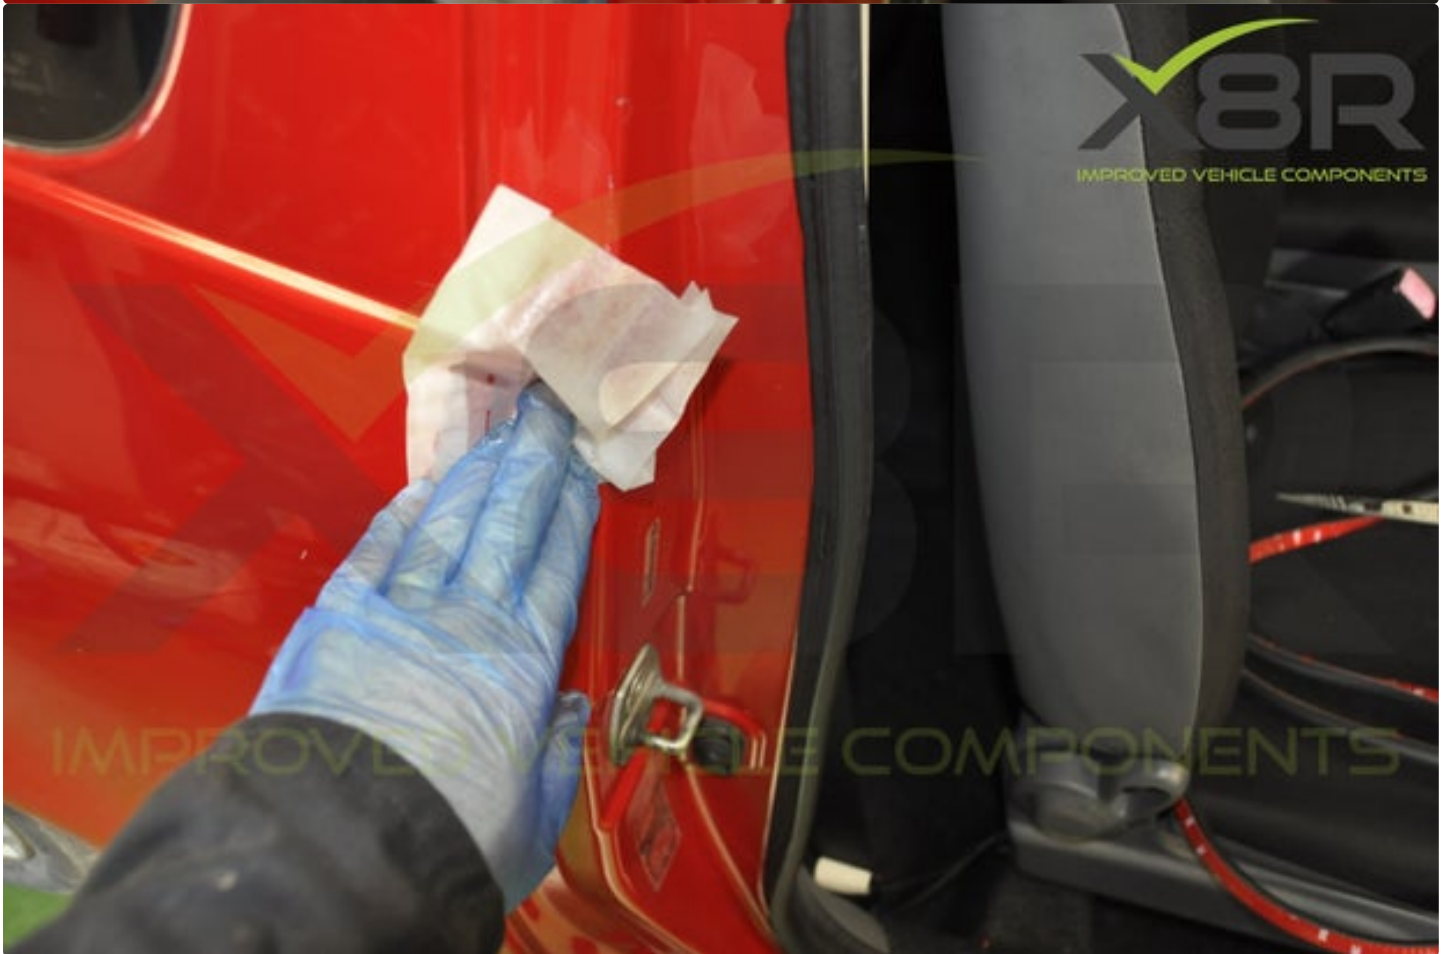
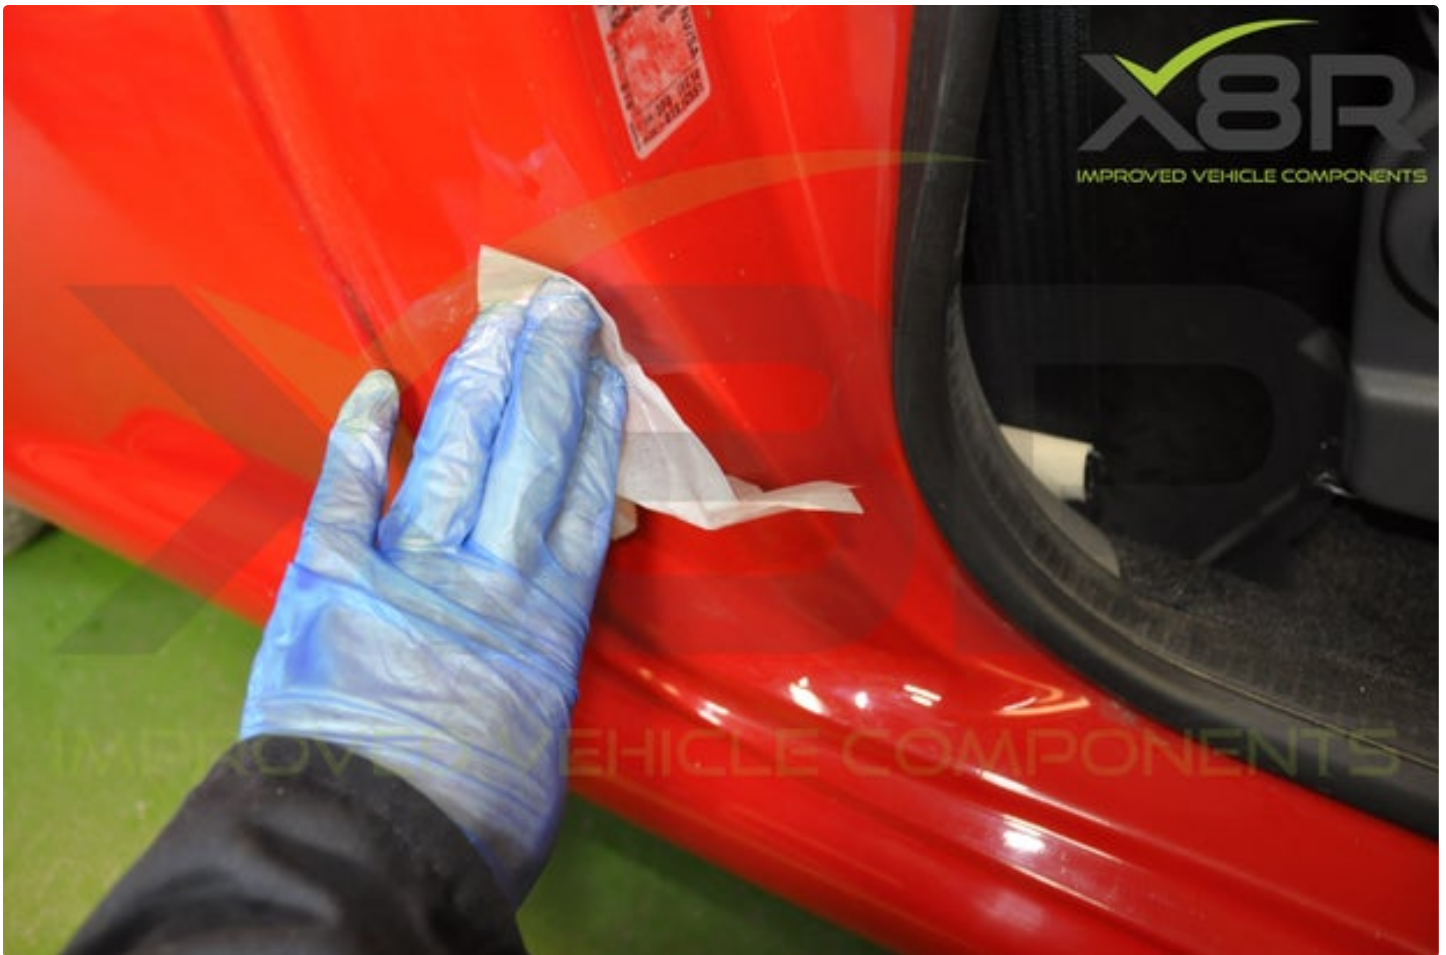
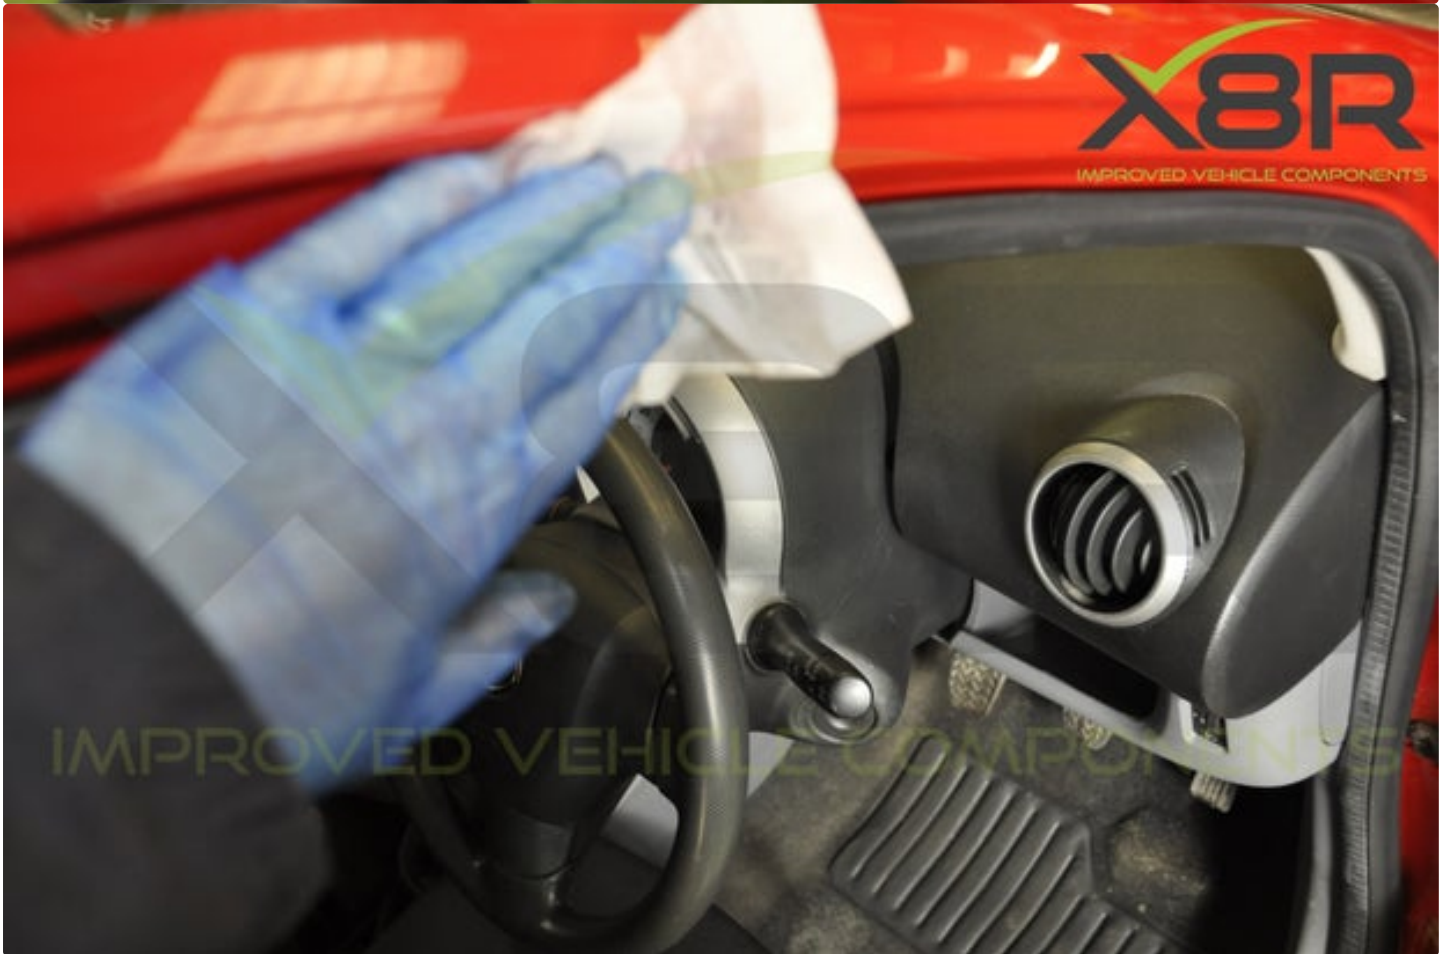
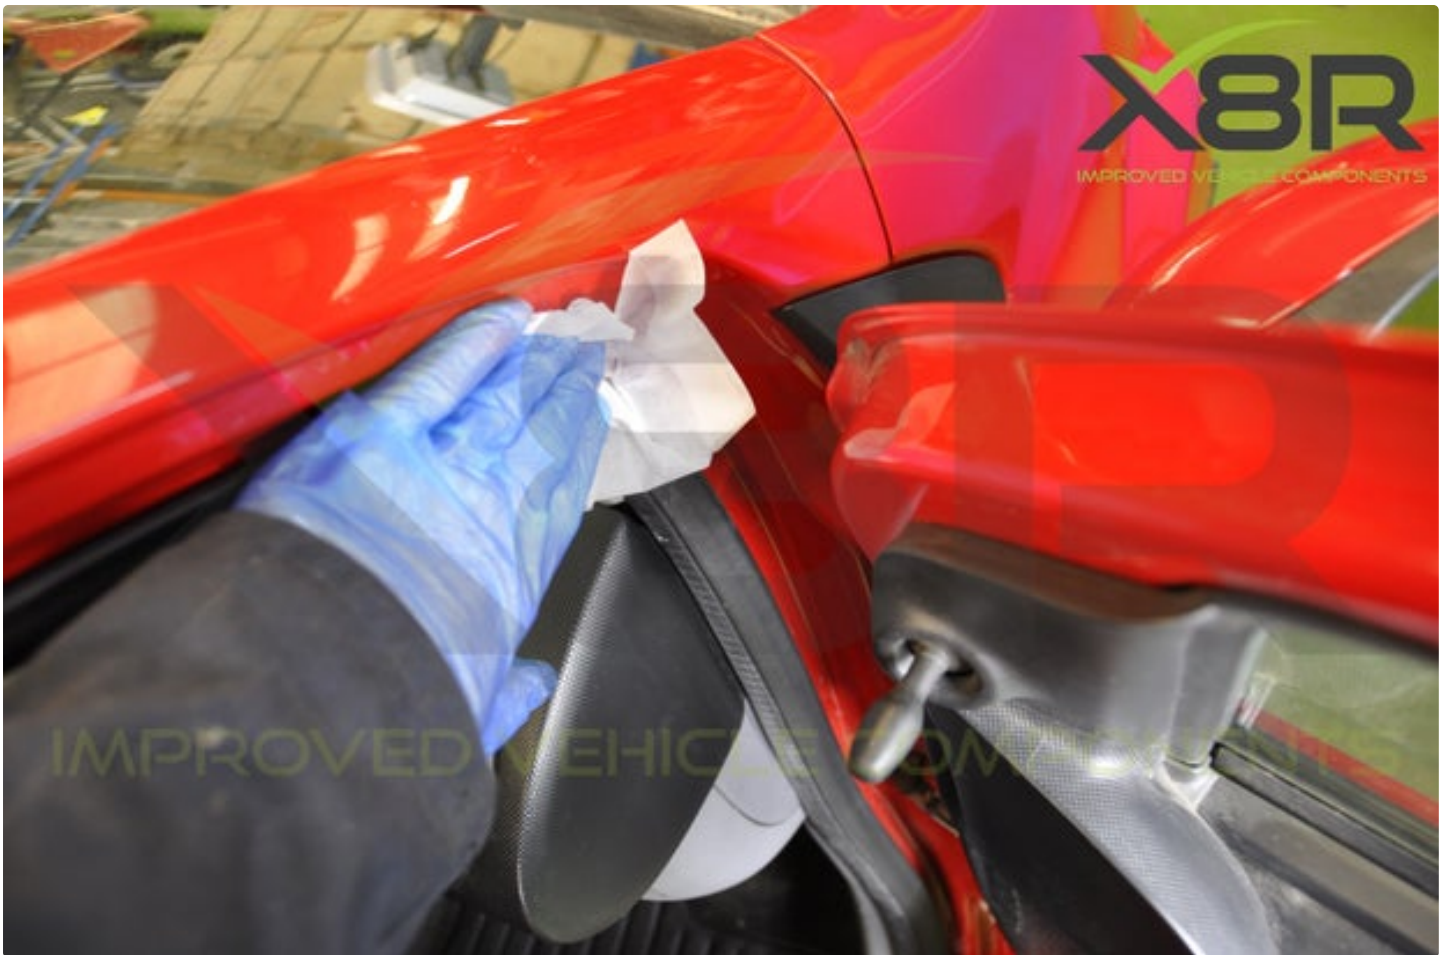
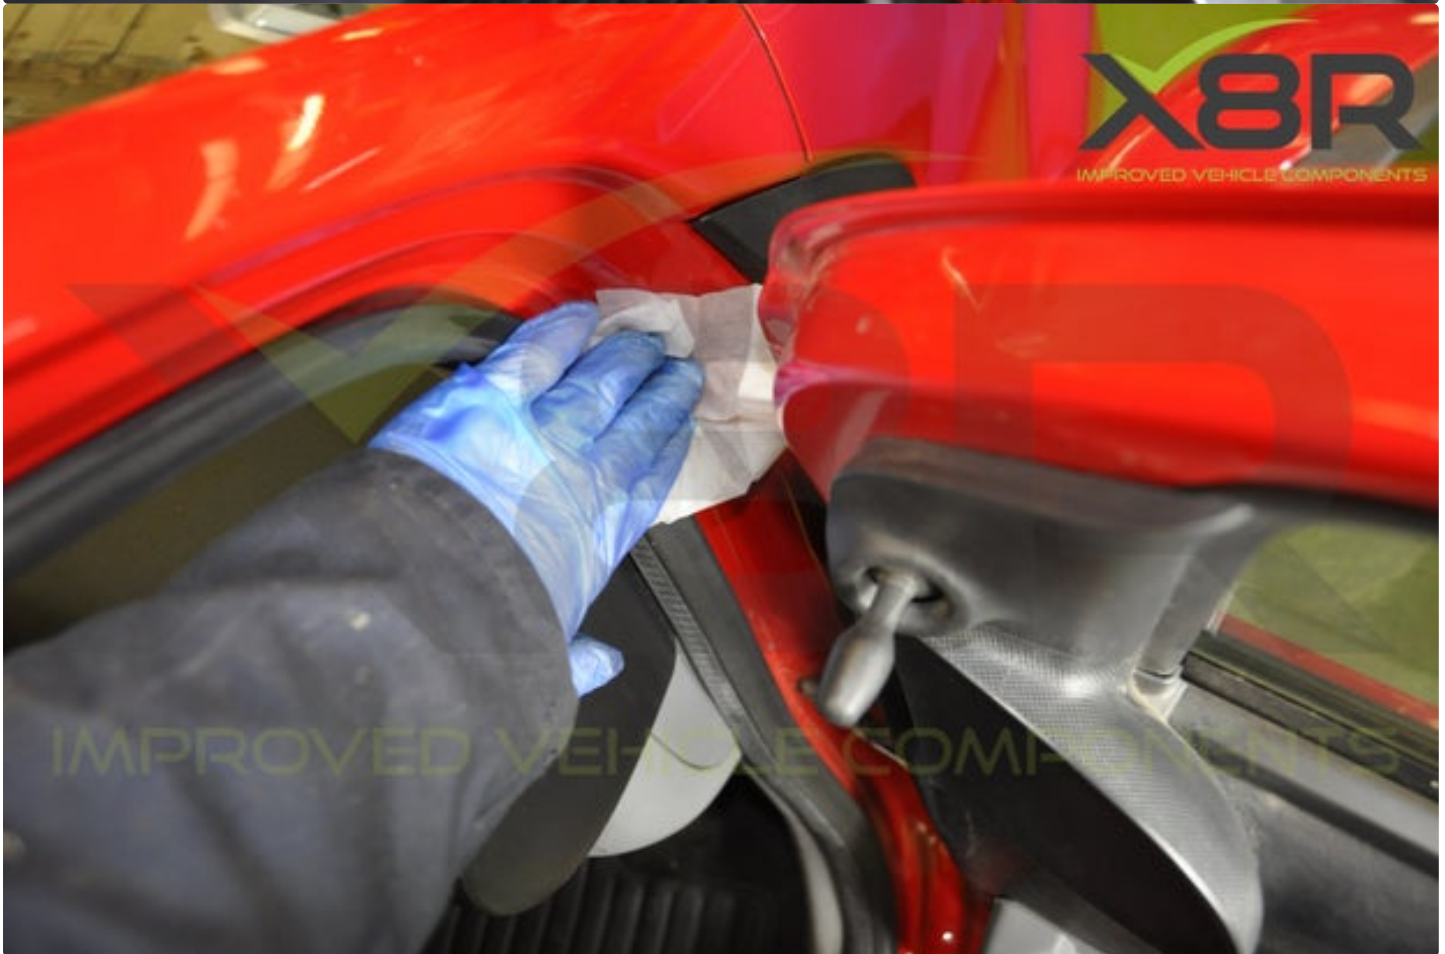
Step 1: Door Seals: Clean Up Surface

Using one of our alcohol wipes clean up the outside edge of the door recess, remove all grime / grease to ensure good adhesion of our seal.
