Toyota AYGO Peugeot 107 Citroen C1 Door Boot Tailgate Seal Leak Fix Seal Kit Seals Install Instruction Guide

by x8rltd

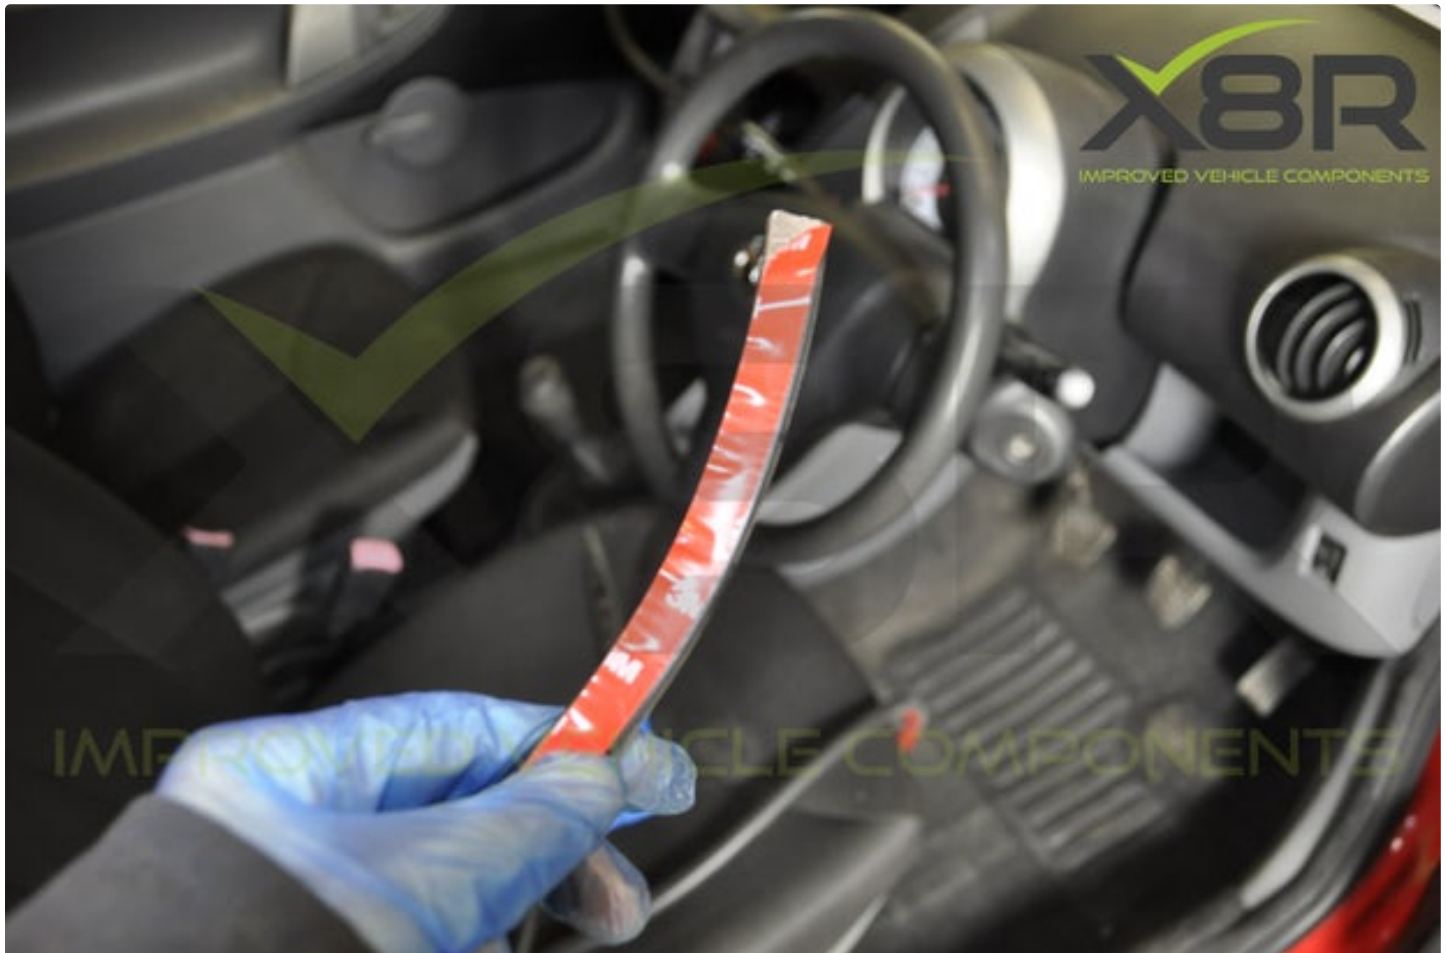
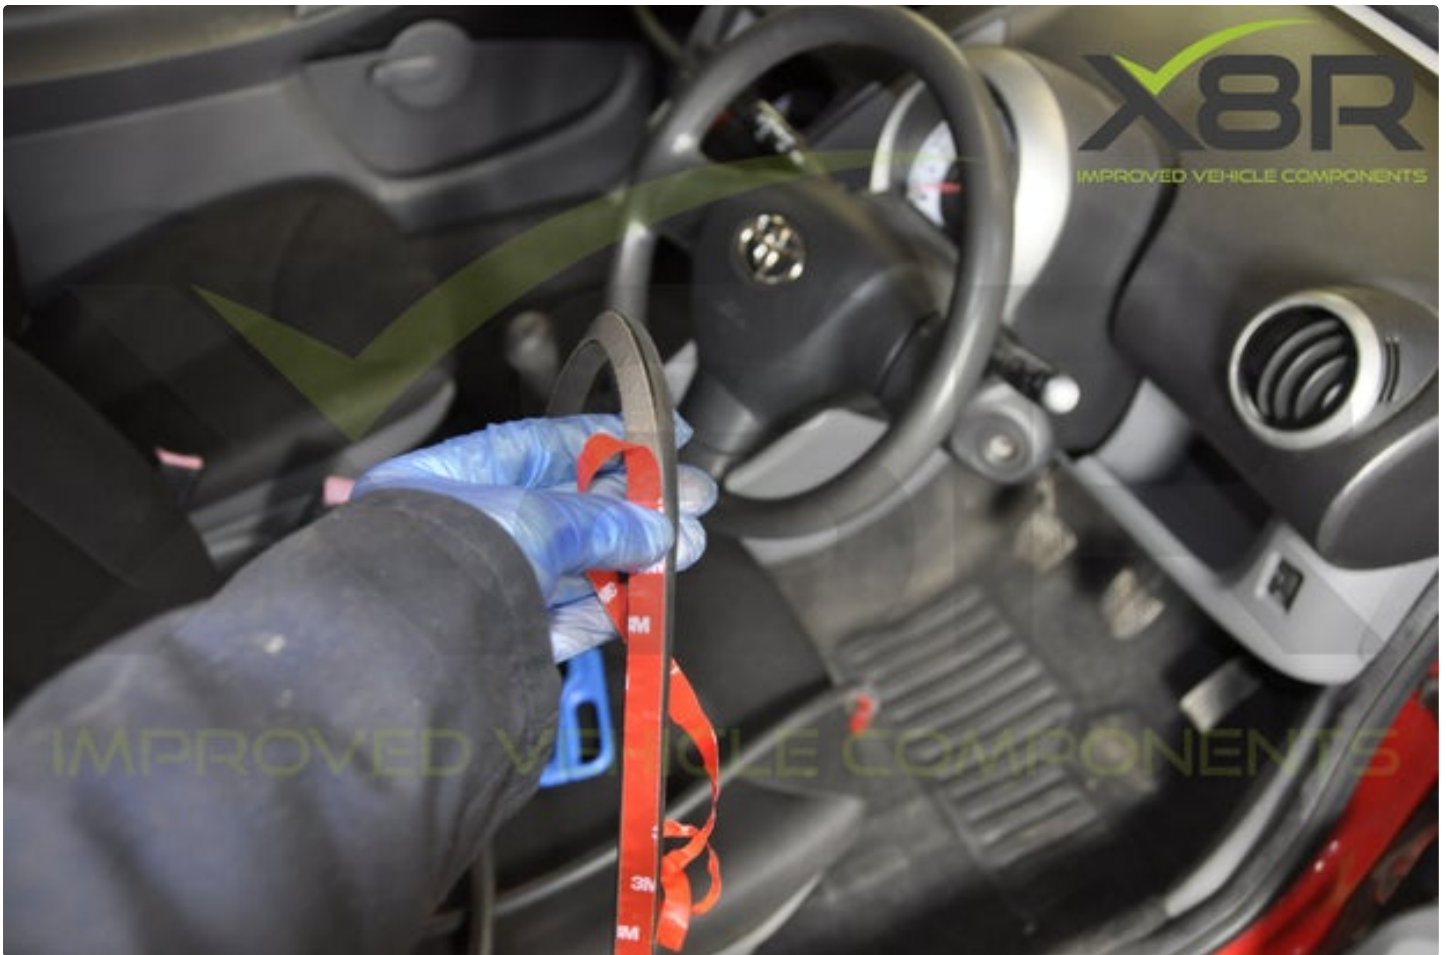
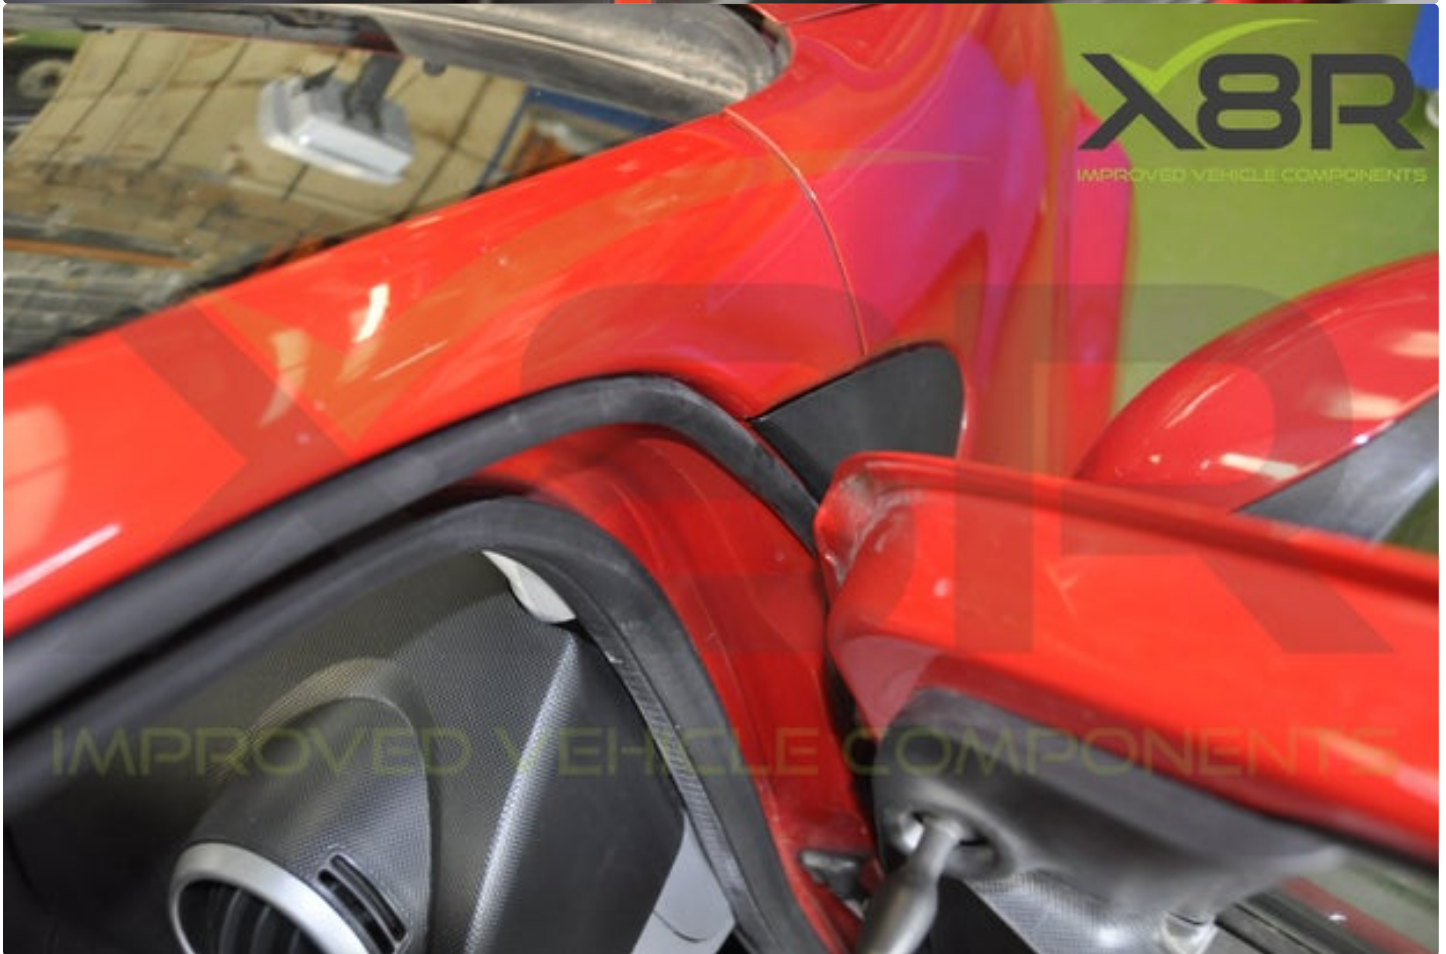
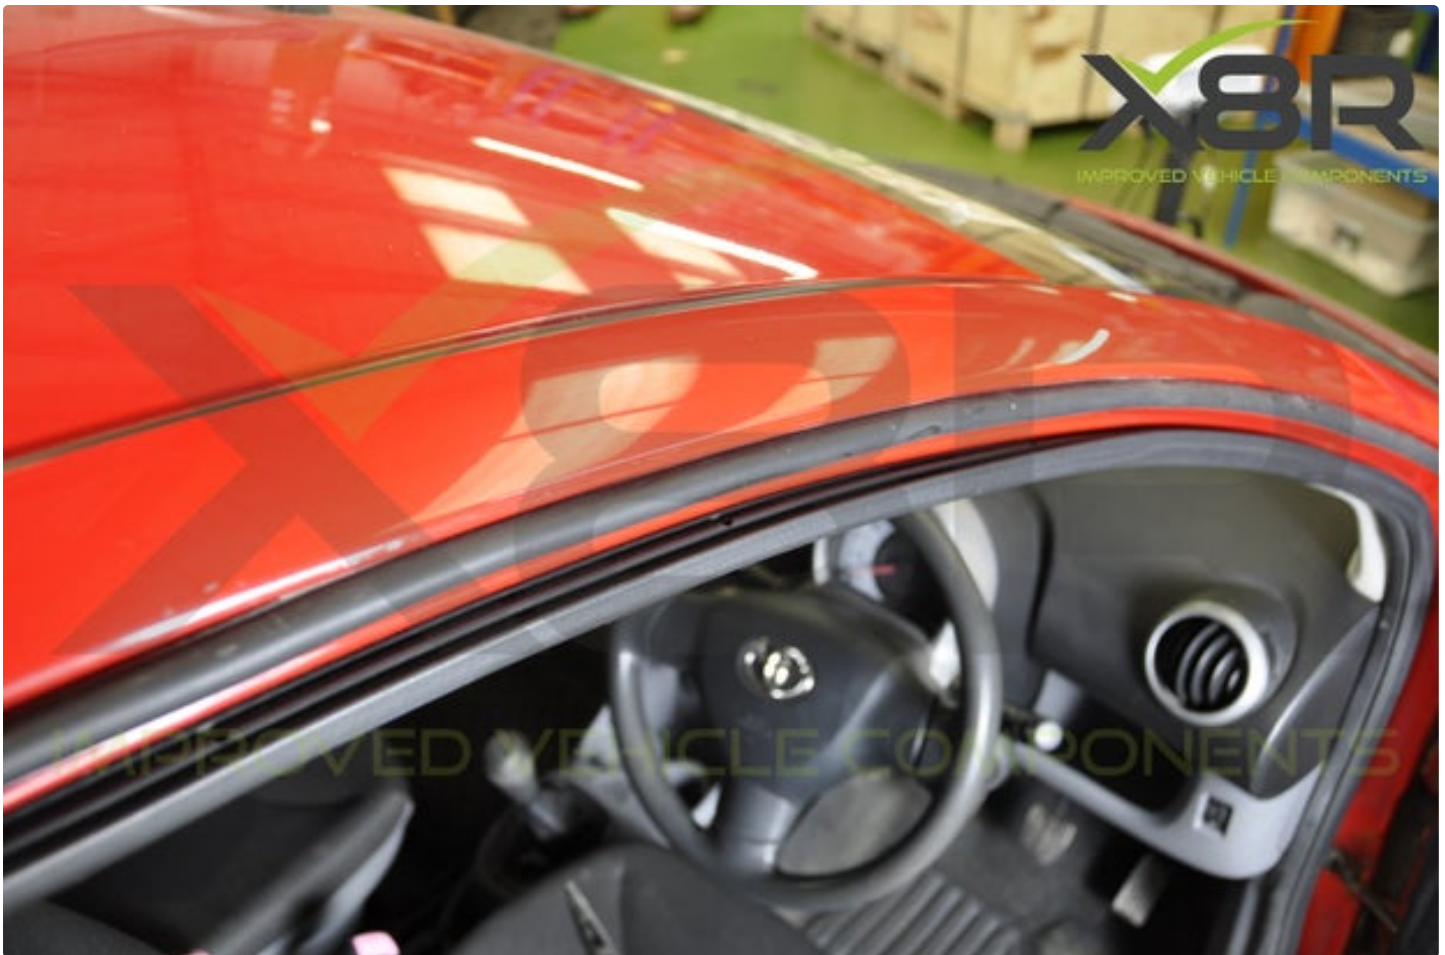
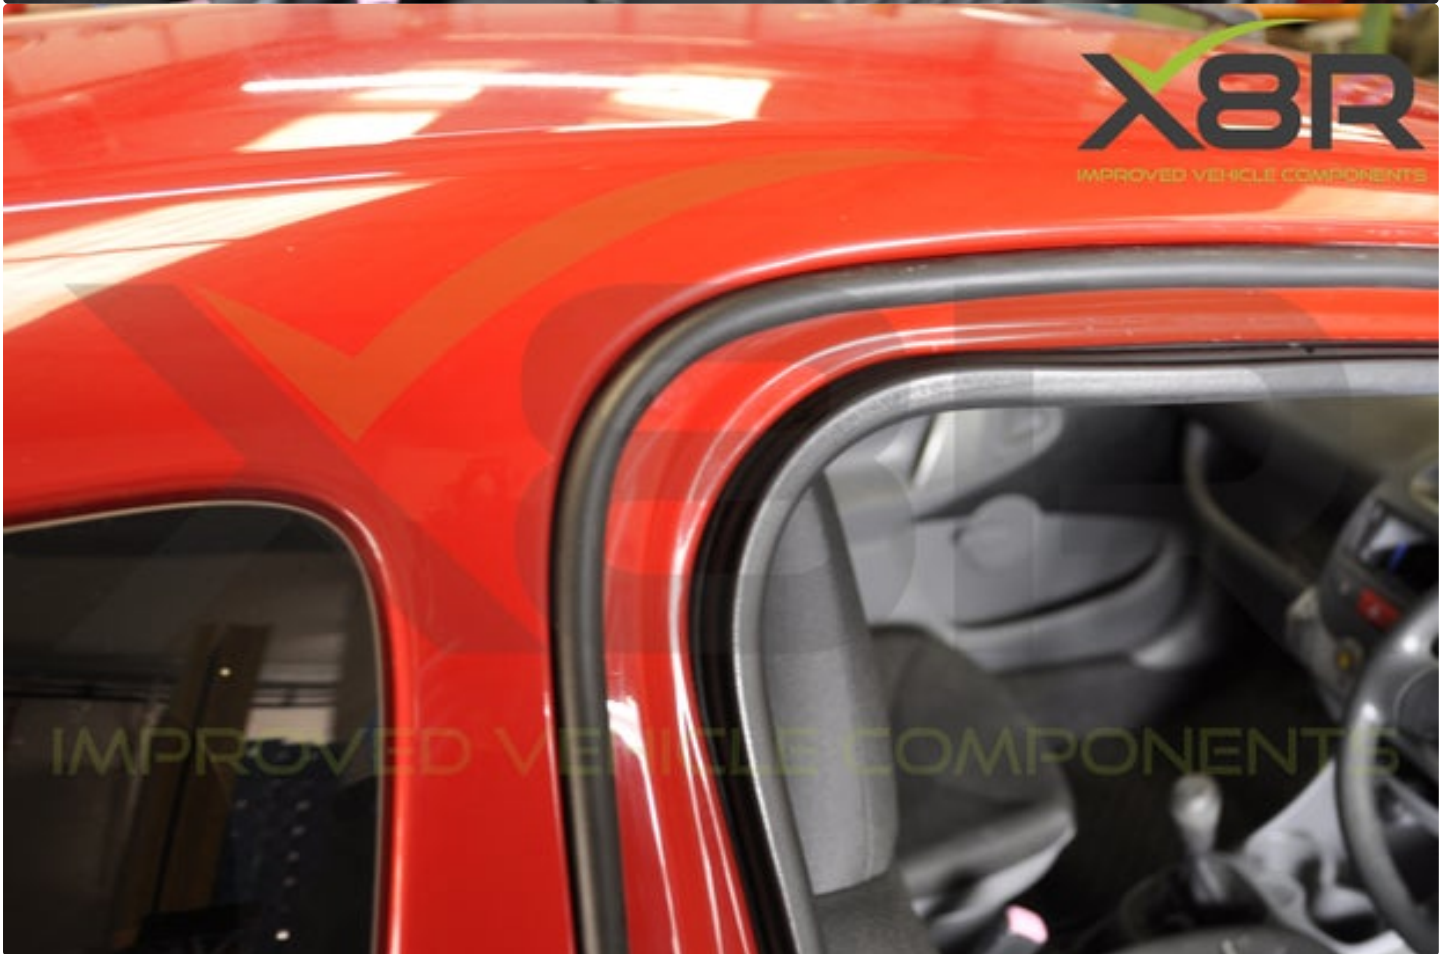
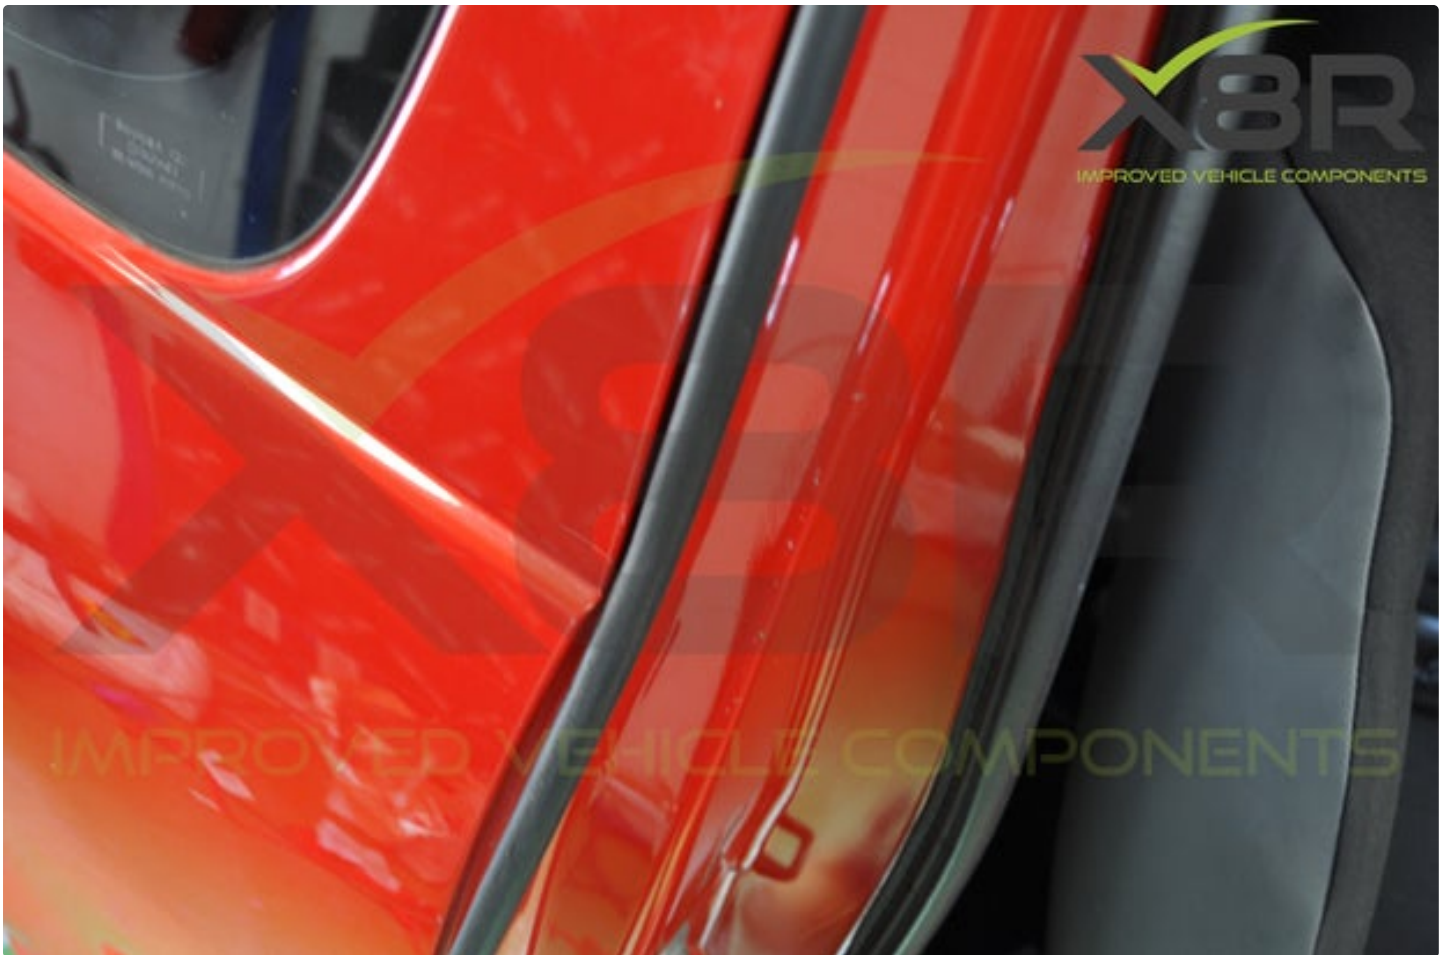
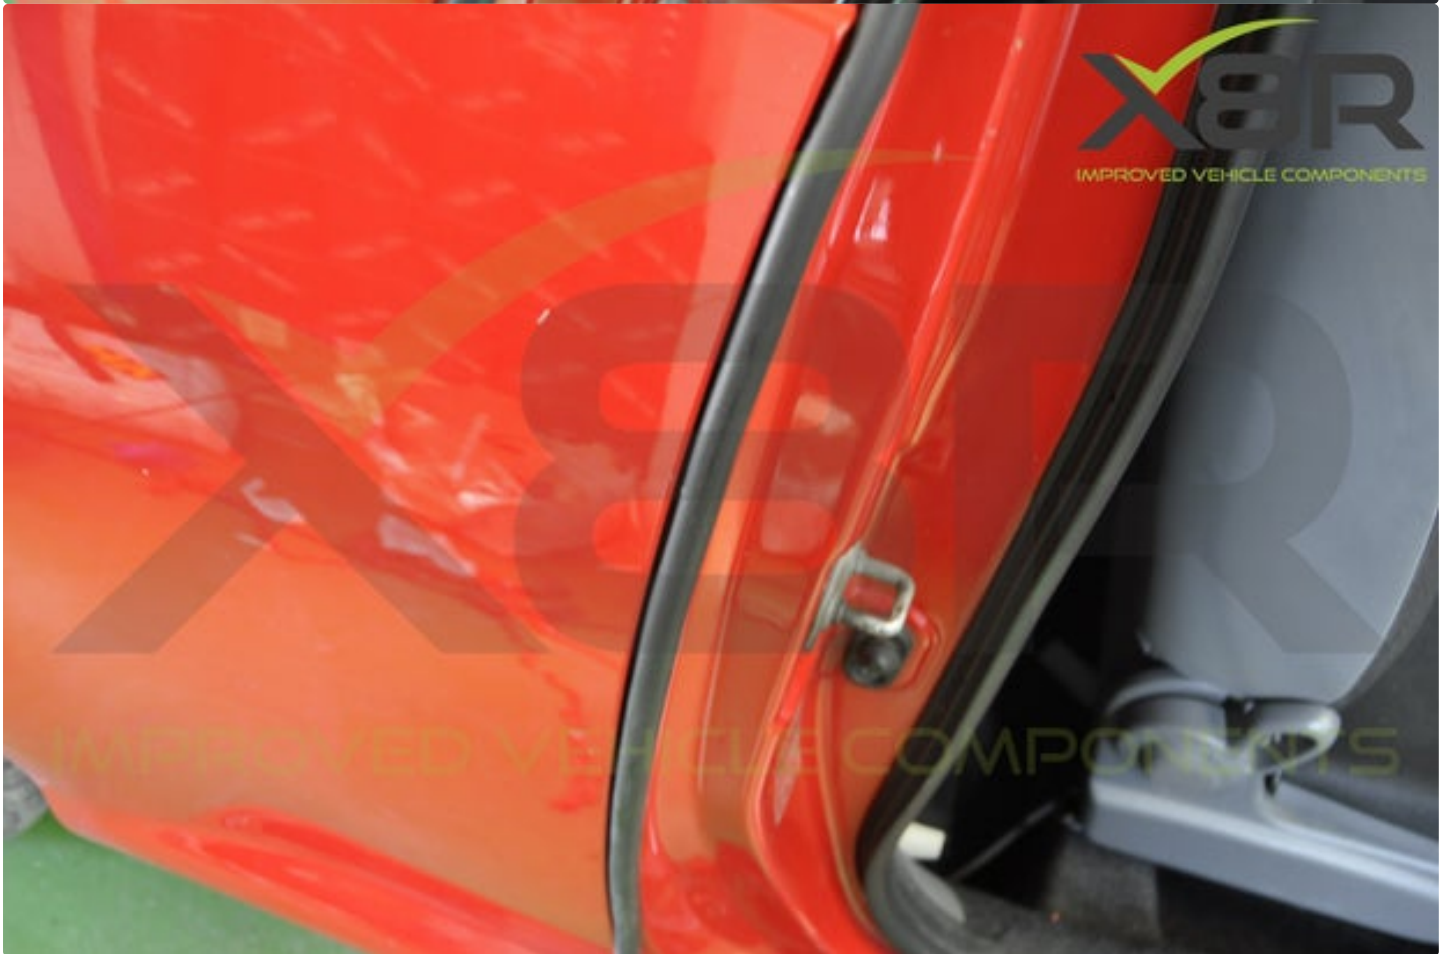
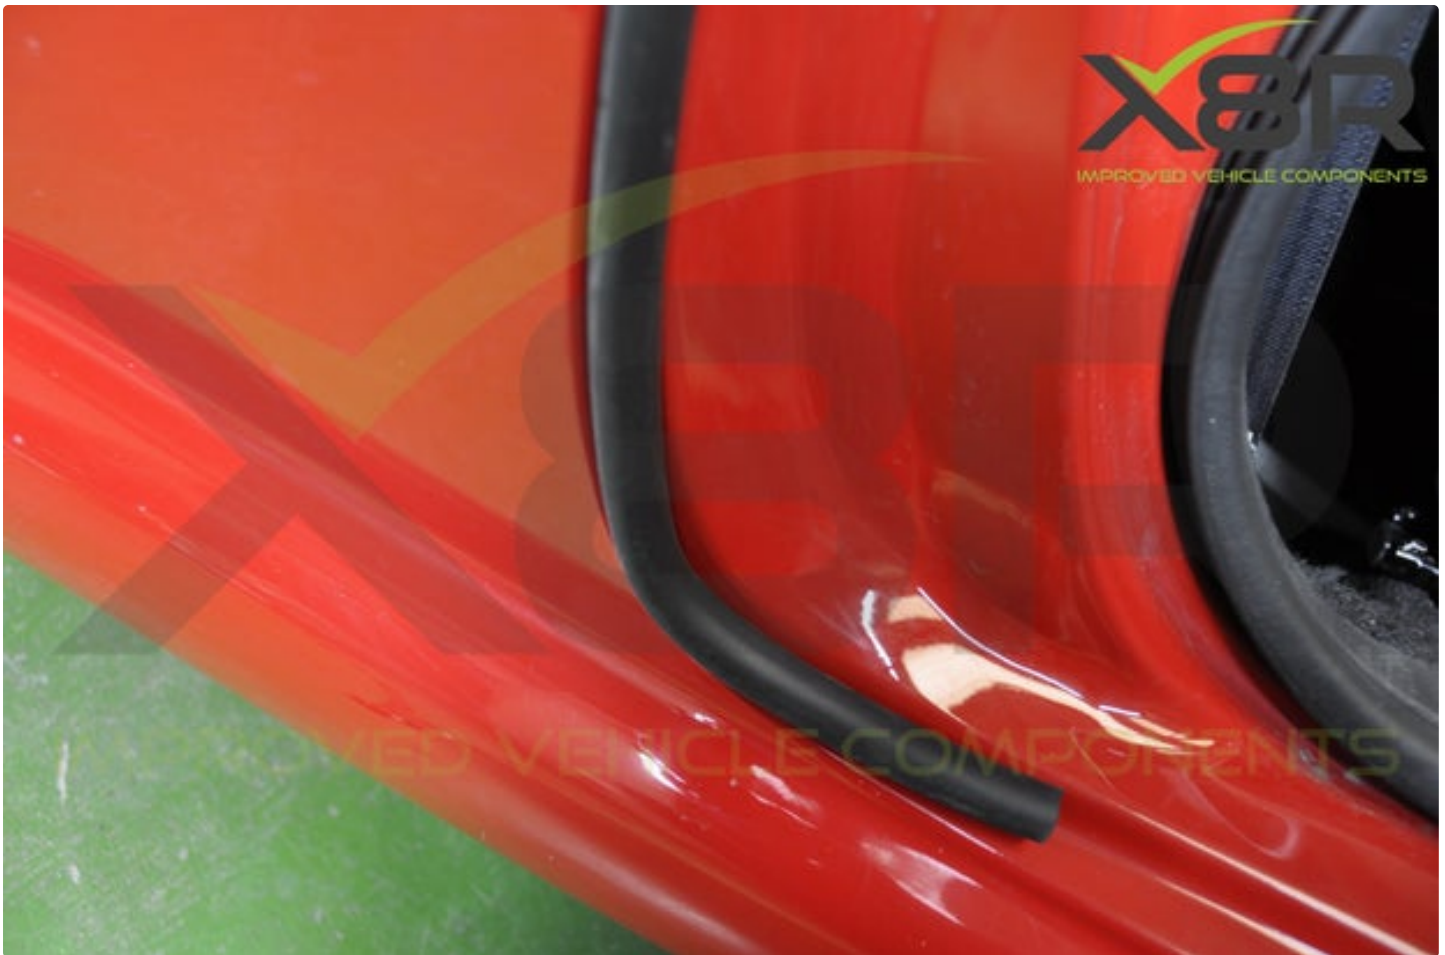
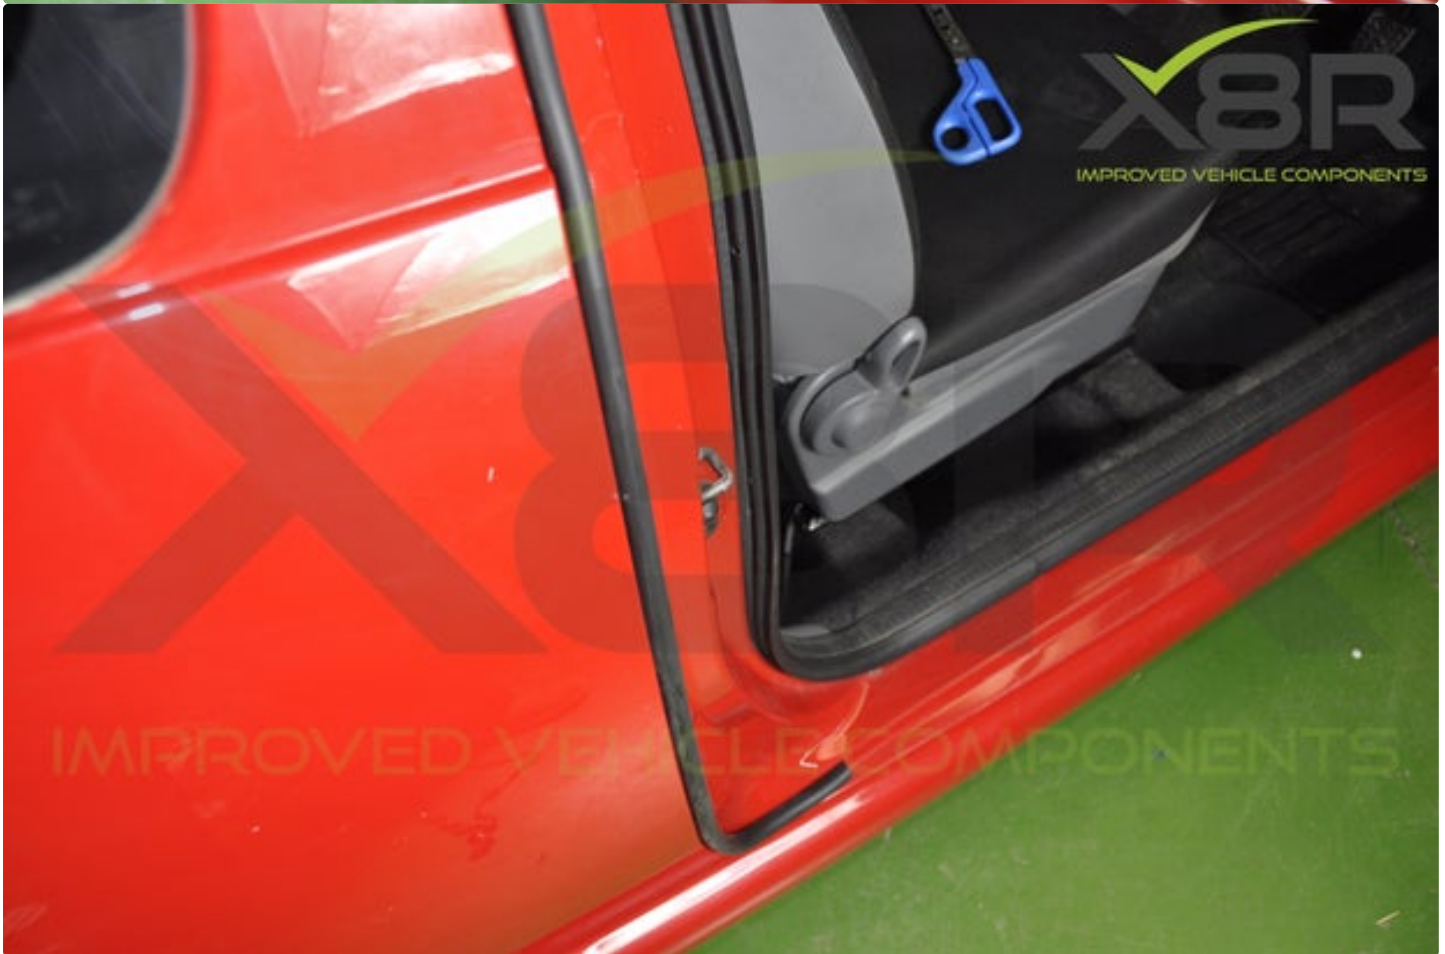
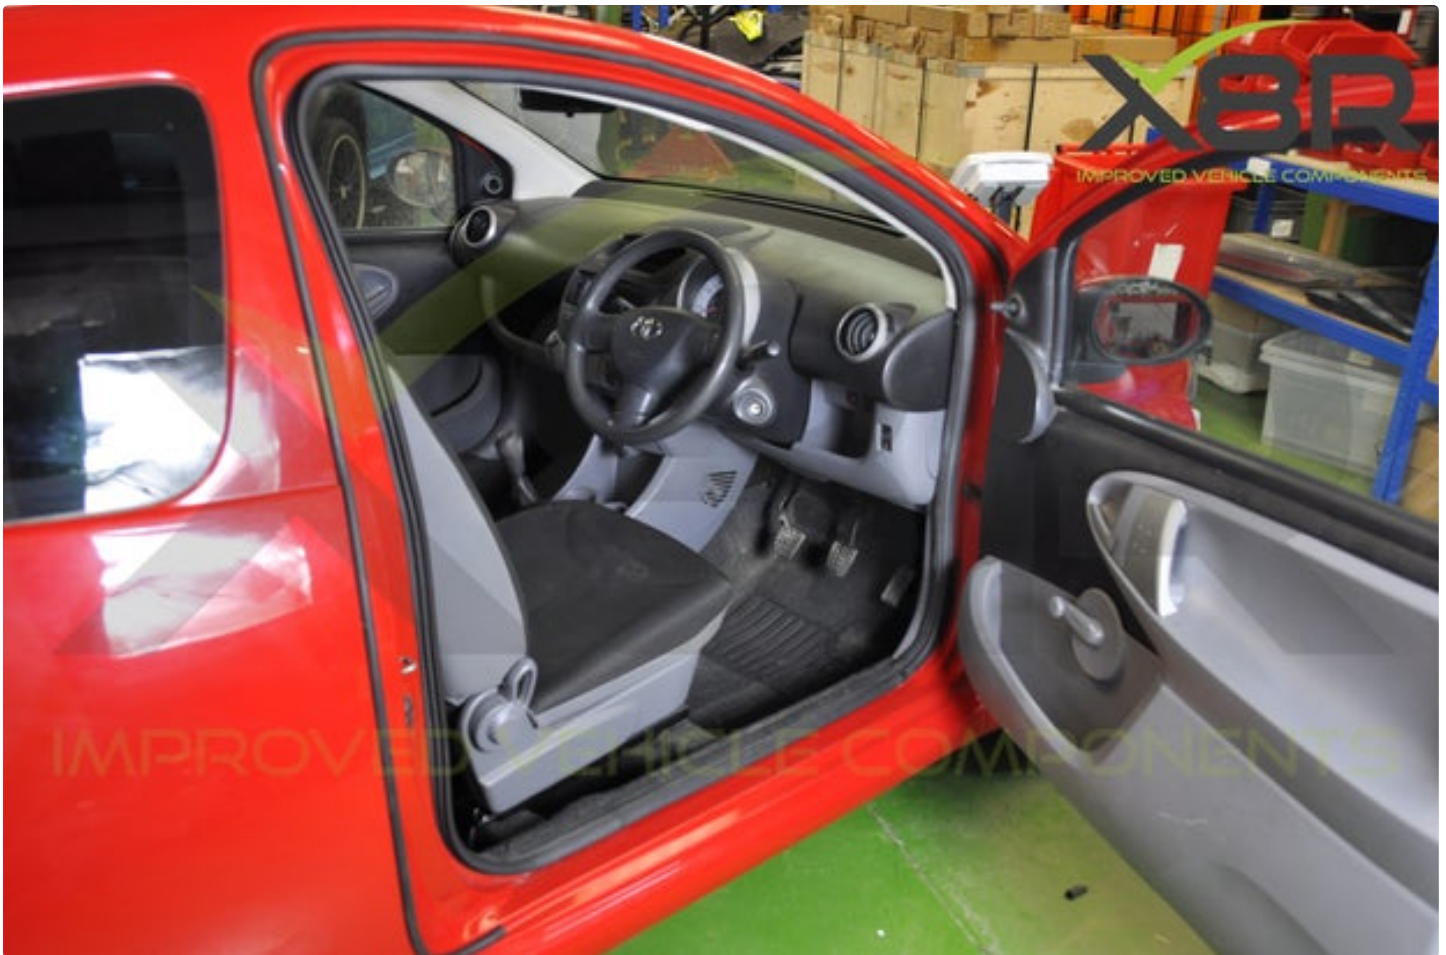
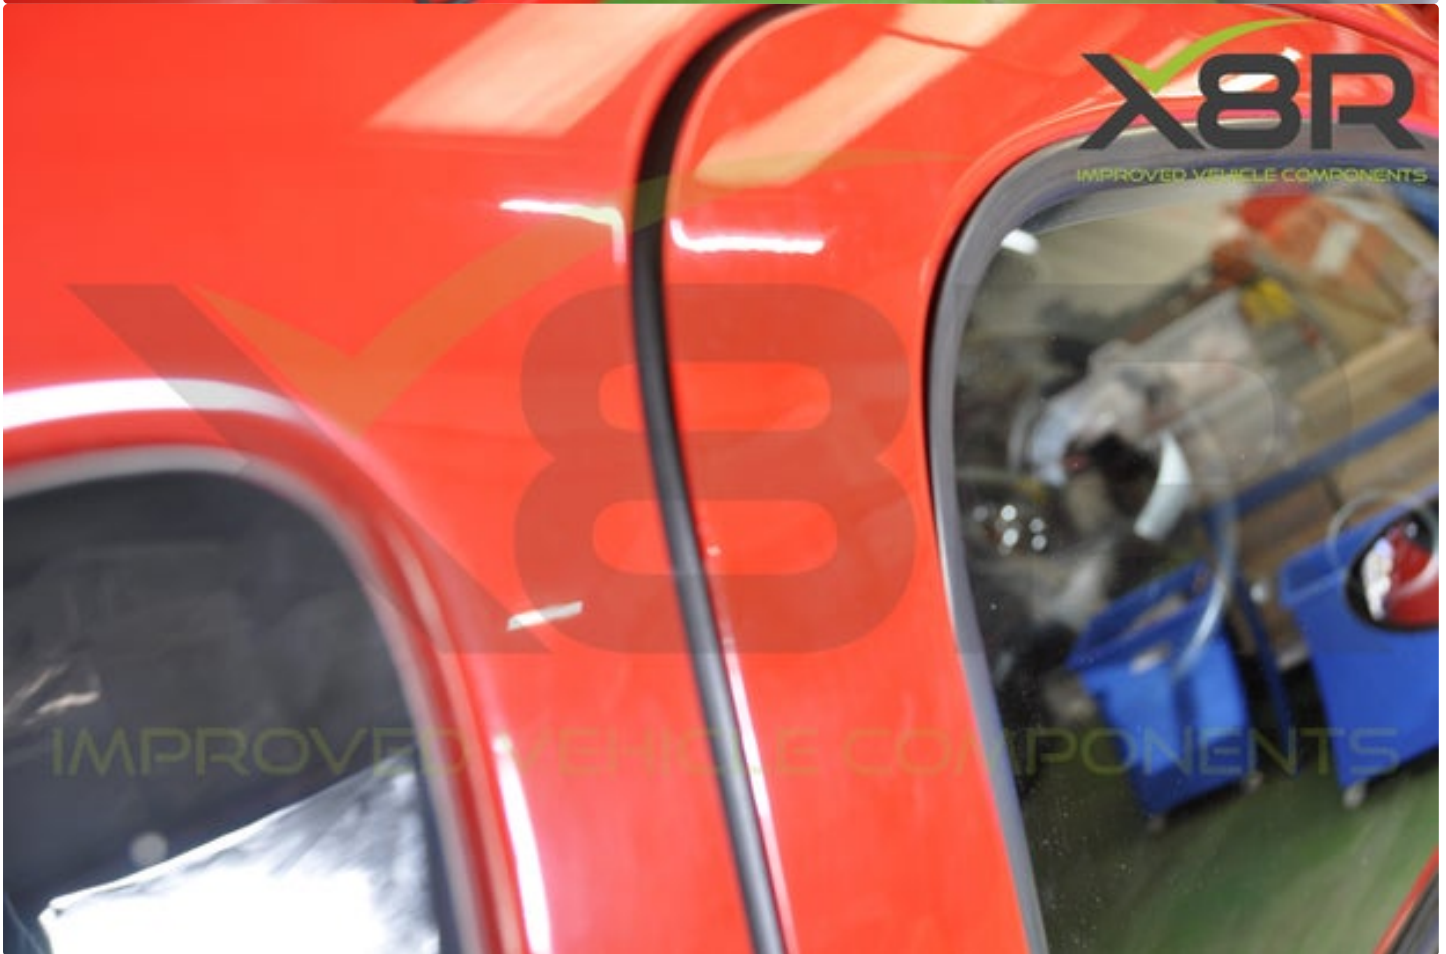
Step 2: Door Seals: Fit Door Seals

Peel back the adhesive backing paper and fit our seal in the position shown. As you work around the recess push the seal firmly in to position. If fitting in cold conditions a hot air gun can be used to make the seal more flexible.

If the seal provided is too long (doors vary slightly by model) cut down to length with a pair of scissors so that the seal finishes at the location shown.

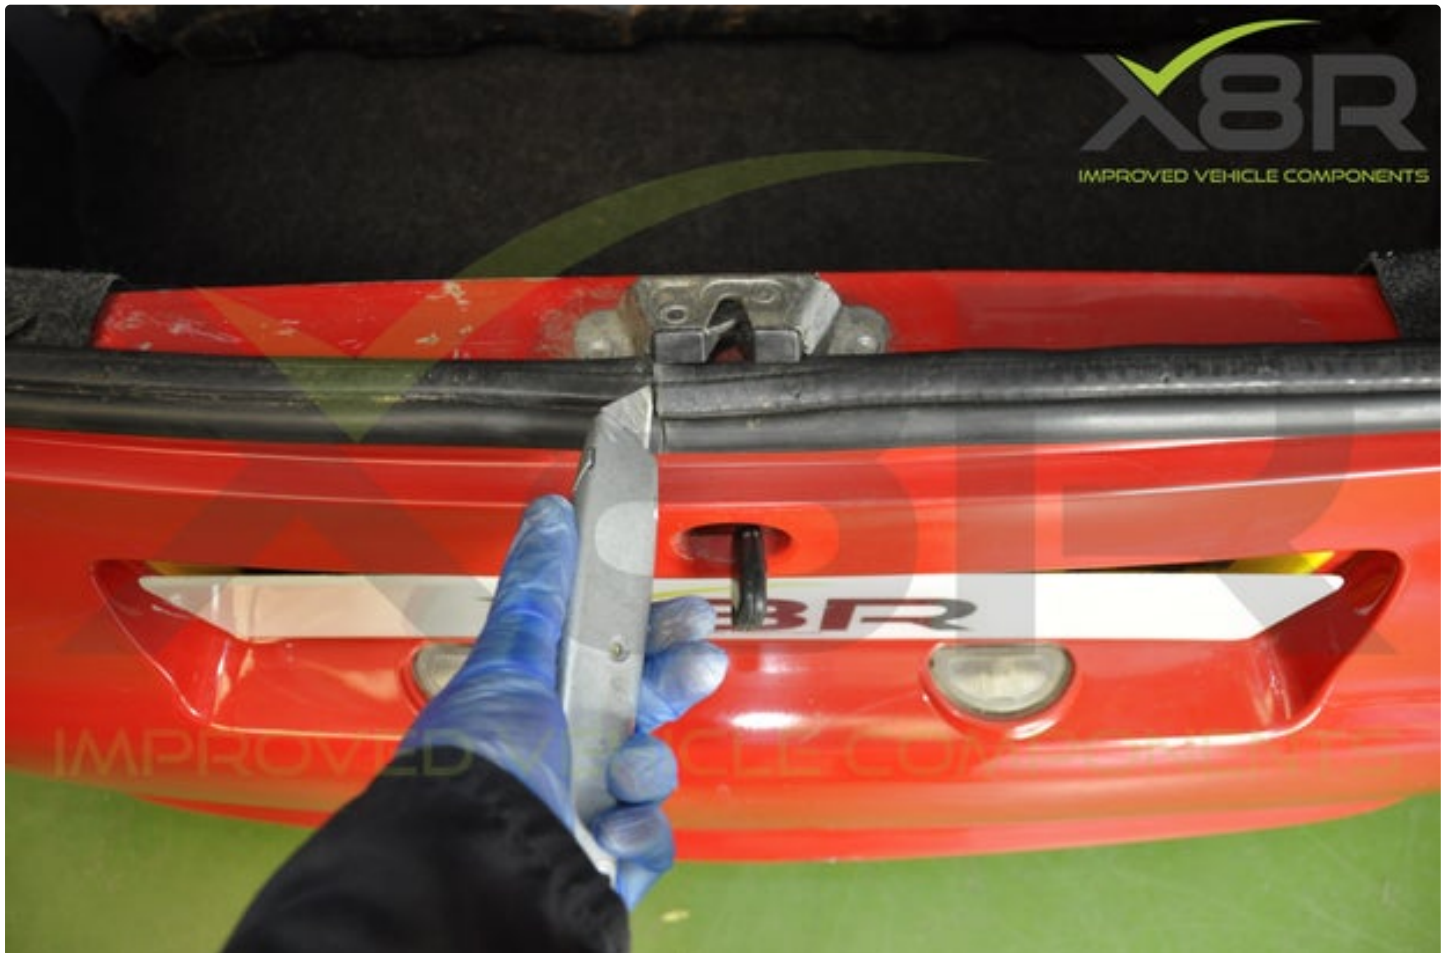
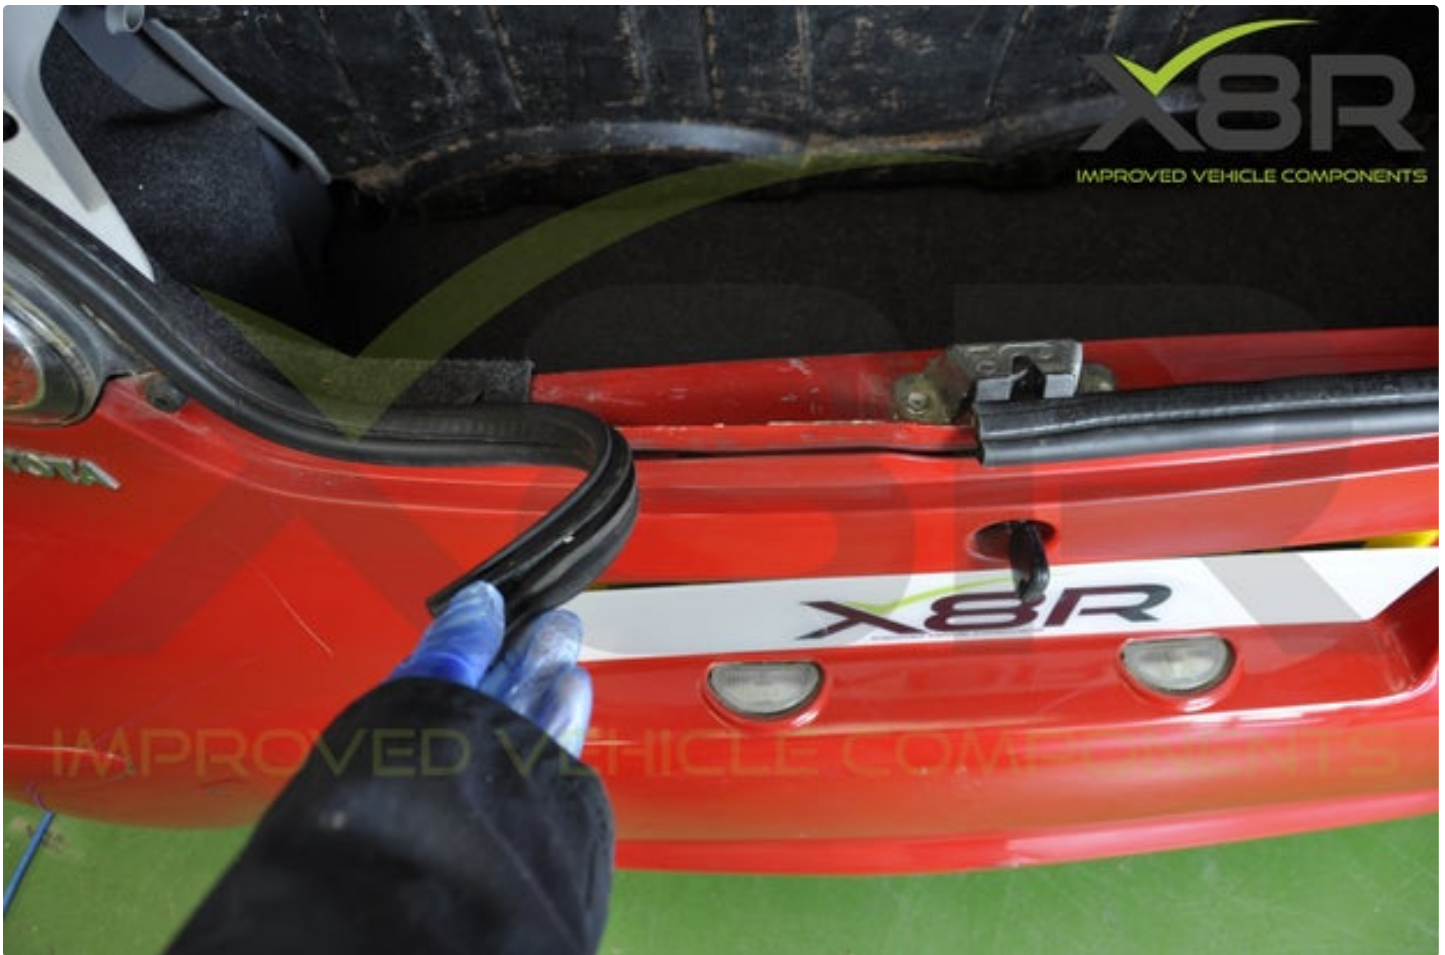
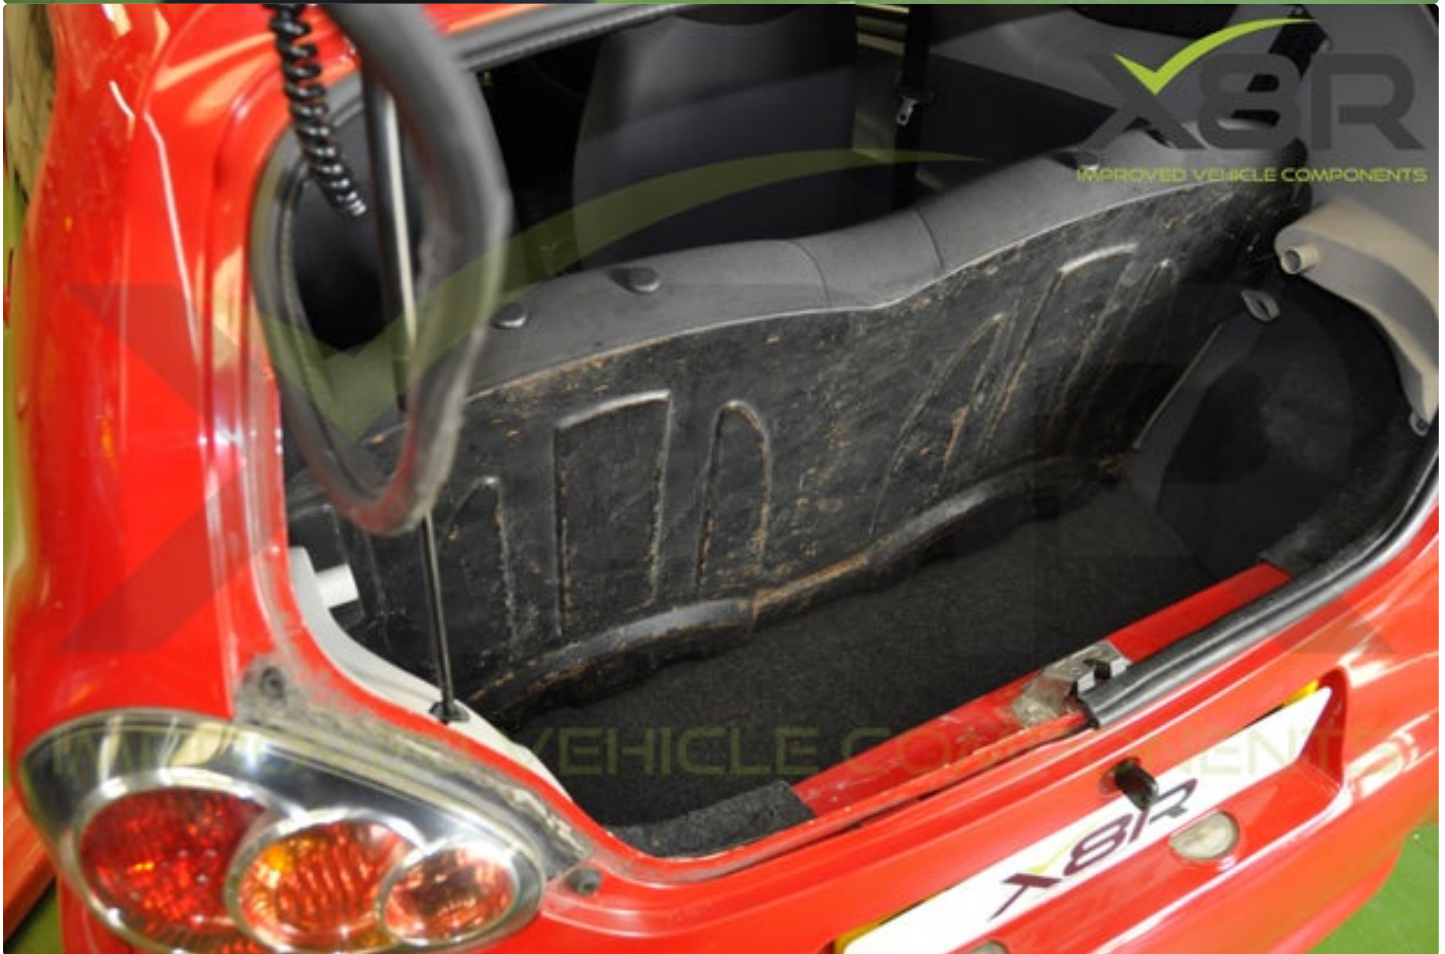
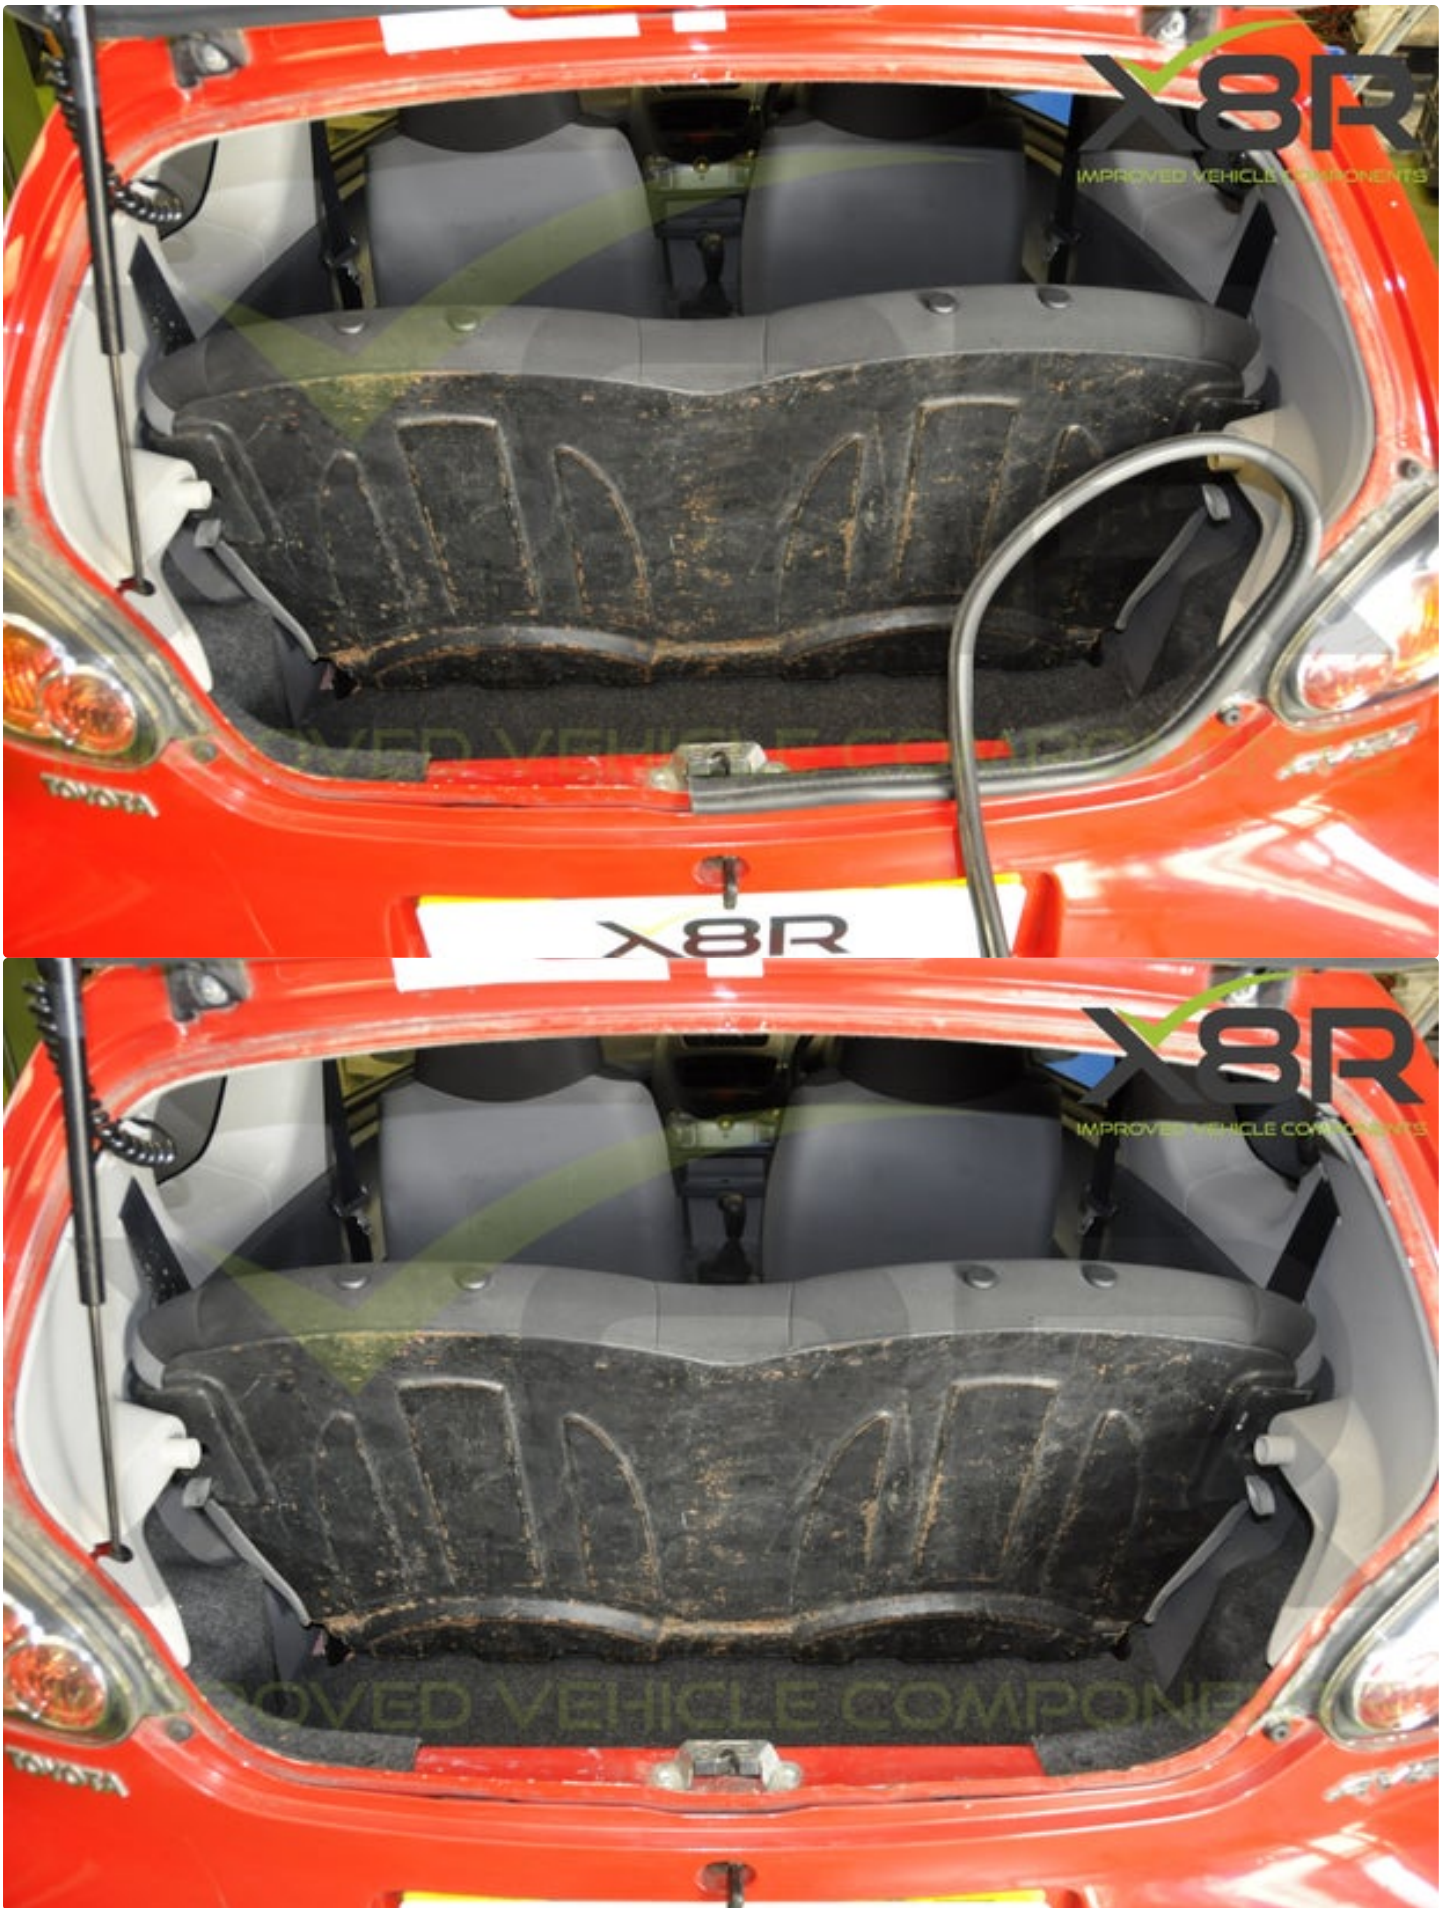
Step 3: Boot Seal Replacement: Remove OEM Seal

Cut the old seal at the location shown near the latch. Pull the OEM seal out of position and remove.
