Toyota AYGO Peugeot 107 Citroen C1 Door Boot Tailgate Seal Leak Fix Seal Kit Seals Install Instruction Guide

by x8rltd

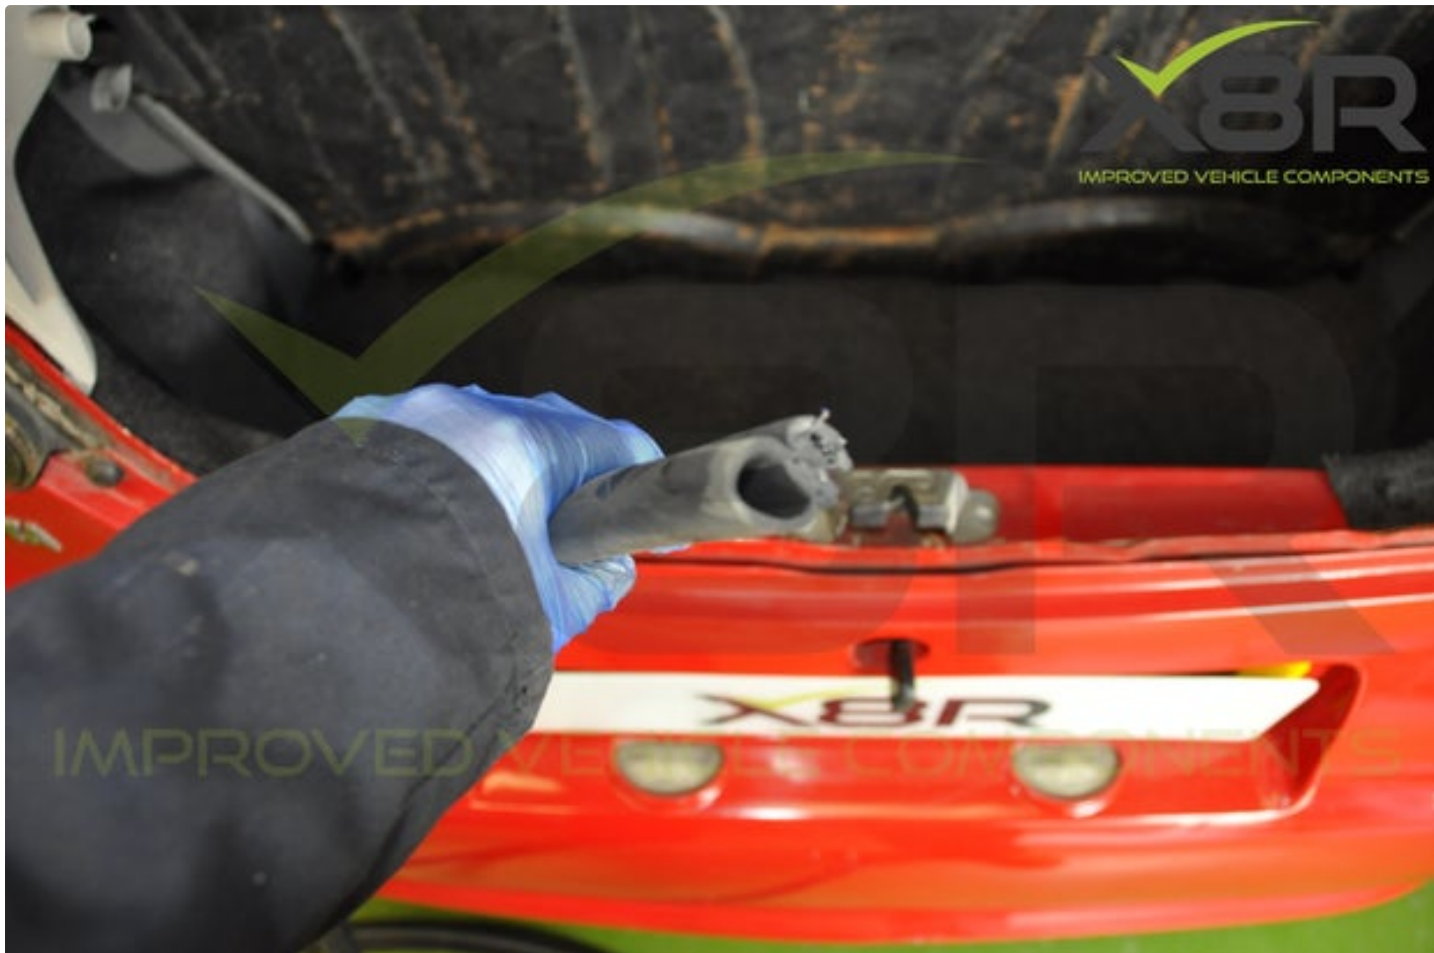
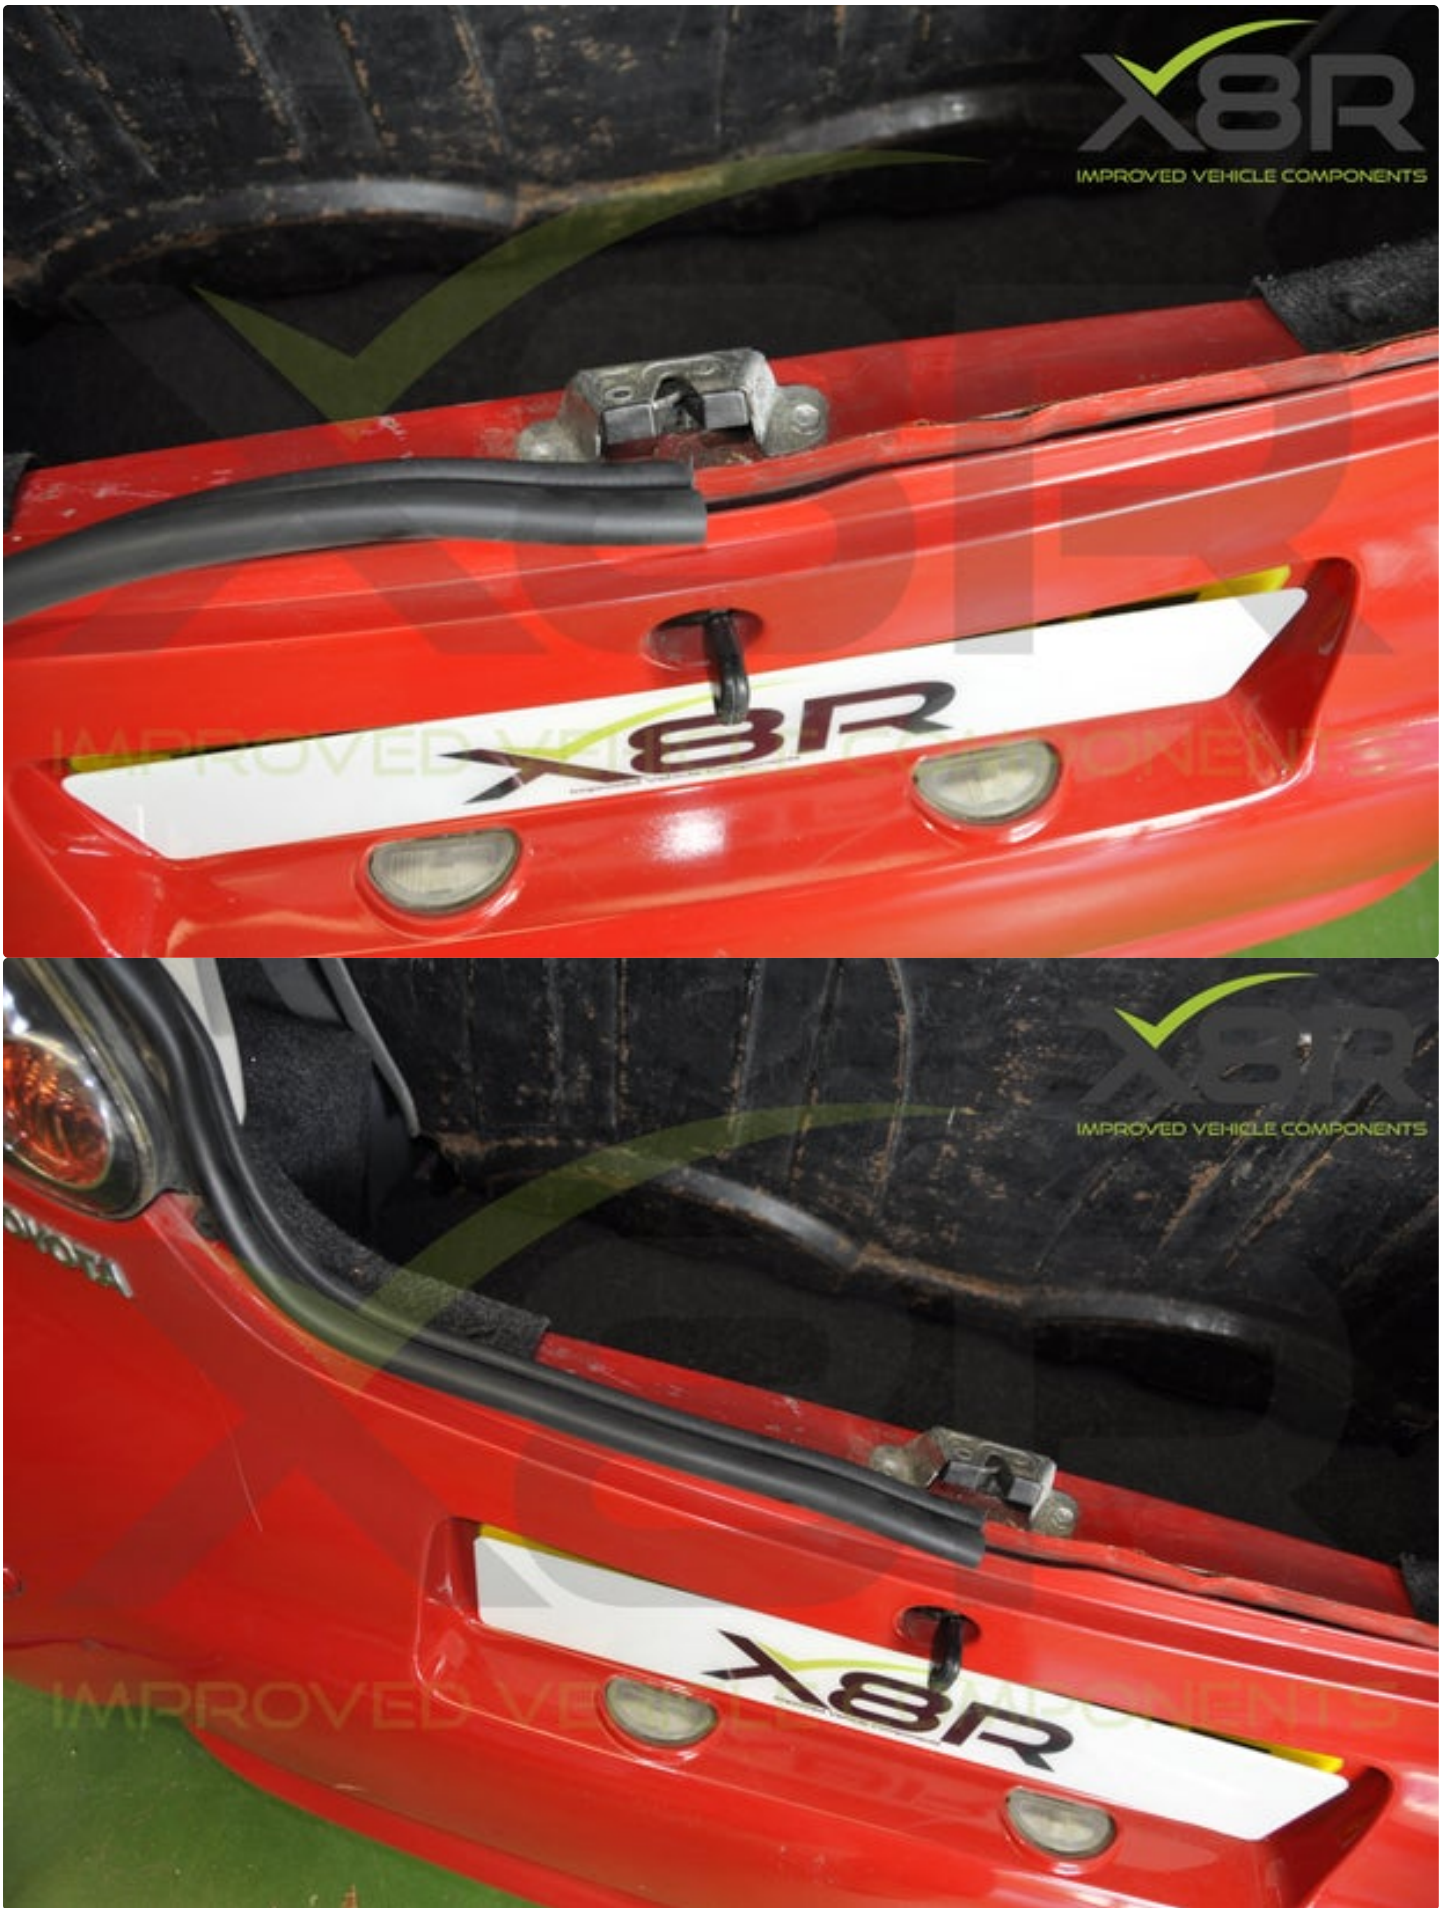
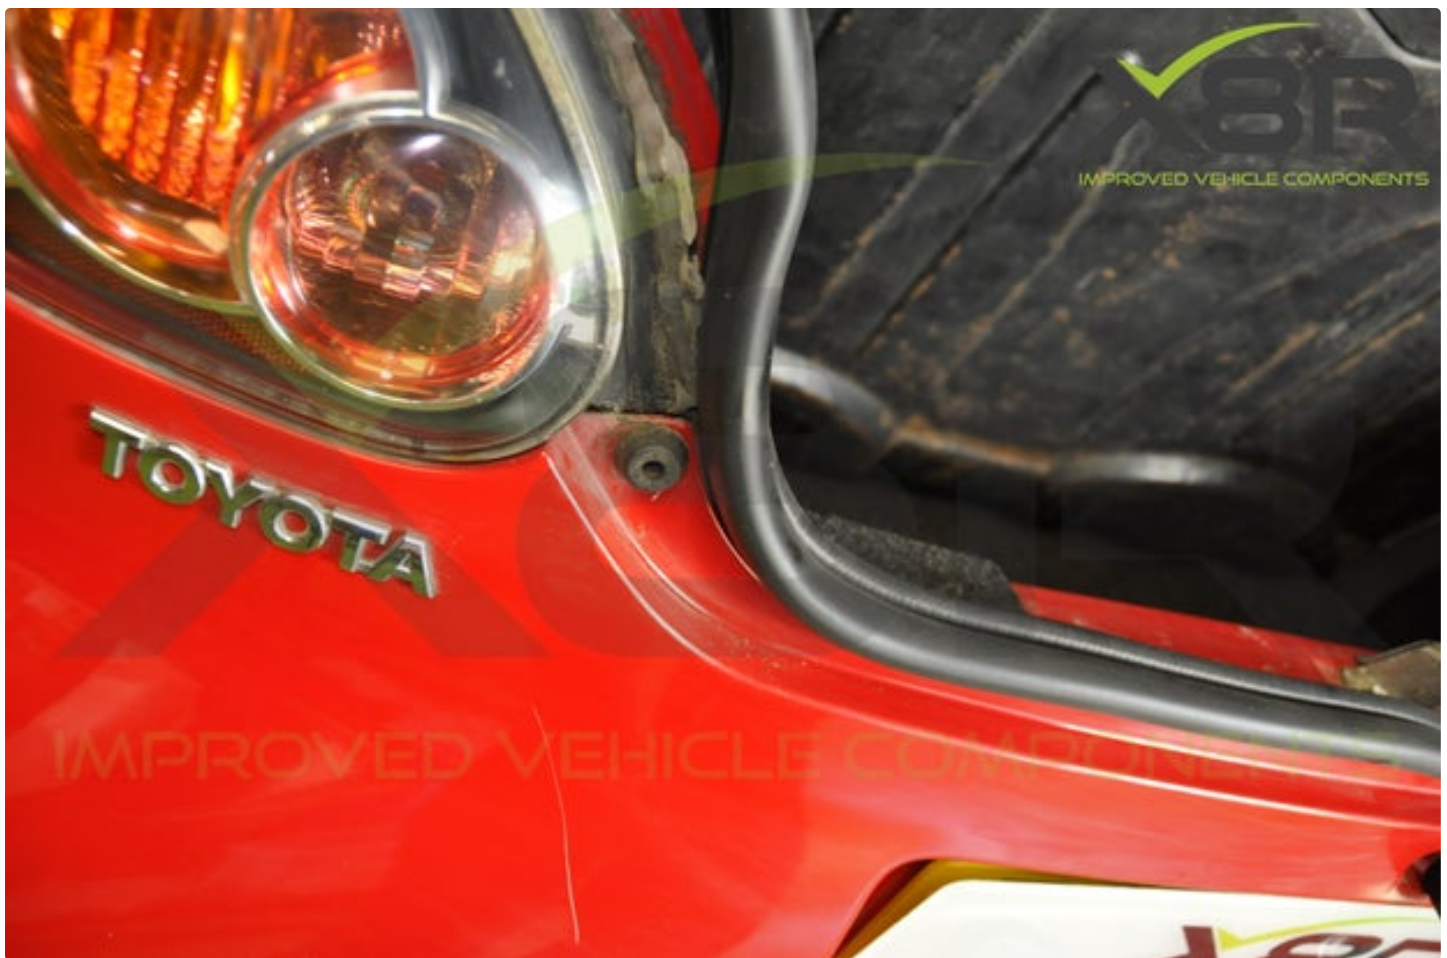
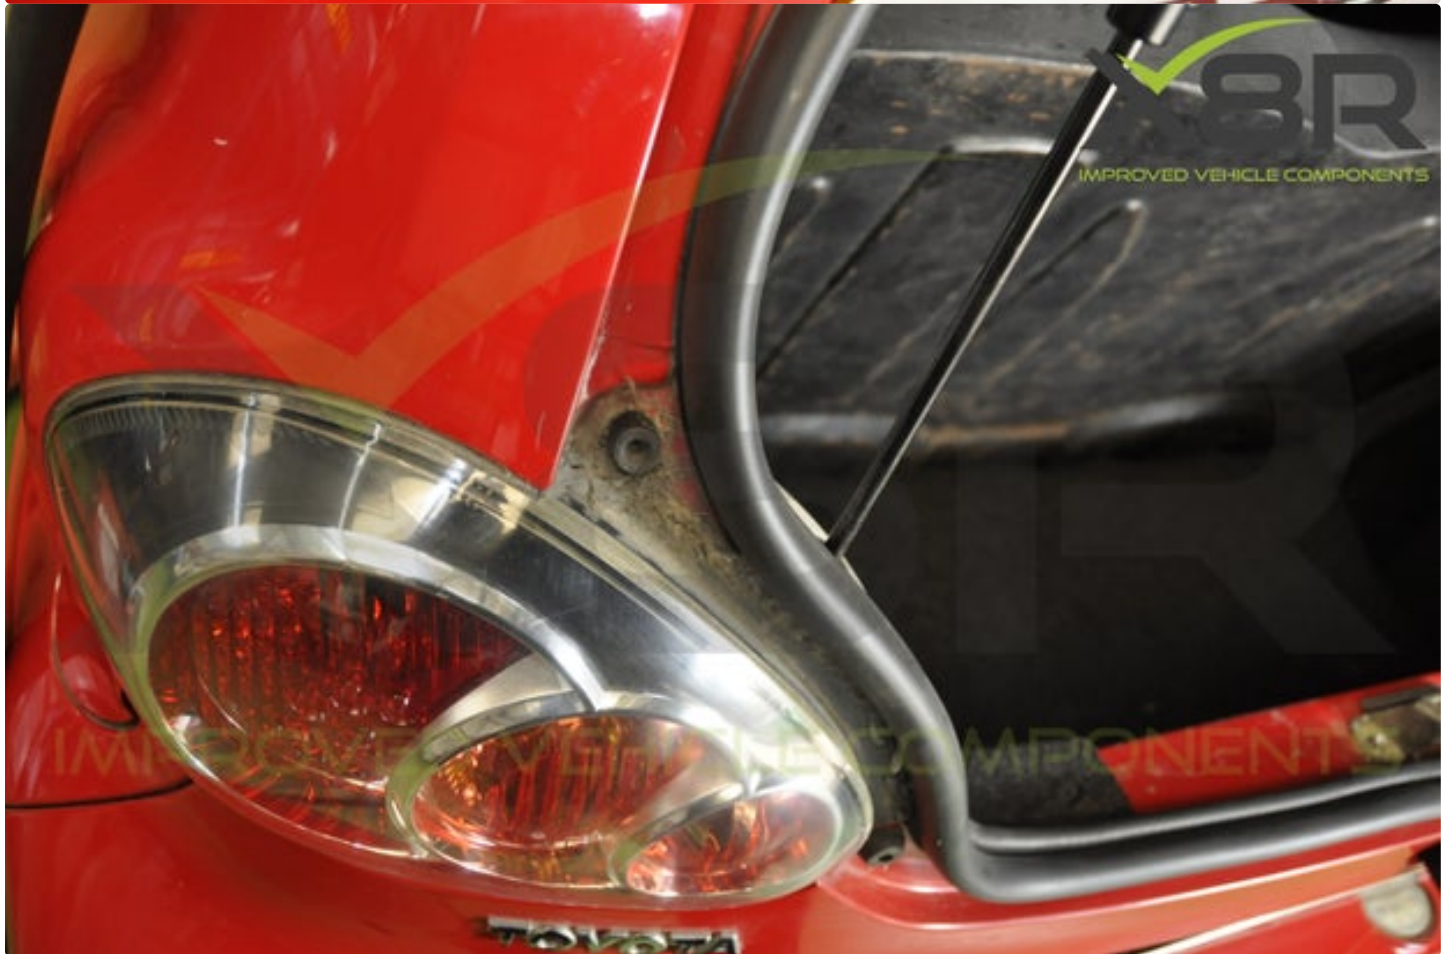
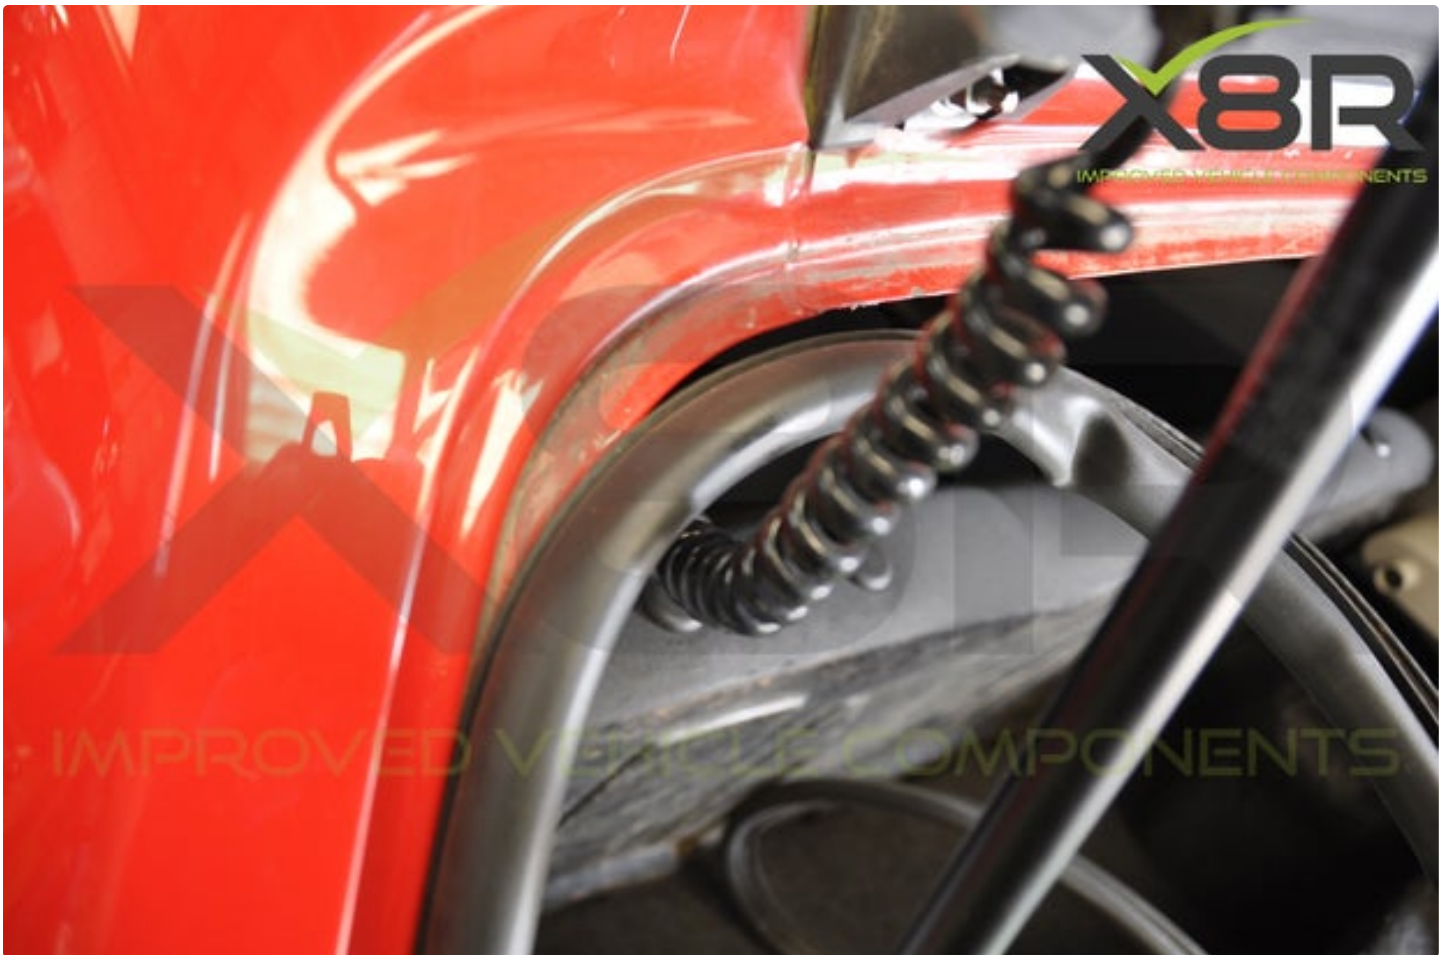
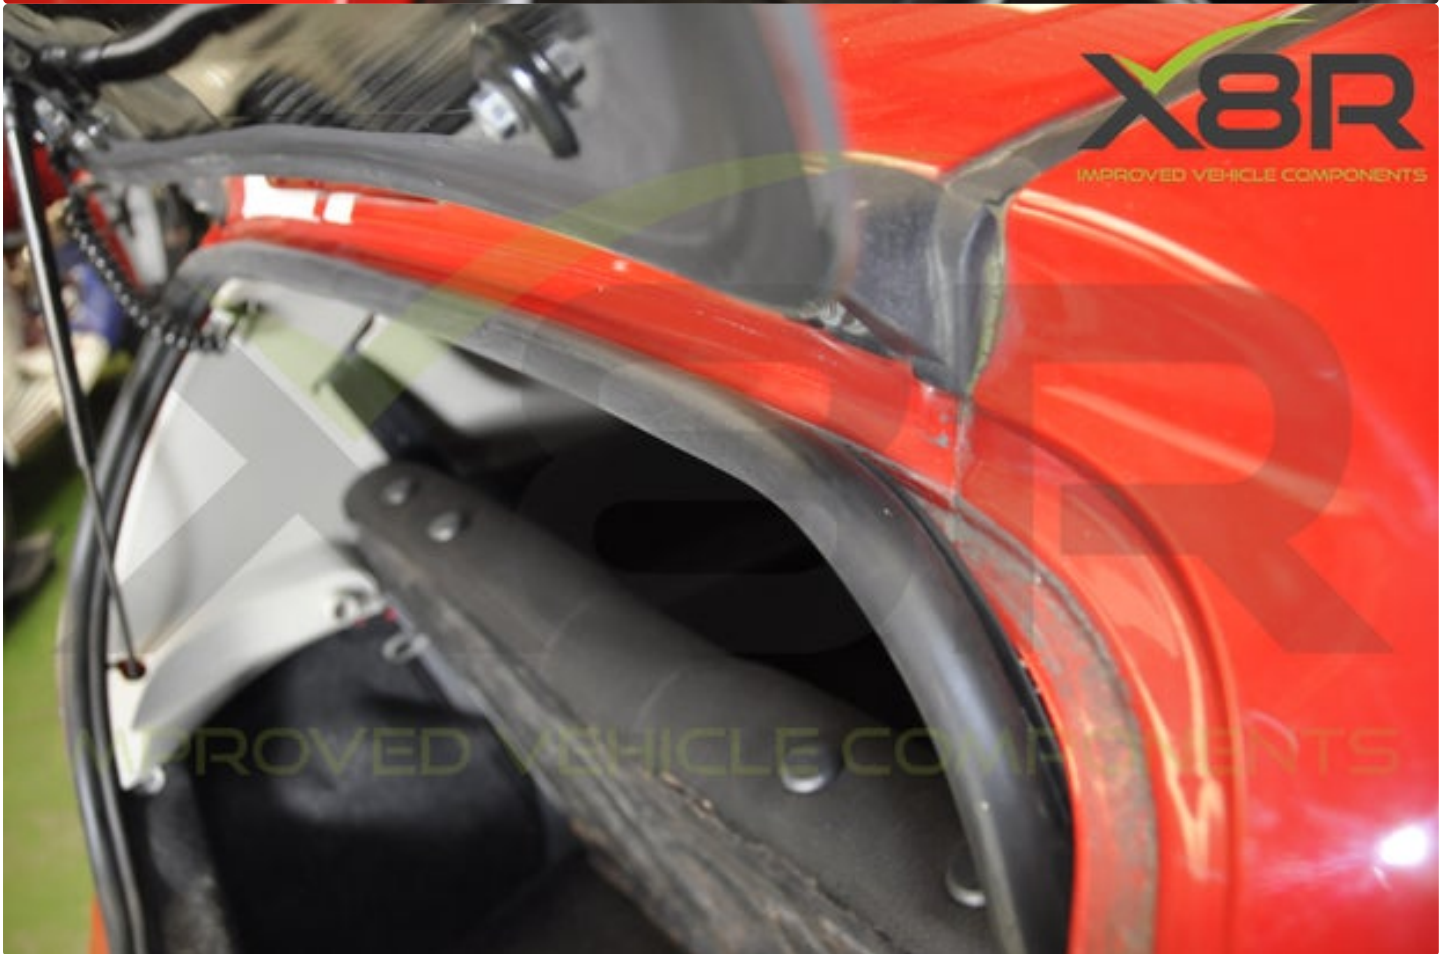
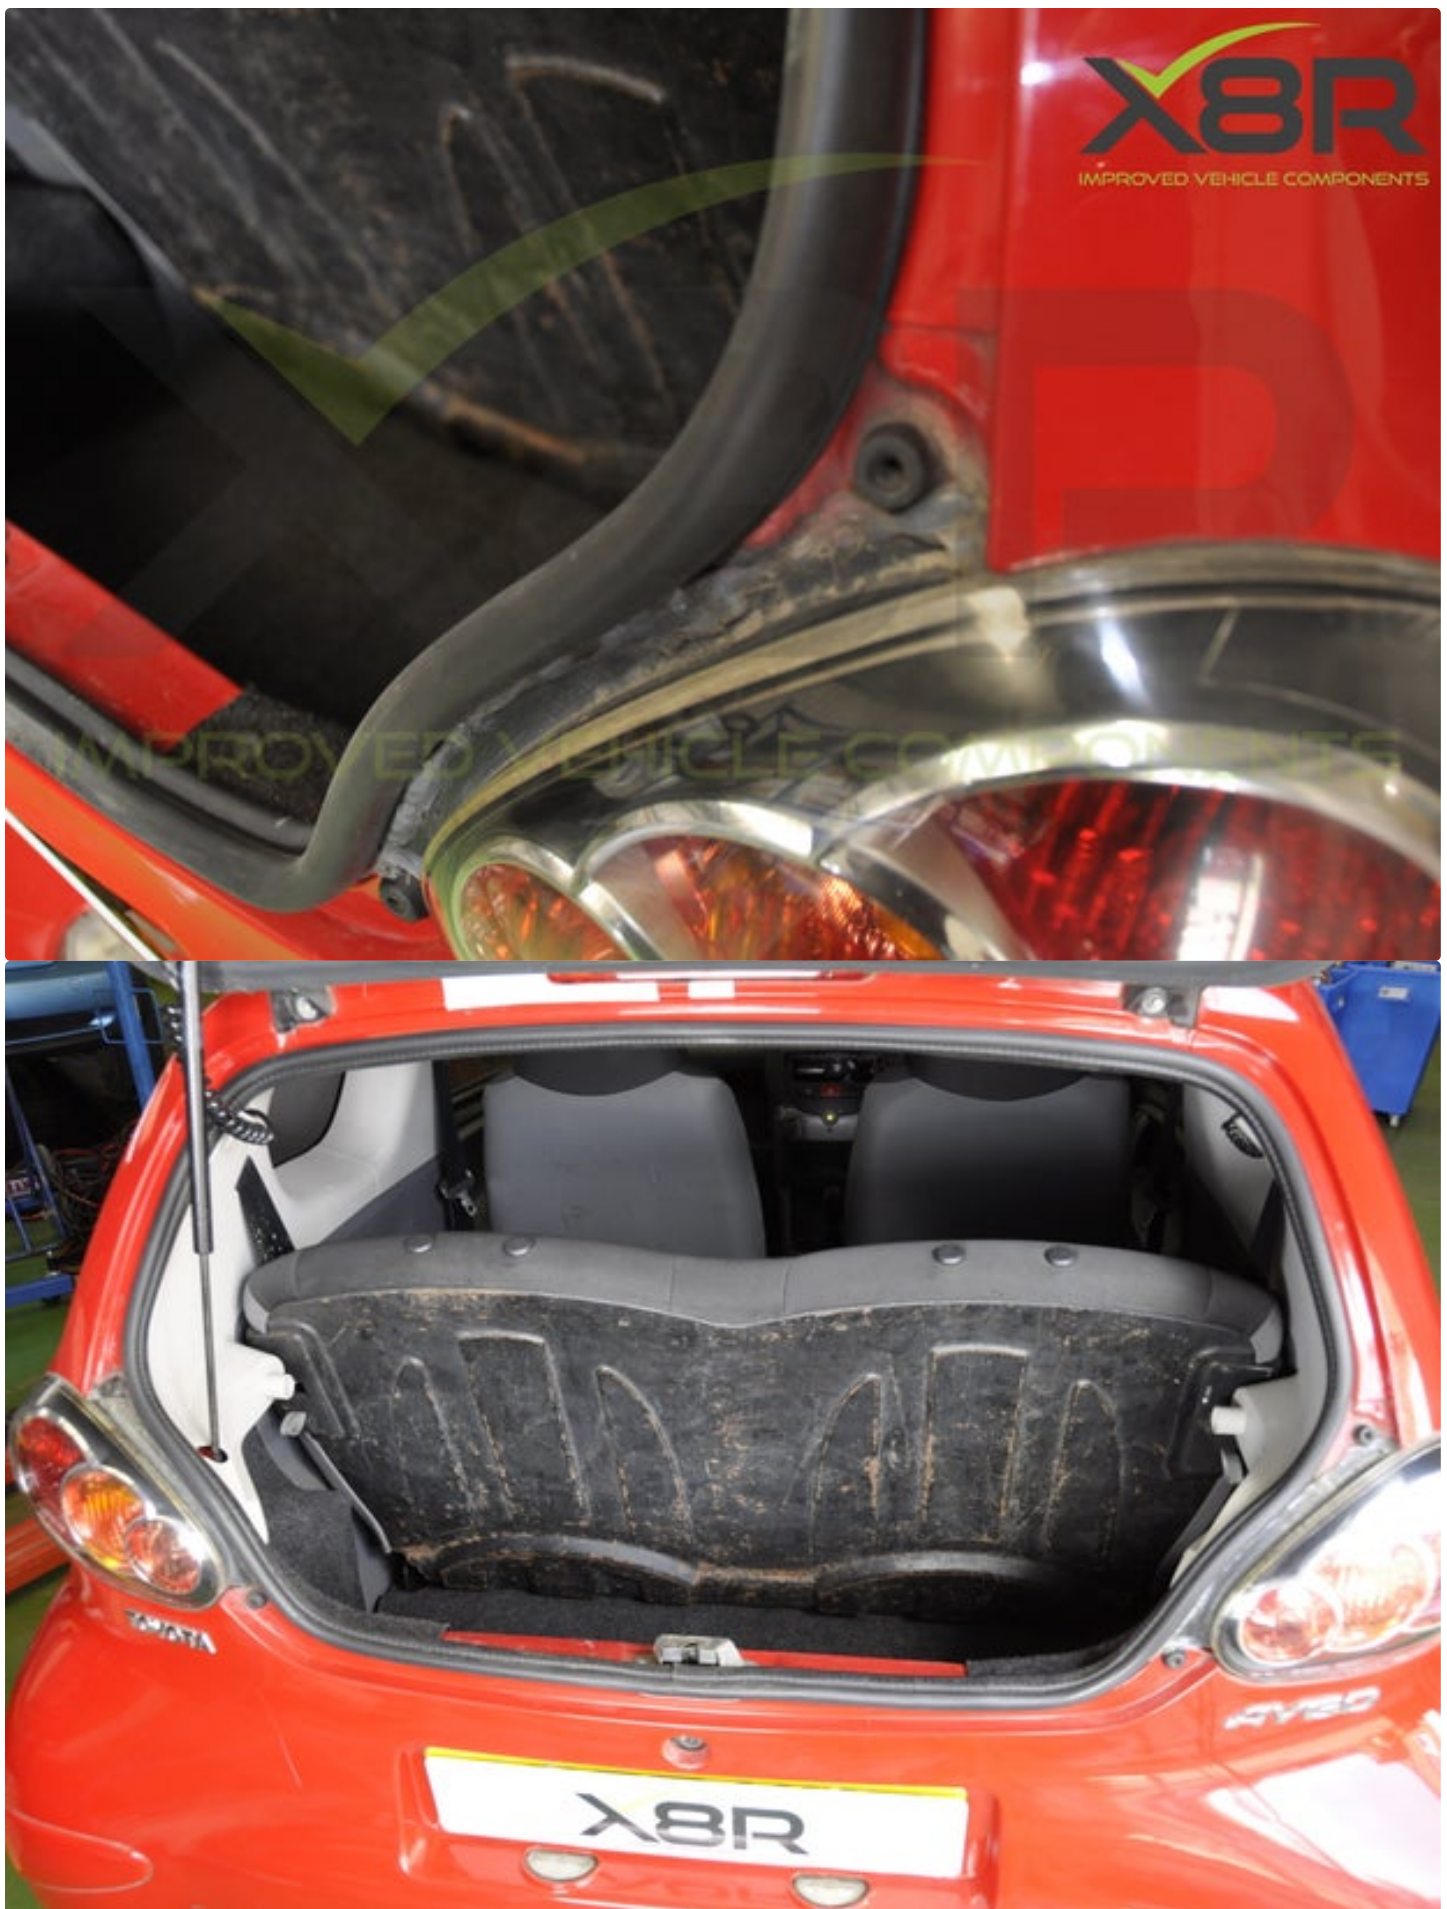
Step 4: Boot Seal Replacement: Fit Our New Seal

Push our seal in to position, our seal fits in exactly the same way as the OEM part. Start at the latch and work around, ensuring the seal is fully pushed in to the recess on the body as far as it will go.

At the end cut the seal down to length to marry up with the start of the seal.

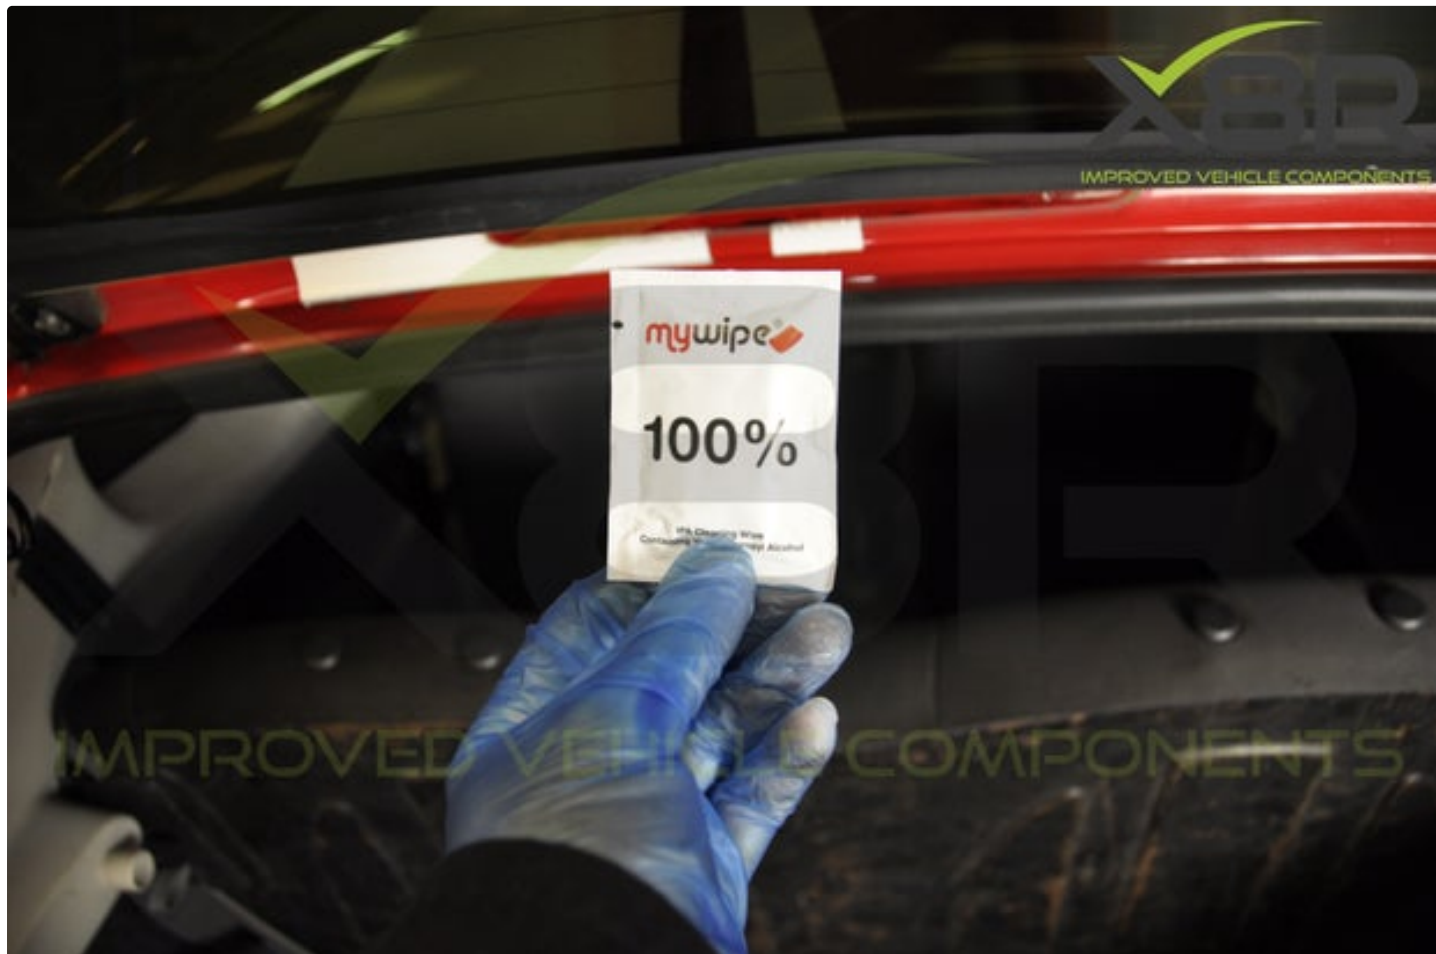
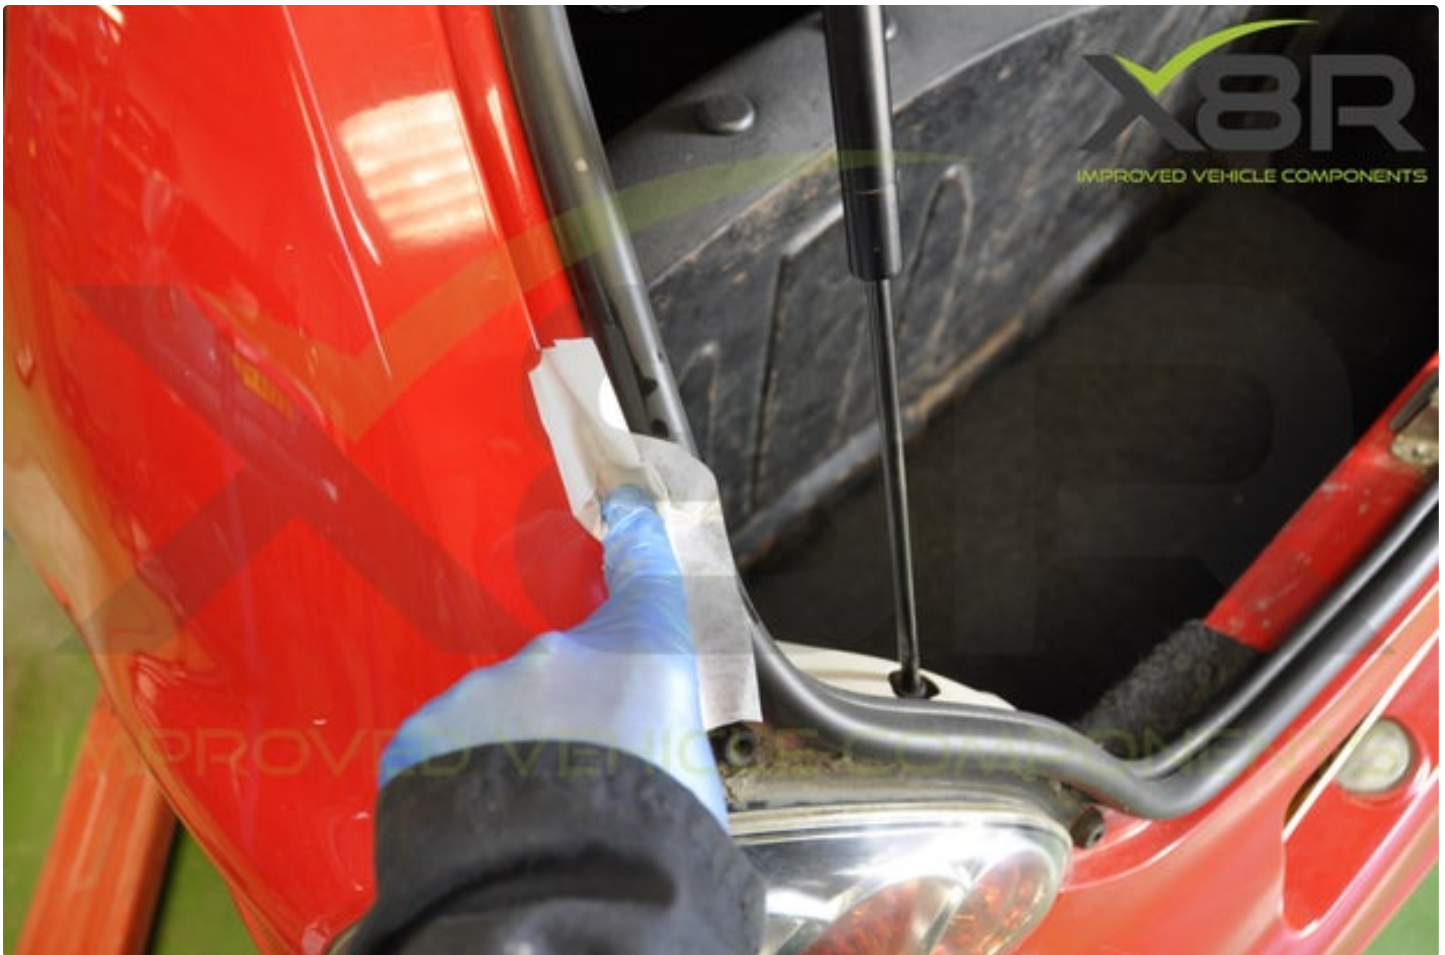
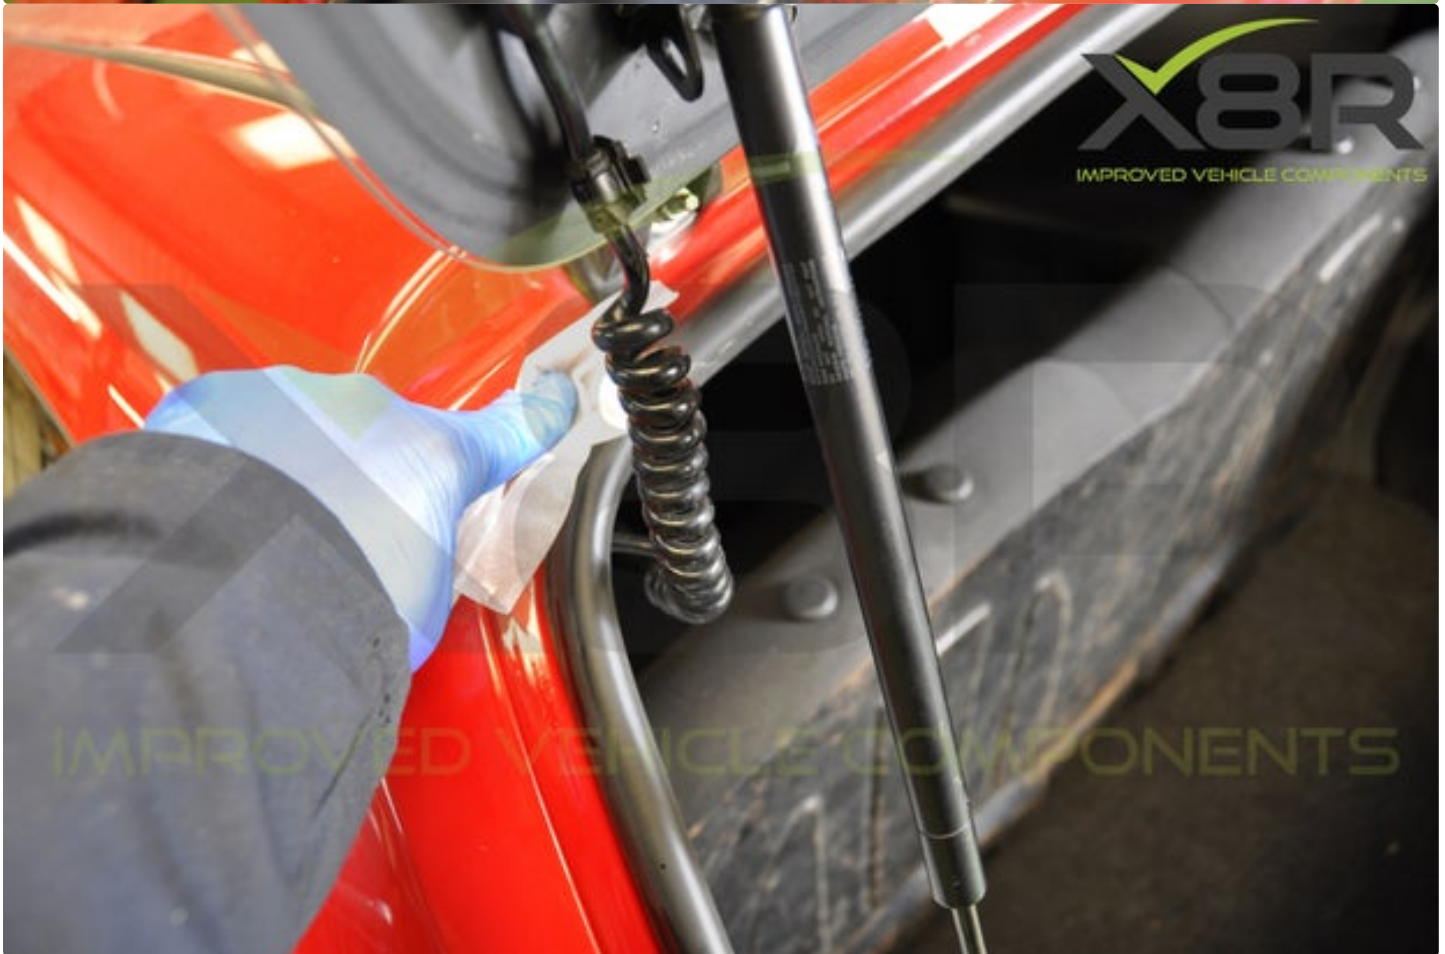
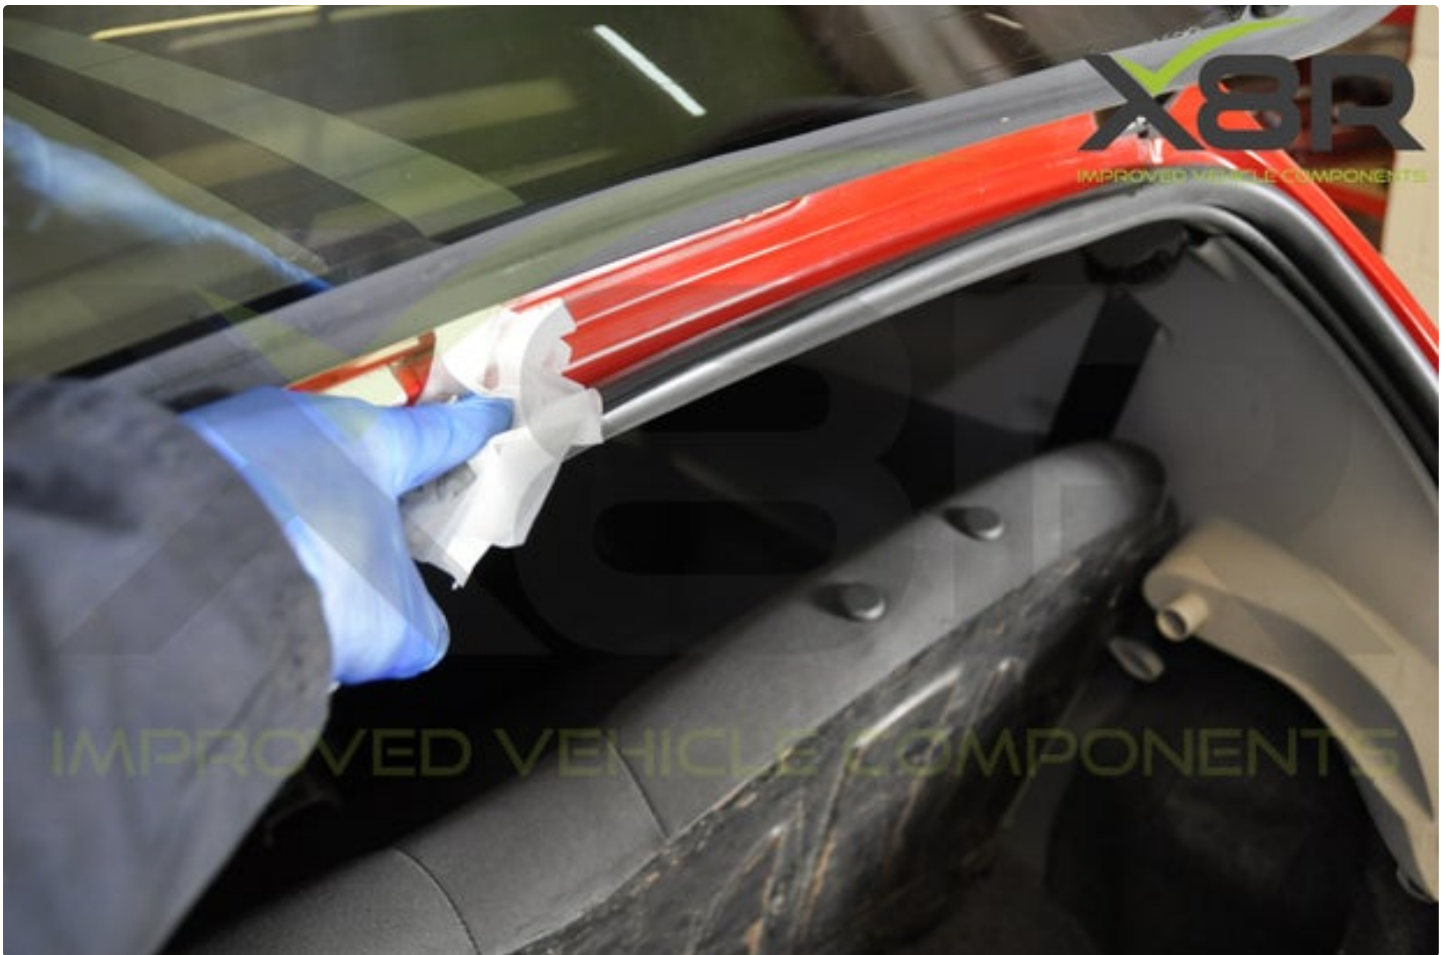
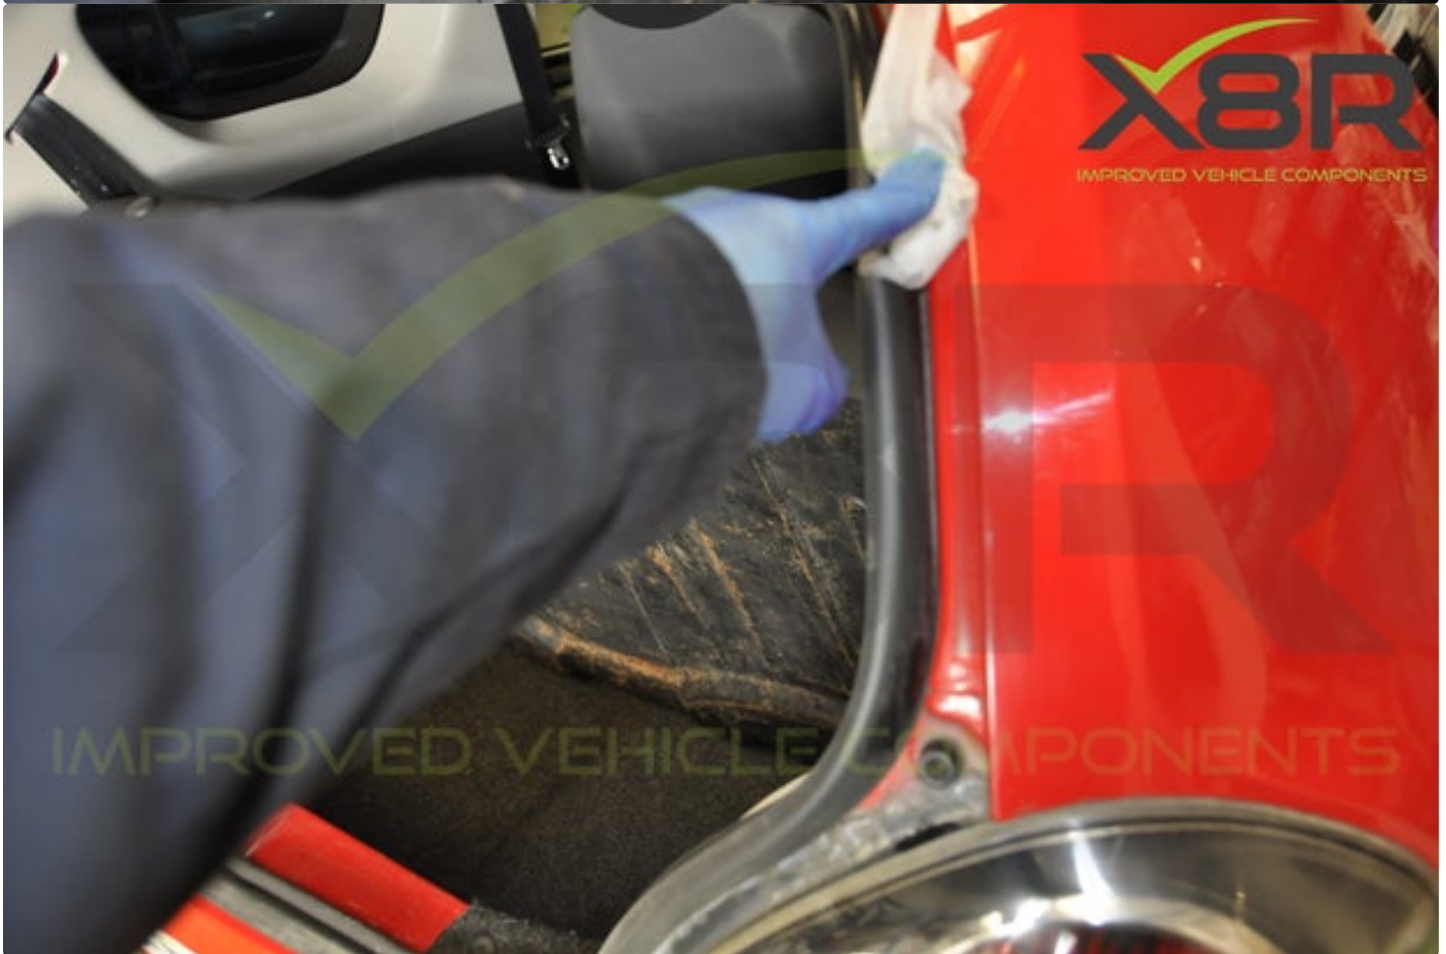
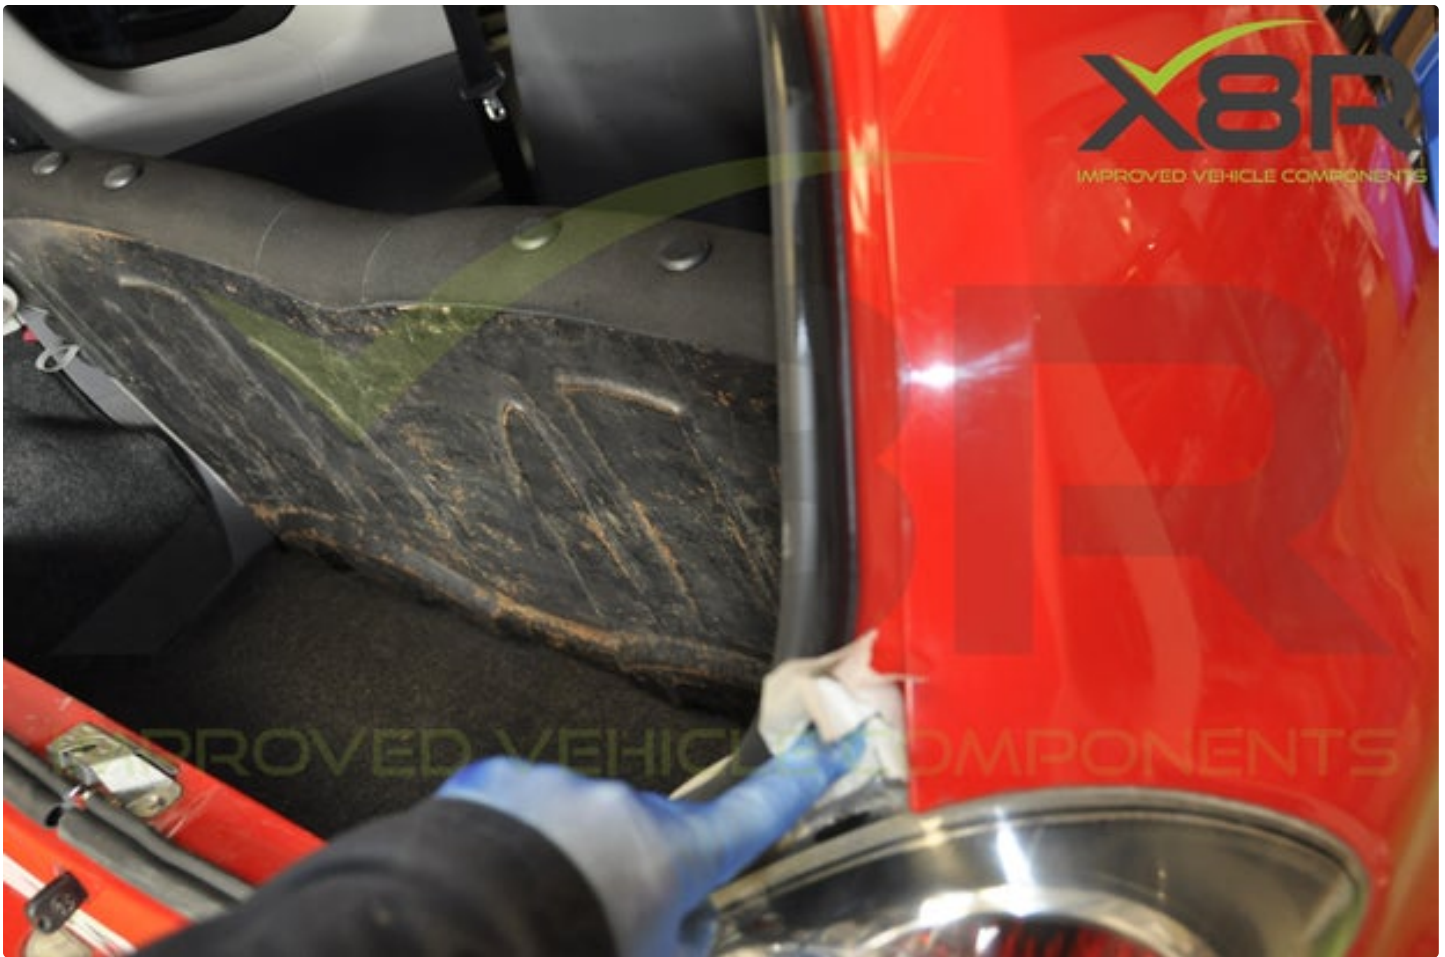
Step 5: Additional Boot Seal: Clean Up Surface

Using one of our alcohol wipes clean up the outside edge of the door recess, remove all grime / grease to ensure good adhesion of our seal.
