Toyota AYGO Peugeot 107 Citroen C1 Door Boot Tailgate Seal Leak Fix Seal Kit Seals Install Instruction Guide

by x8rltd

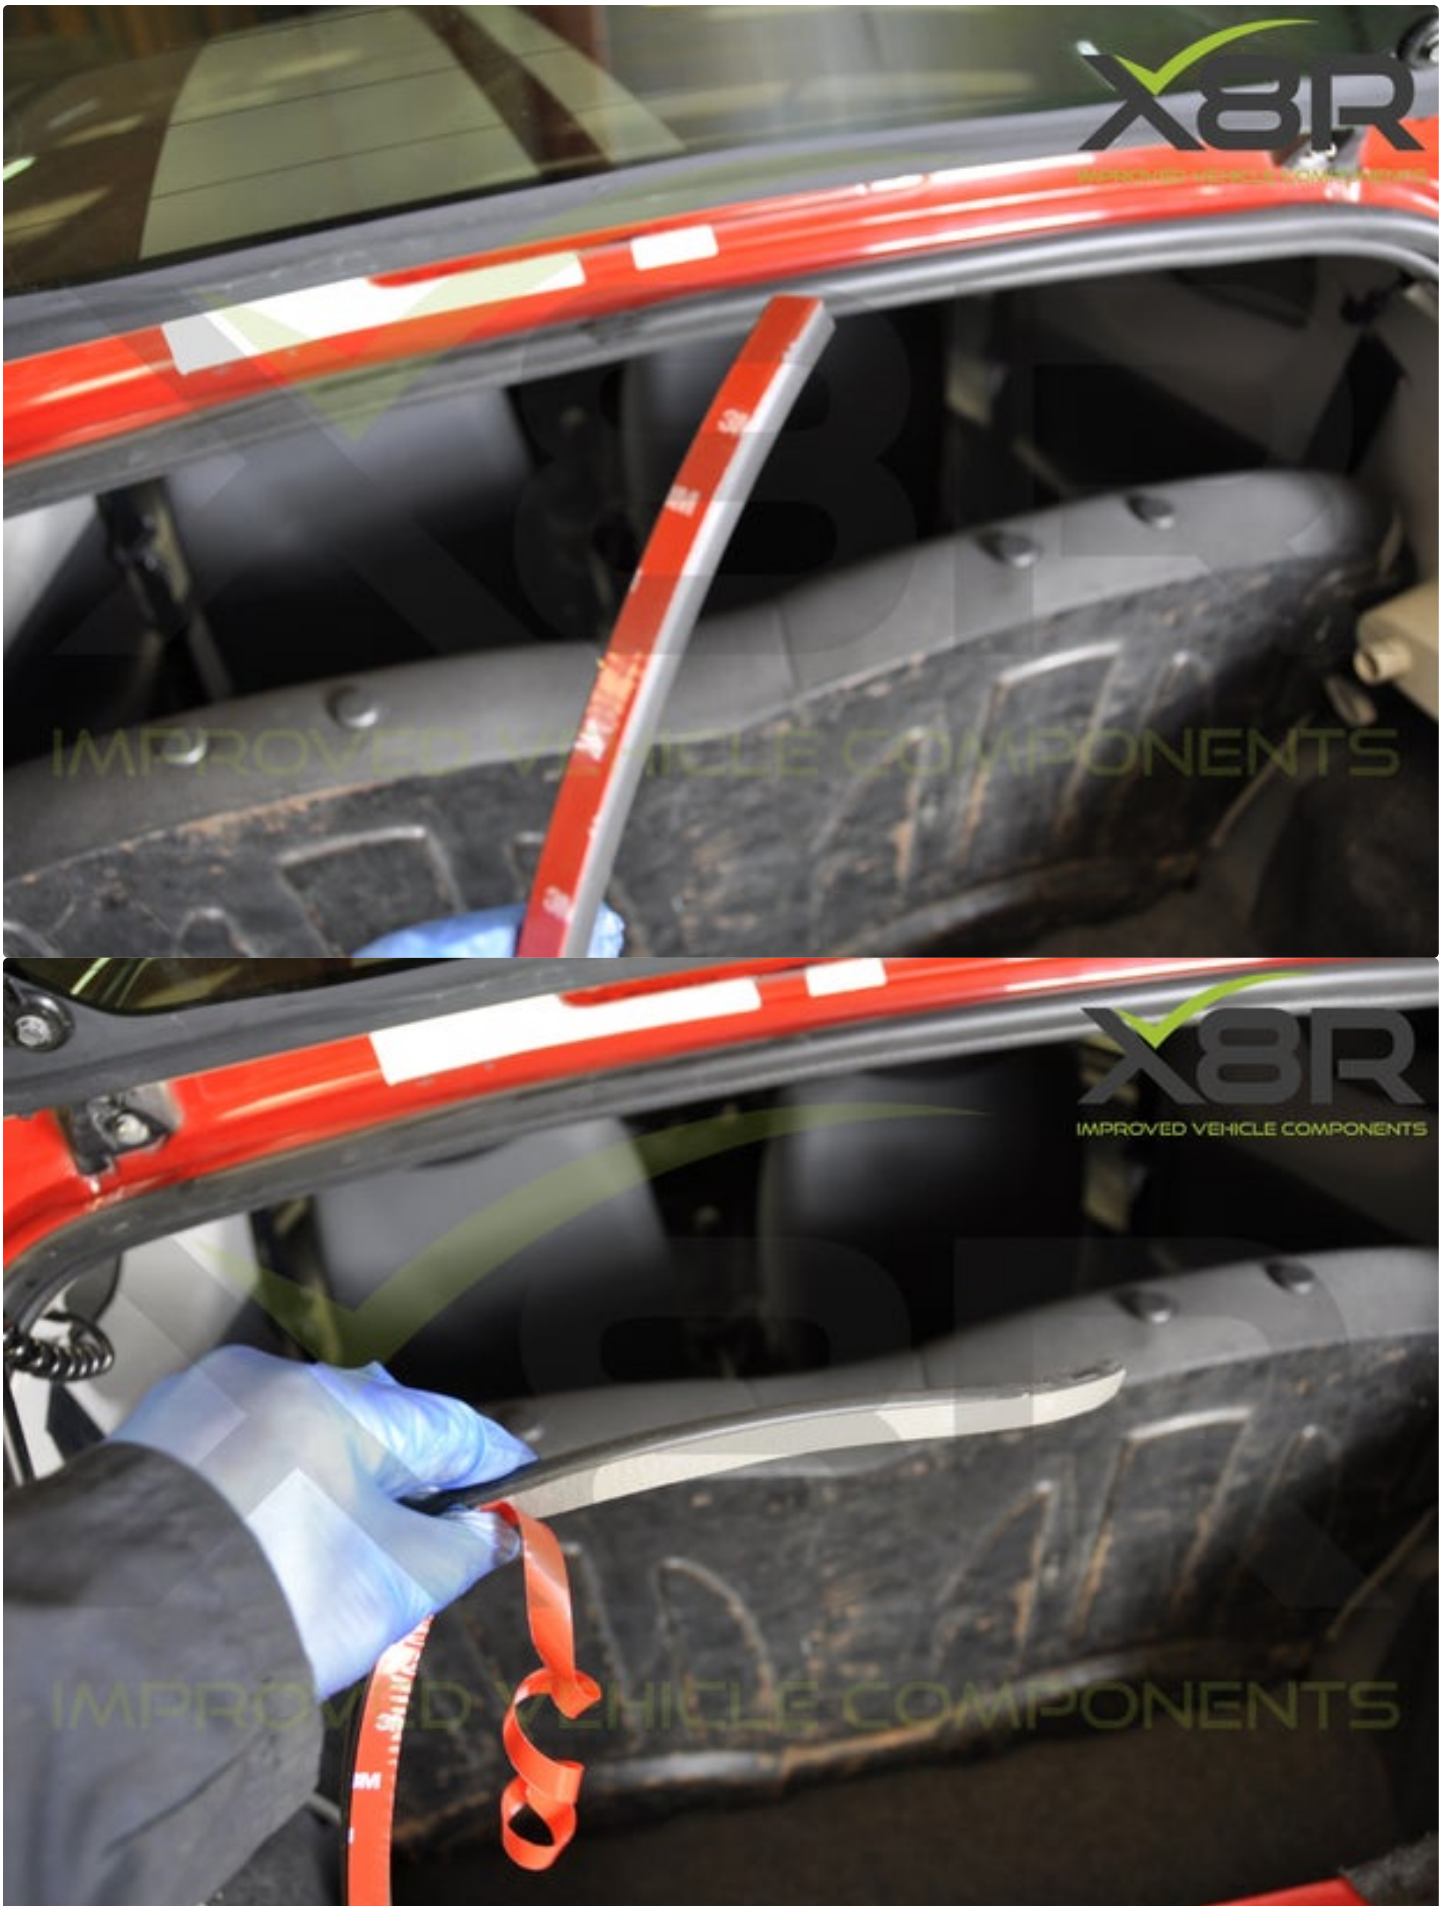
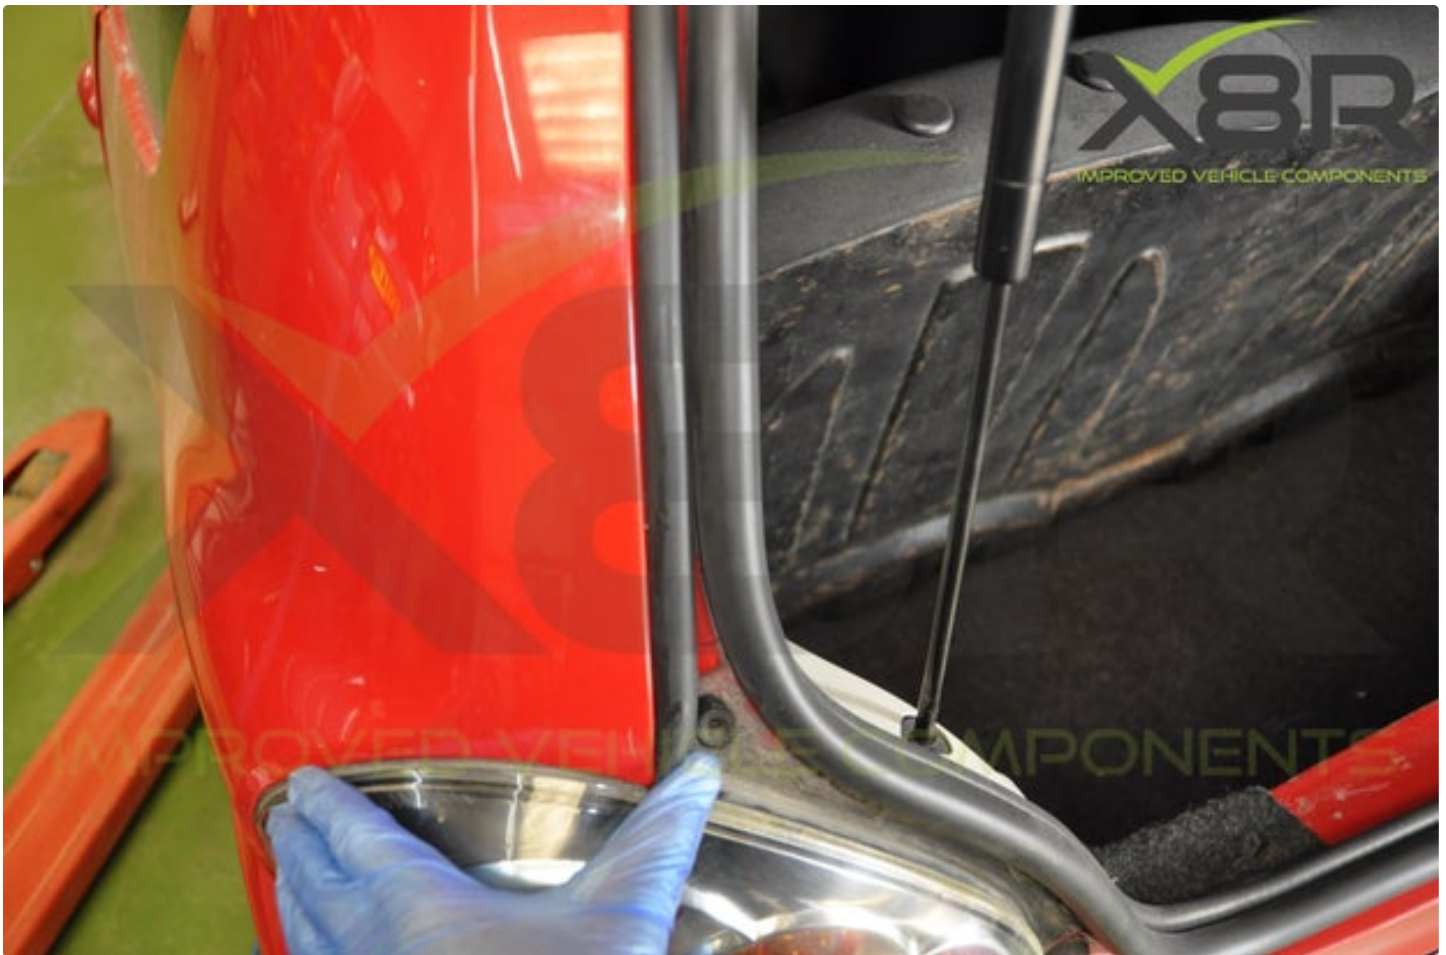
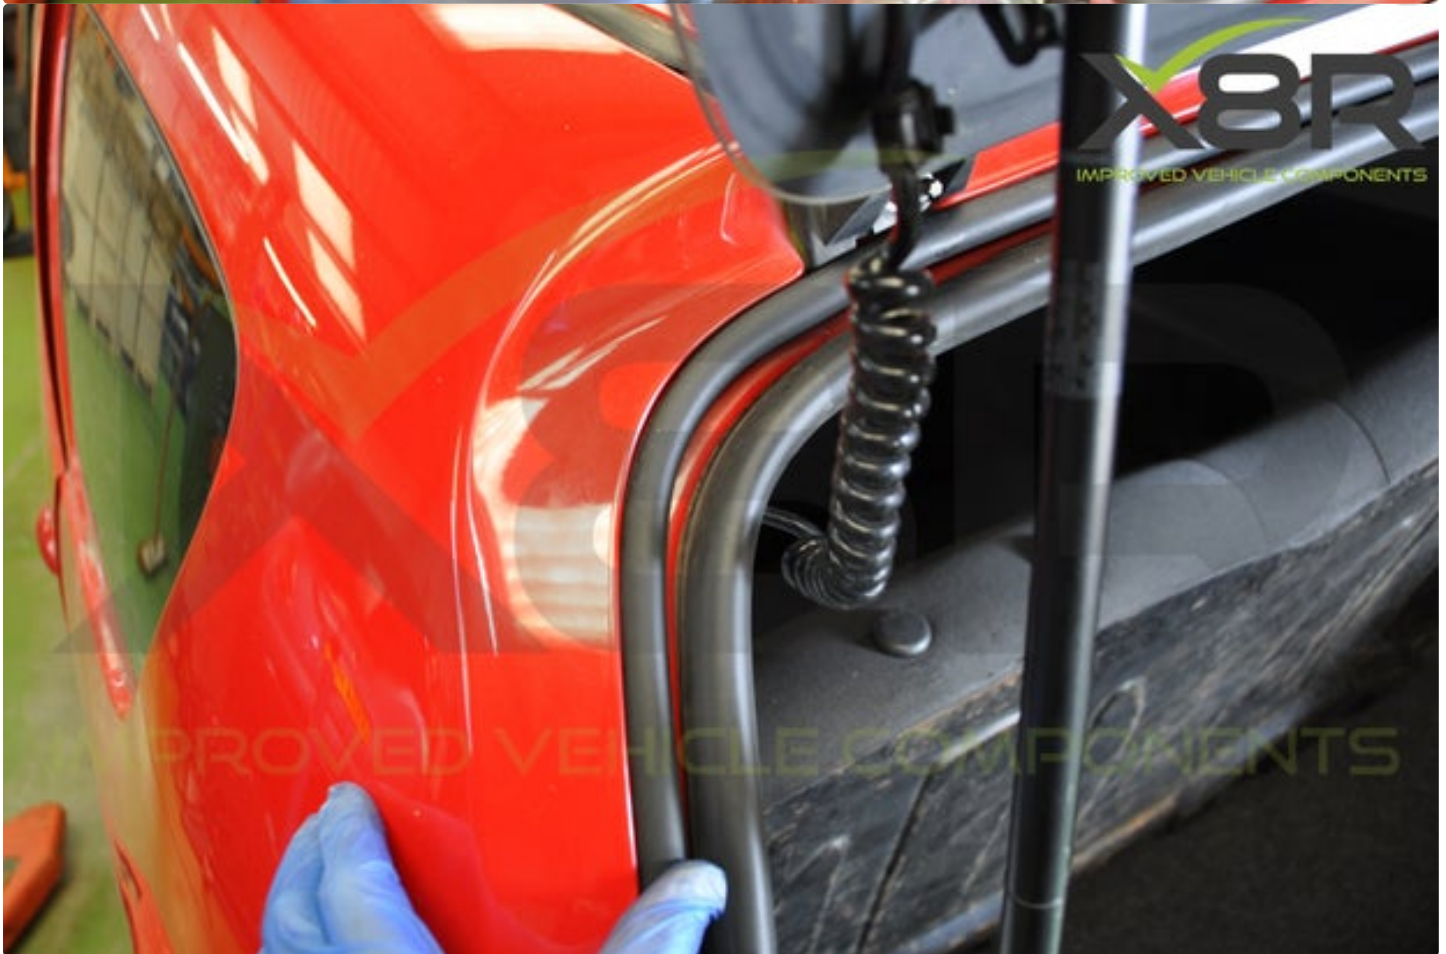
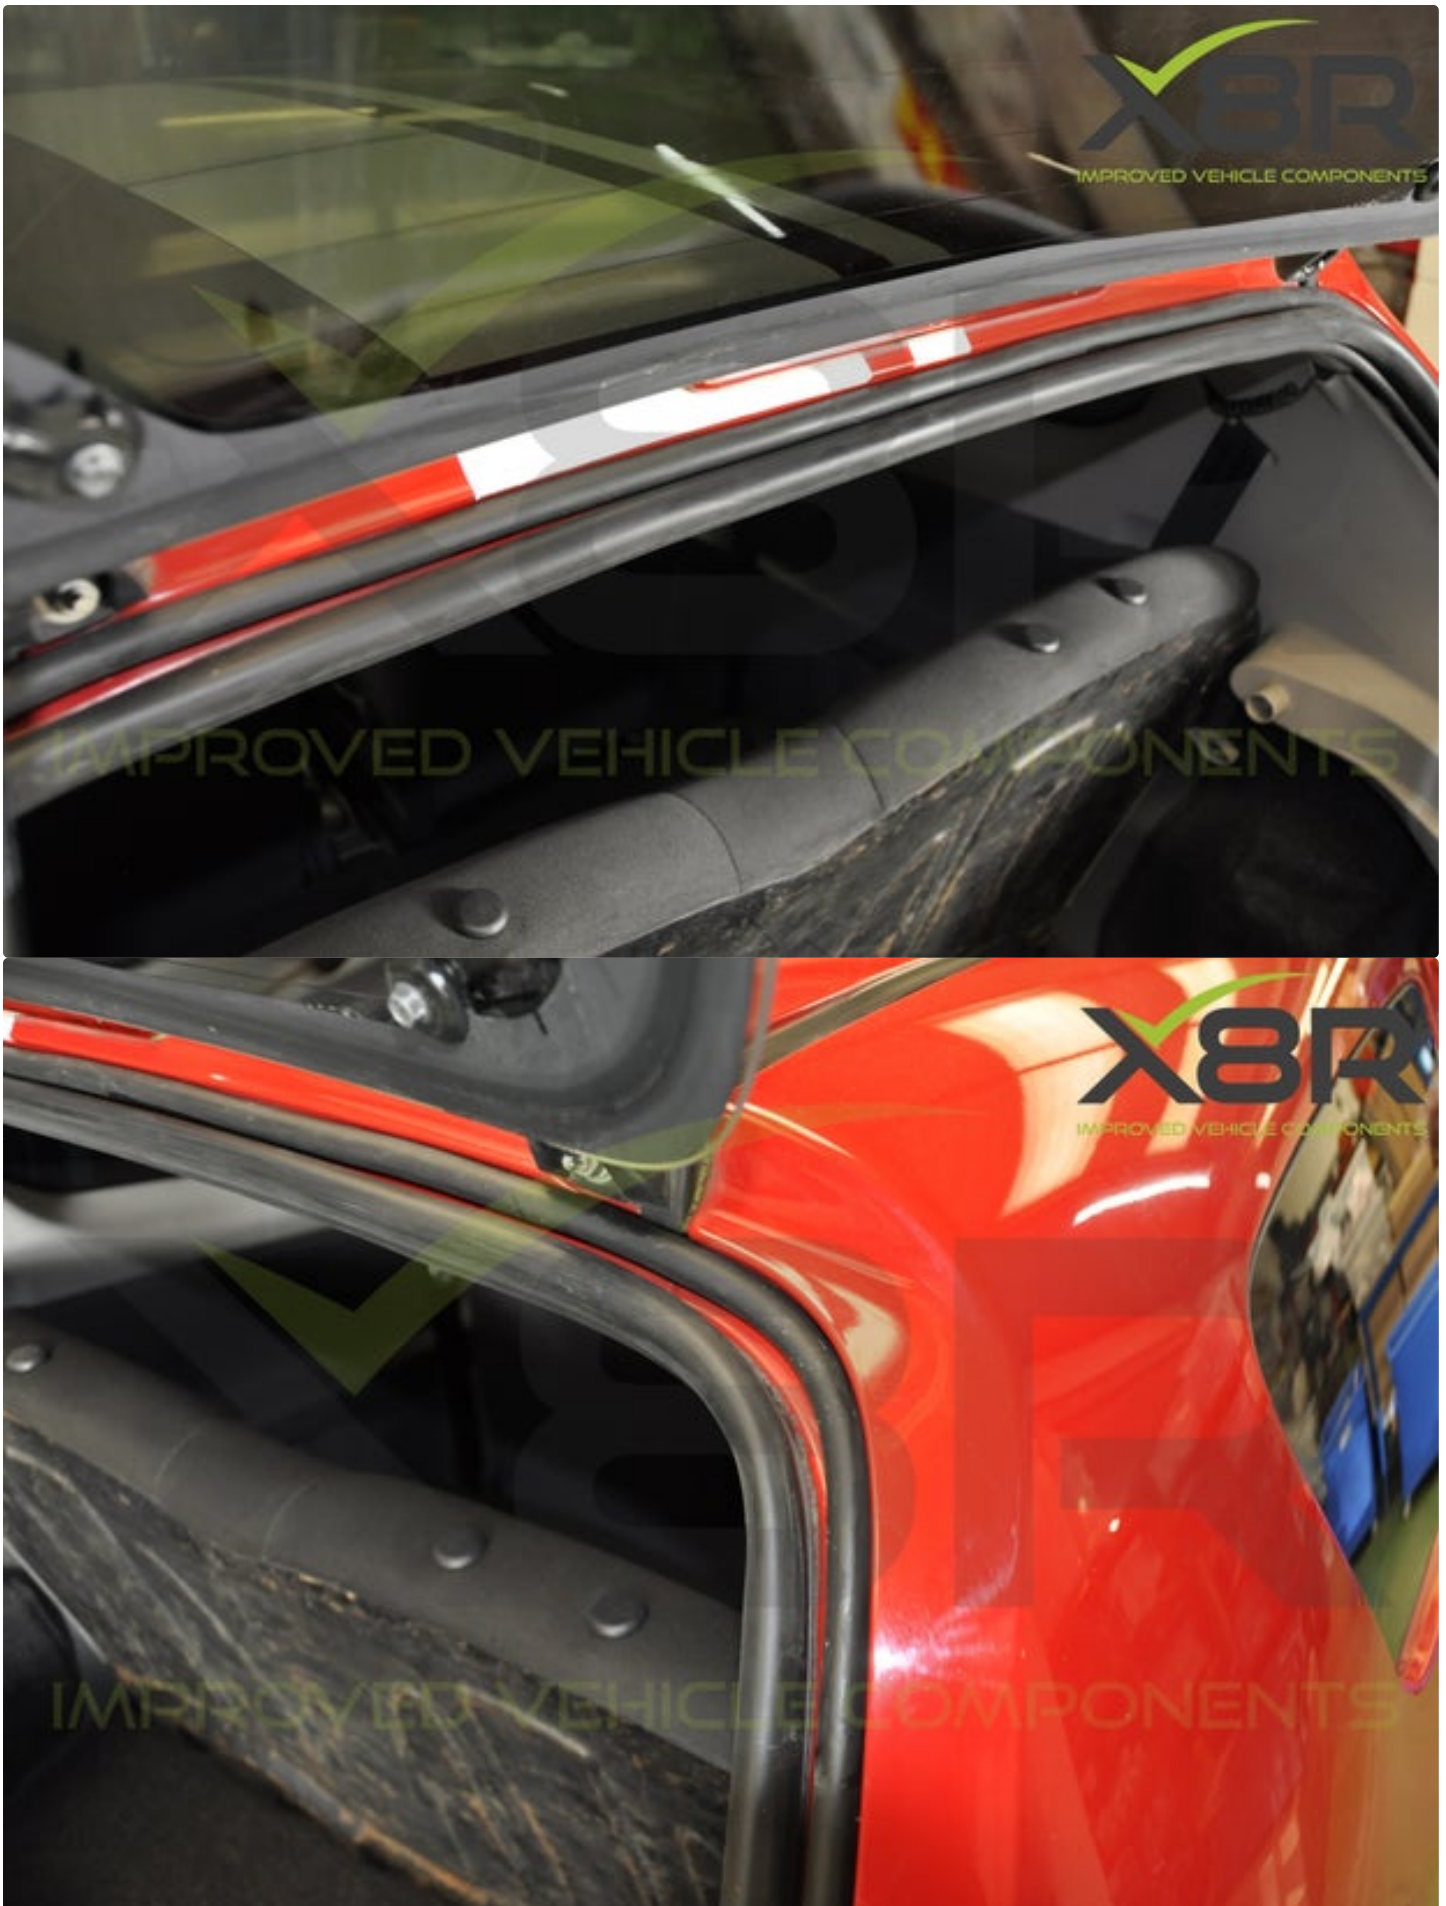
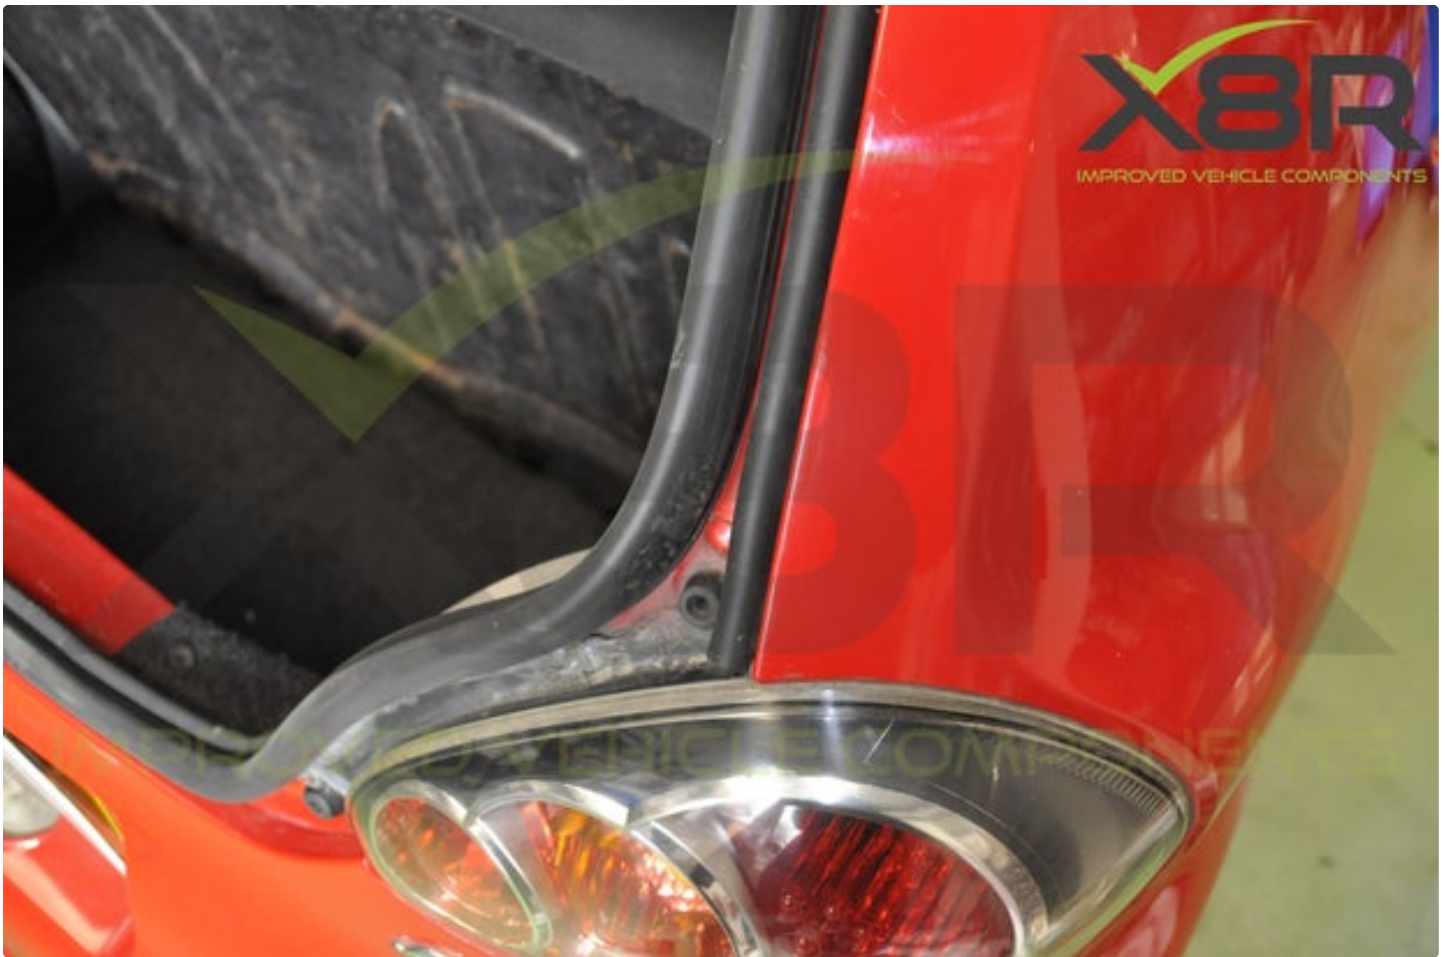
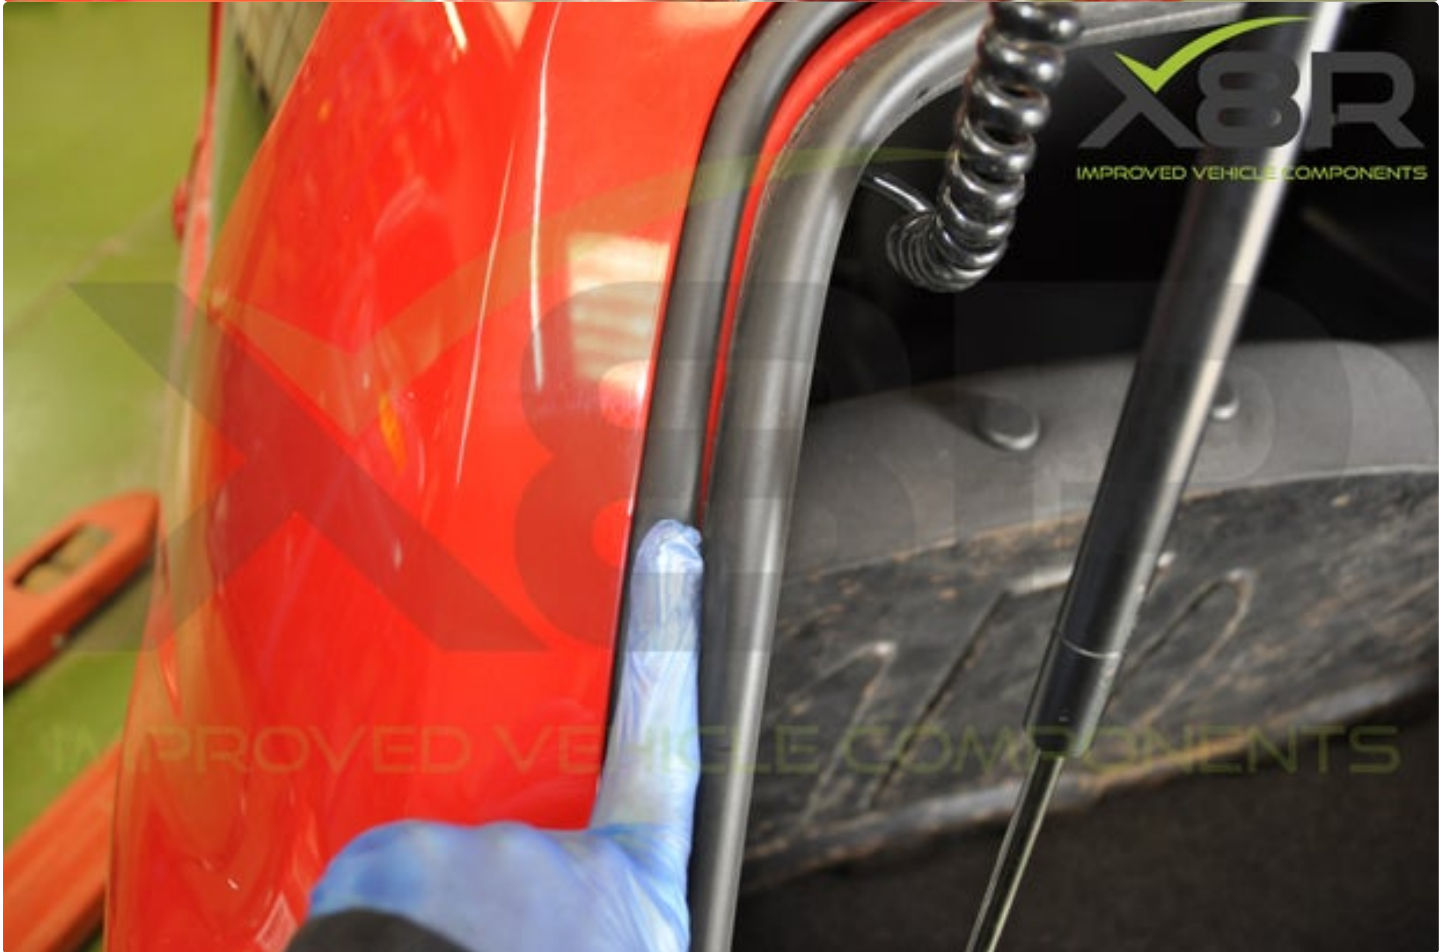
Step 6: Additional Boot Seal: Fit Seal

Peel back the adhesive backing paper and fit our seal in the position shown. As you work around the recess push the seal firmly in to position. If fitting in cold conditions a hot air gun can be used to make the seal more flexible. If the seal provided is too long (doors vary slightly by model) cut down to length with a pair of scissors so that the seal finishes at the location shown.
