TECHNICAL SERVICE BULLETIN				reissue No.26/2013 05 August 2013		
Circulate to:	Service Manager	Body Shop Manager	Parts Manager	Foremen	Receptionists	Technicians
© Ford Motor Company						
All rights reserved.						
This bulletin represents technical service information only. Without exception all gratis repairs and replacements are subject to the individual warranty and policy procedures of the supervisory Ford Company. The illustrations, technical information, data and descriptive text in this issue, to the best of our knowledge, were correct at the time of publication.						
This reissue replaces all previous versions. Please destroy all previous versions. Only refer to the electronic version of this TSB in FordEtis. The Service Instruction has been update to refer to the actual Warranty Bulletin 8/2013.						
Subject/Concern:		BOSCH 5-inch navigation unit will not switch on after a period of discontinued use or battery disconnection

Model:						
Fusion 2002.75 (06/2002–12/2011) - with BOSCH navigation system (5-inch display)				Build Date: 01.06.2008-01.06.2009 Build Code: 8K-9R Assembly Plant: Cologne		
Focus 2004.75 (07/2004–07/2011) - with BOSCH navigation system (5-inch di

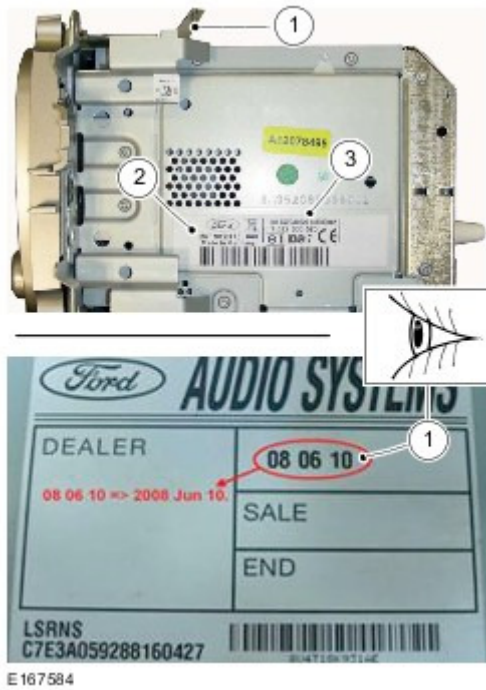
1. Partially remove the audio unit. For additional information refer to the corresponding Workshop Manual Section 415-01 on FordEtis.
 1. Obtain unit **build date** from sticker/tag.
Example: **08 06 10** = Calendar year / Month / Day = **2008 June 10**.
 2. Obtain unit **part number** from sticker/tag.
 3. Obtain unit **serial number** (last seven digits).
 - If the unit build date and part number is within the specified range (see Summary),

apply the Ford Direct Repair Process to obtain a unit replacement. Go to next step.
